Mill Creek Fish Passage Improvements

Joe Pecharich and Bob Pagliuco NOAA Restoration Center

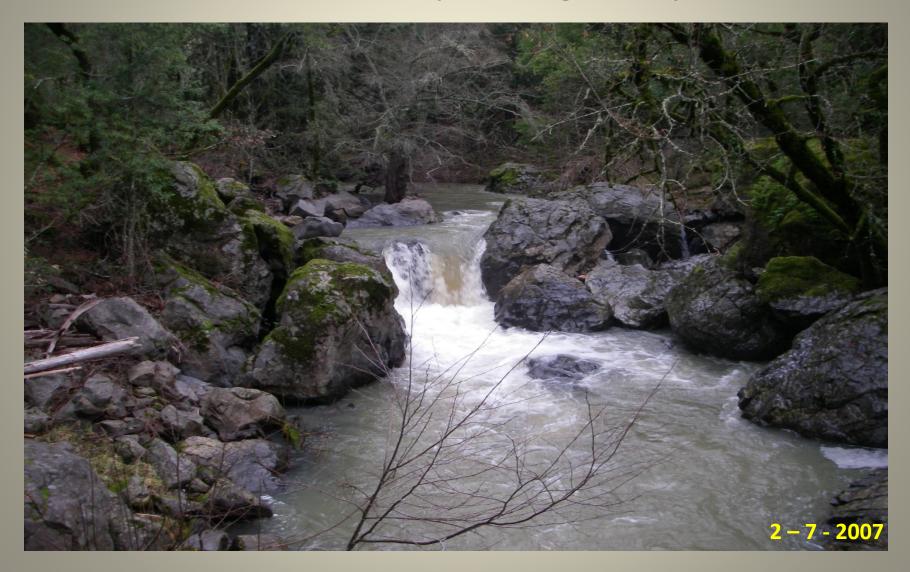
Barrier #1 – Modified waterfall and "sacrete" passageway

Modified waterfall – boulder placed created an ~6-7 foot jump with only 2-3 feet of depth

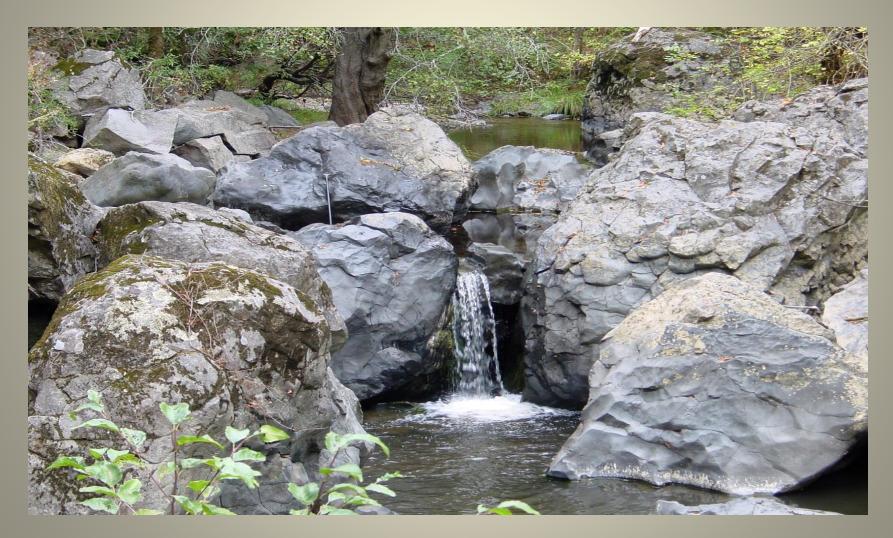
"Sacrete" filled passageway 10-4-2012

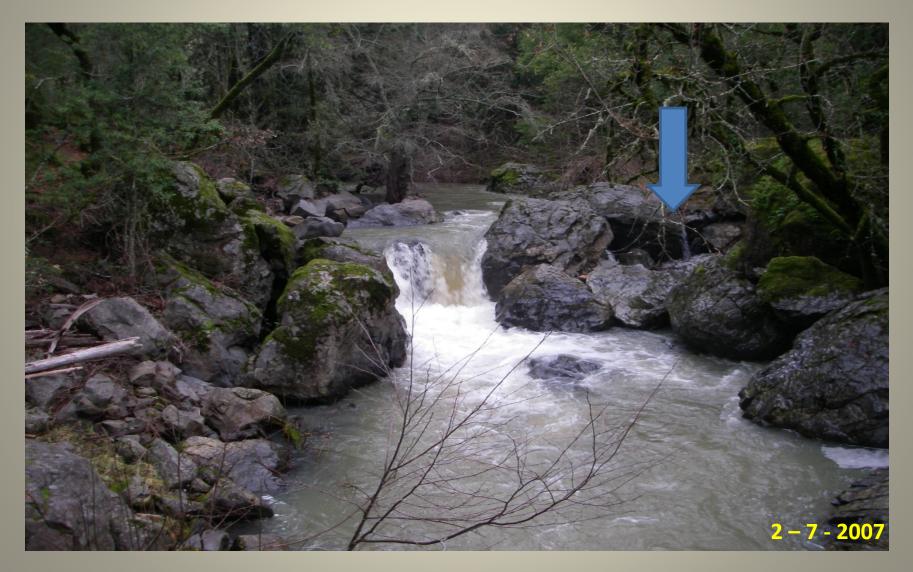
Waterfall area with "passage flows" - before

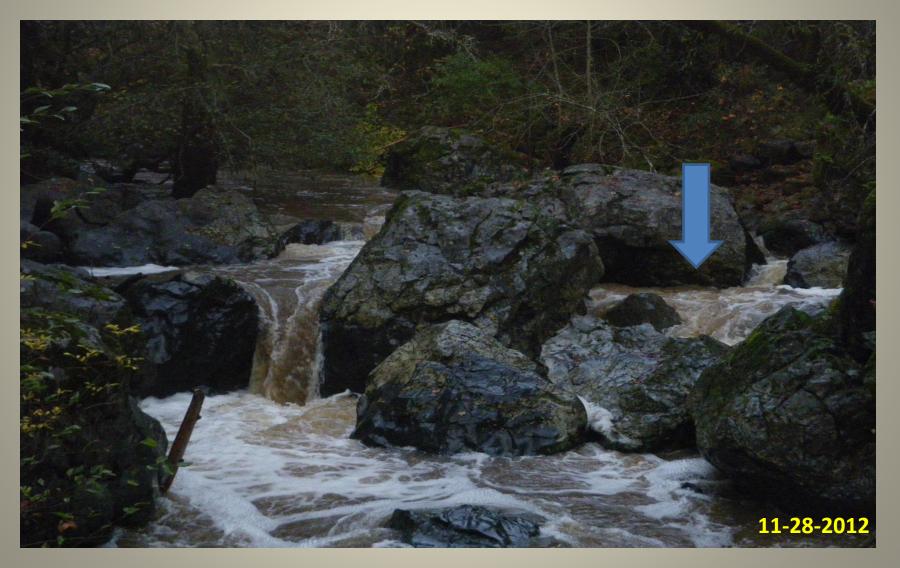
Waterfall area with "passage flows" - after

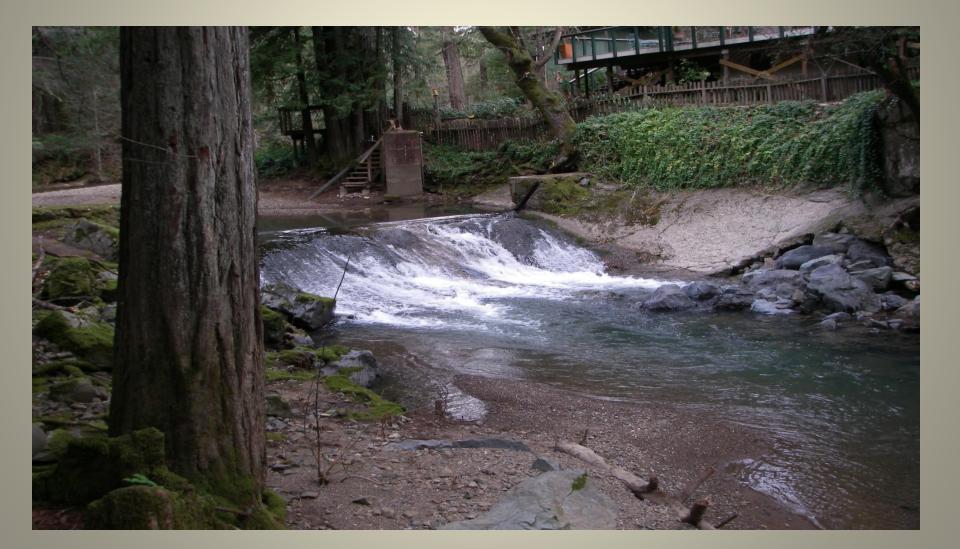
Barrier #2 – Large Flashboard Dam w/ Sill

blocks ~ 90% passage to 11.3 miles of habitat (~62% of the watershed) for coho and steelhead
