CORTE MADERA STREAM CROSSING INVENTORY AND FISH PASSAGE EVALUATION

FINAL REPORT

Prepared for the Friends of the Corte Madera Creek Watershed

Ross Taylor and Associates

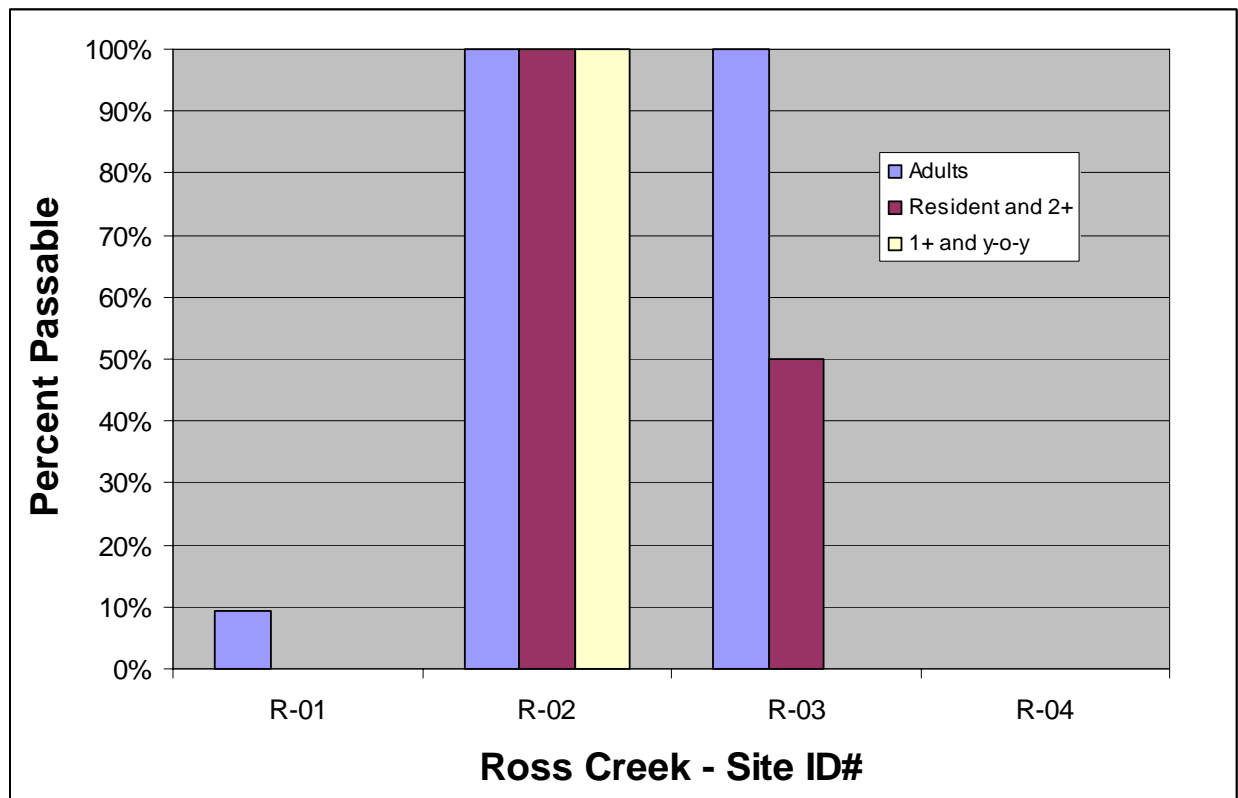
Figure 8. Passage evaluation results for four stream crossings in Ross Creek, Corte Madera Creek watershed, Marin County, CA.

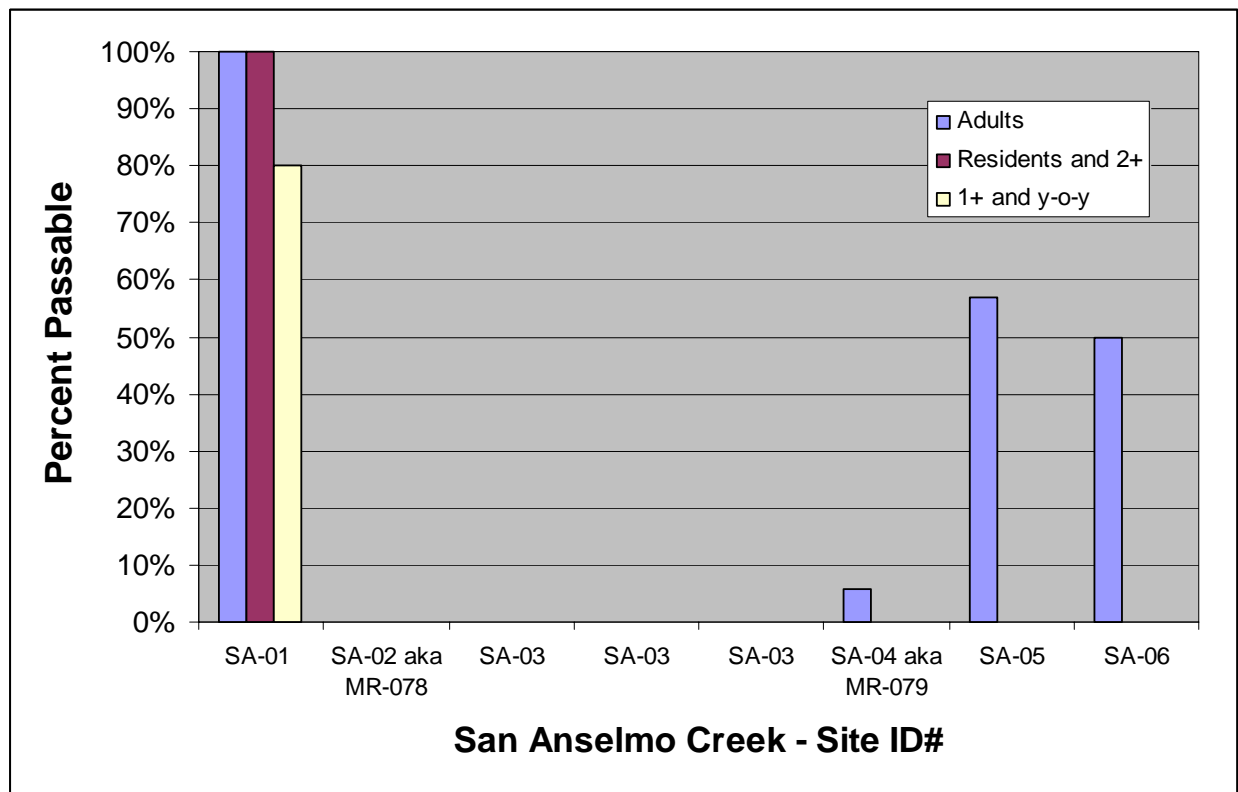
Figure 9. Passage evaluation results for six stream crossings in San Anselmo Creek, Corte Madera Creek watershed, Marin County, CA. SA-03 is comprised of two-bay box and arch.

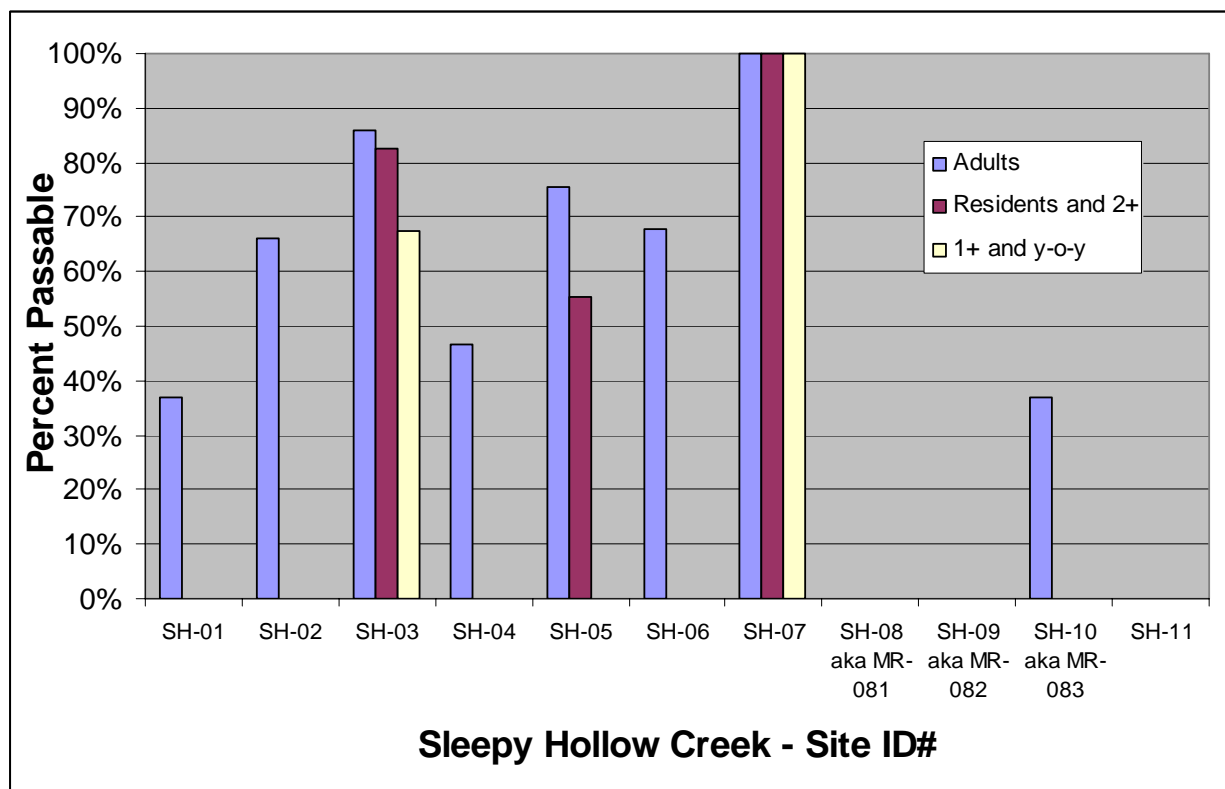
Figure 10. Passage evaluation results for 11 stream crossings in Sleepy Hollow Creek, Corte Madera Creek watershed, Marin County, CA.

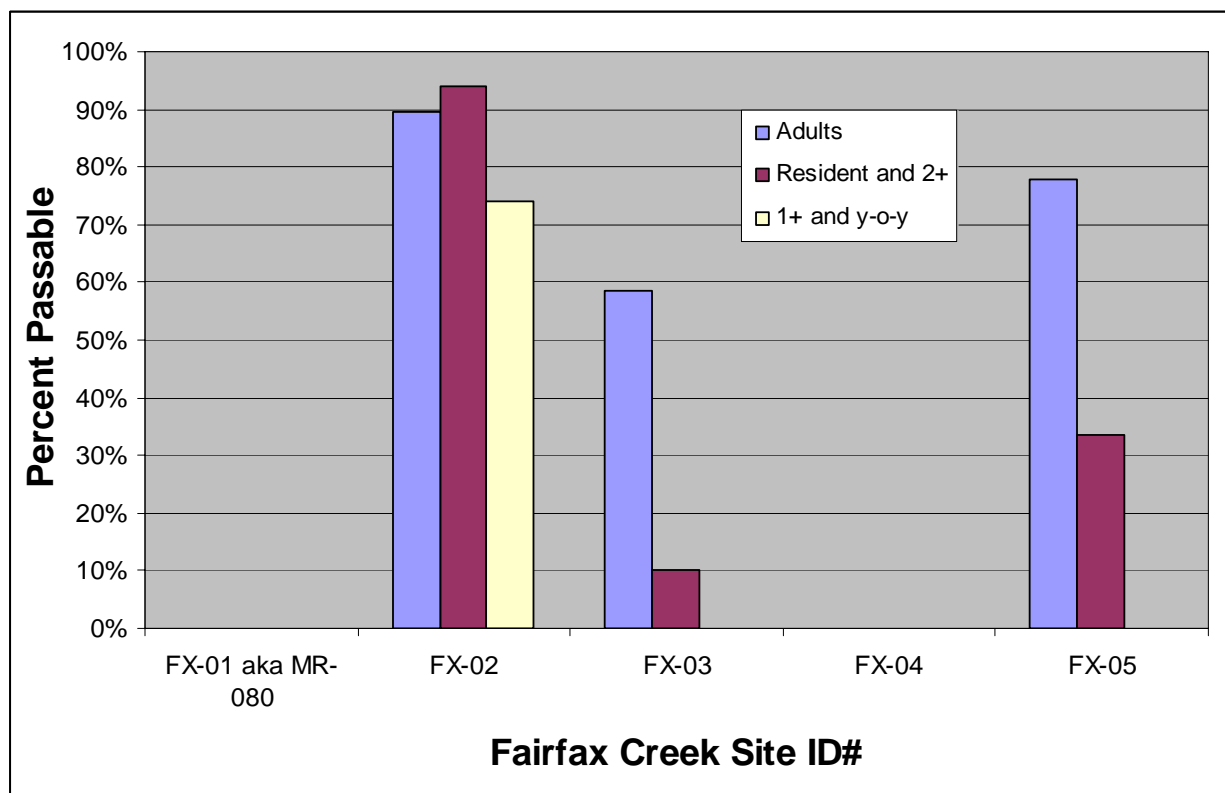
Figure 11. Passage evaluation results for five stream crossings in Fairfax Creek, Corte Madera Creek watershed, Marin County, CA.
