MARIN COUNTY STREAM CROSSING INVENTORY AND FISH PASSAGE EVALUATION

FINAL REPORT

Prepared for the County of Marin – Department of Public Works

Ross Taylor and Associates

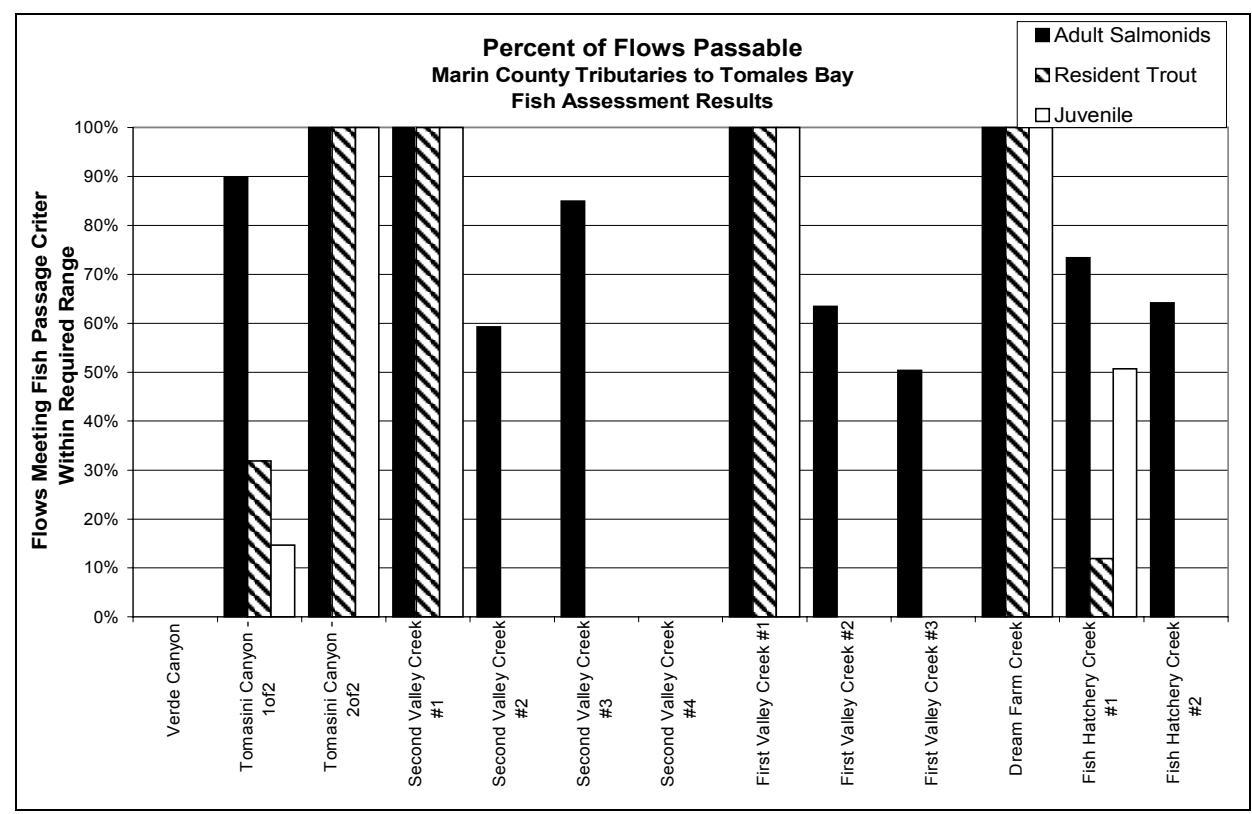
Figure 7. Percent passable as estimated by the Green-Gray-Red evaluation filter and FishXing for 12 Marin County stream crossings within tributaries of the Tomales Bay sub-watershed, by three groups of life stages.

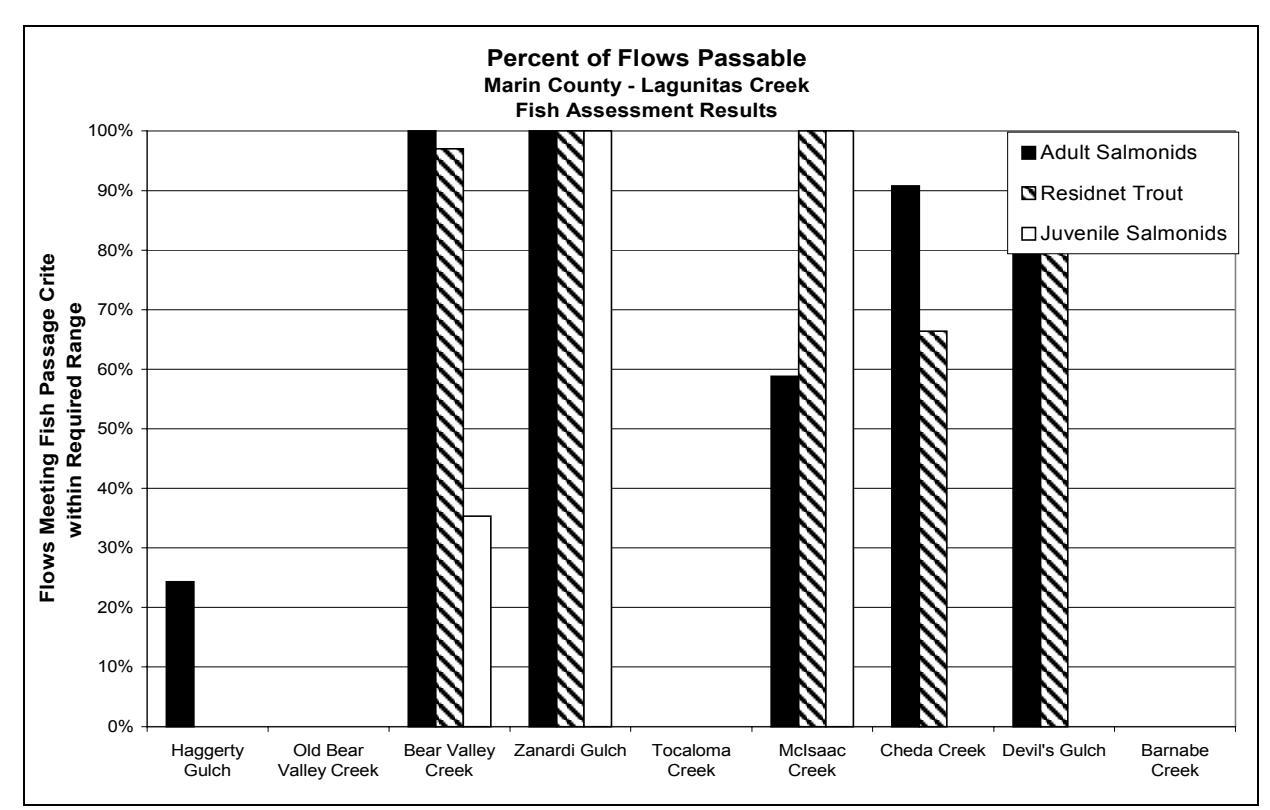
Figure 8. Percent passable as estimated by the Green-Gray-Red evaluation filter and FishXing for nine Marin County stream crossings within tributaries of Lagunitas Creek, by three groups of life stages.

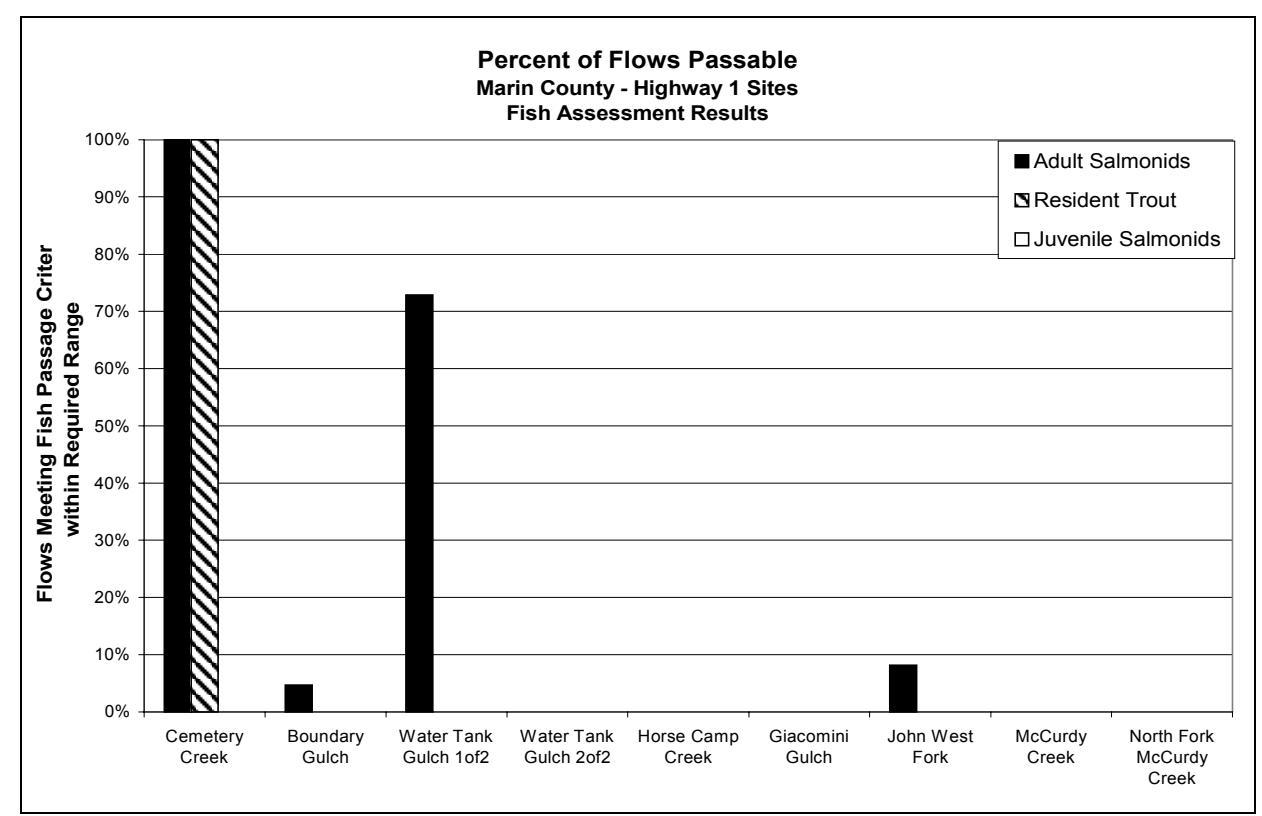
Figure 9. Percent passable as estimated by FishXing for eight Marin County stream crossings located on Highway One on tributaries to Olema Creek and Pine Creek, by three groups of life stages.

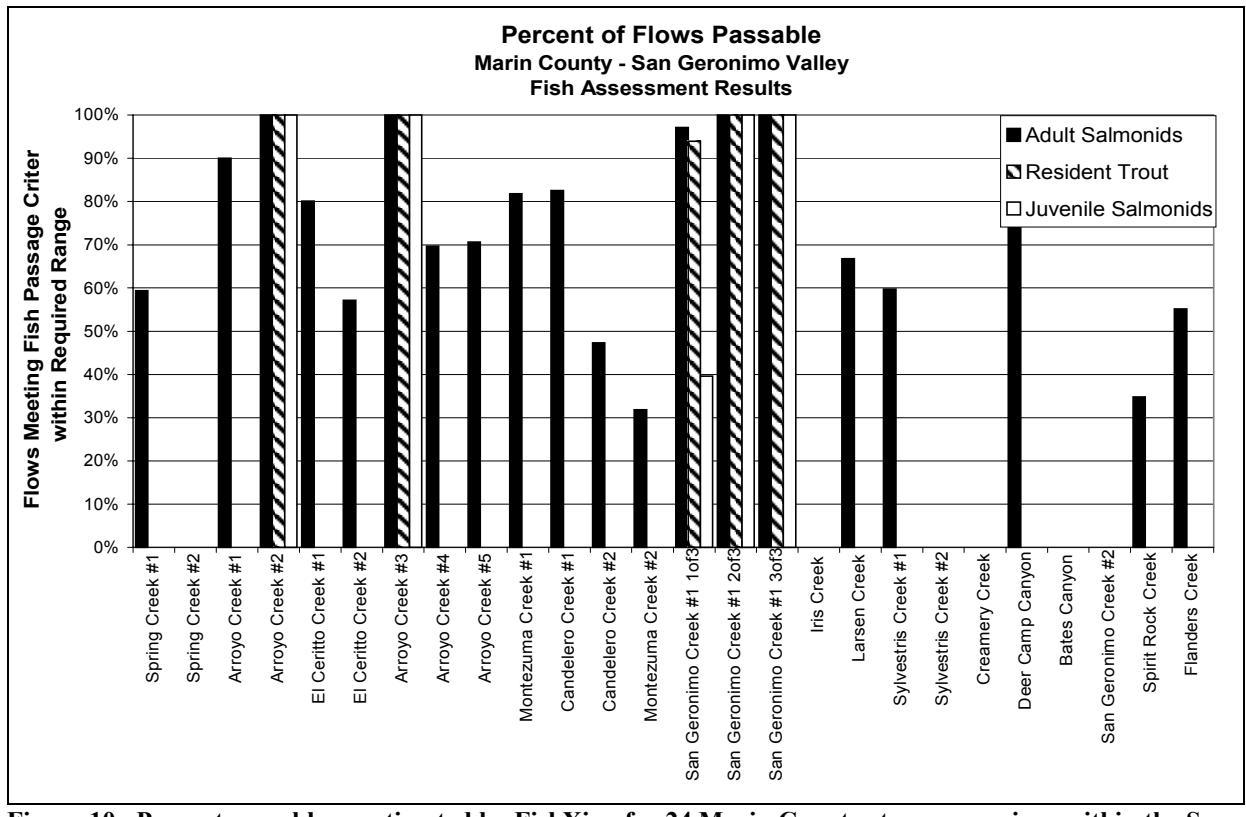
Figure 10. Percent passable as estimated by FishXing for 24 Marin County stream crossings within the San Geronimo sub-basin of the Lagunitas Creek watershed, by three groups of life stages.

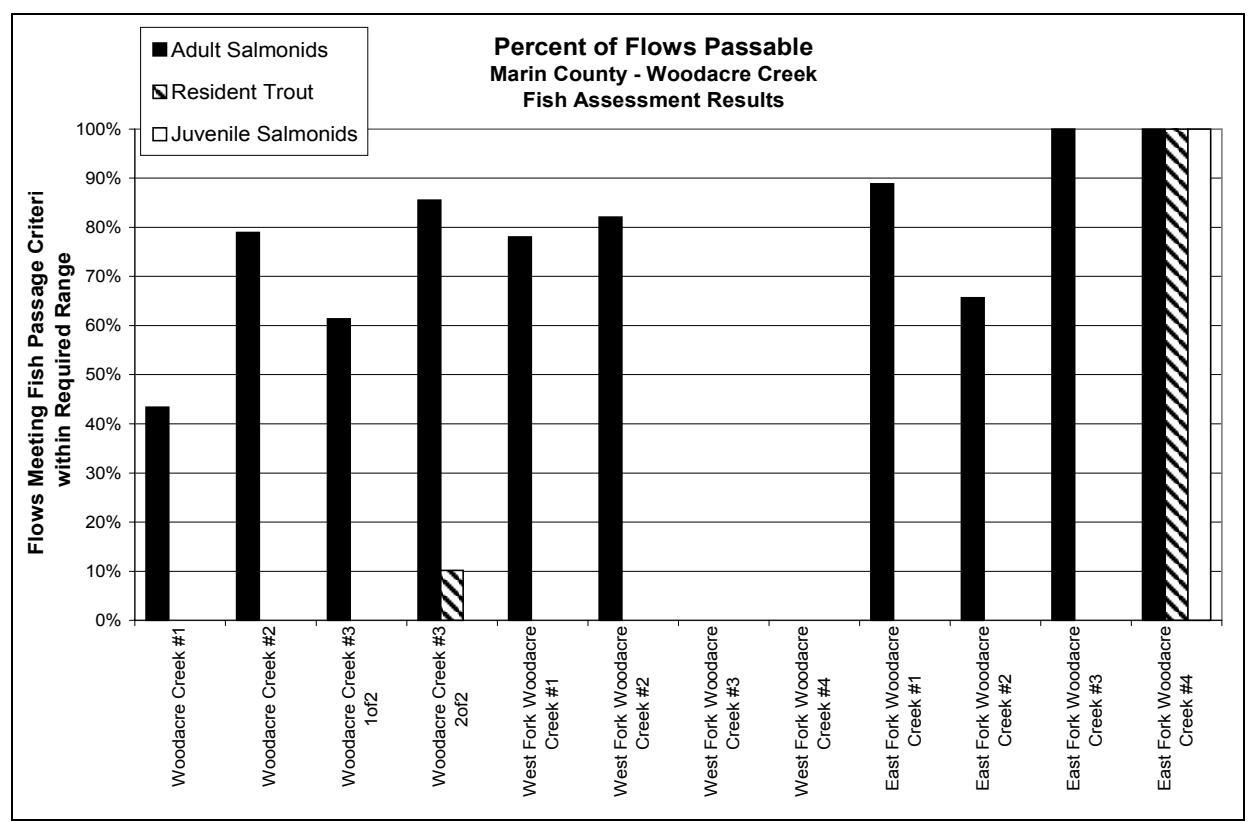
Figure 11. Percent passable as estimated by FishXing for 11 Marin County stream crossings within the Woodacre Creek sub-basin of the Lagunitas Creek watershed, by three groups of life stages.

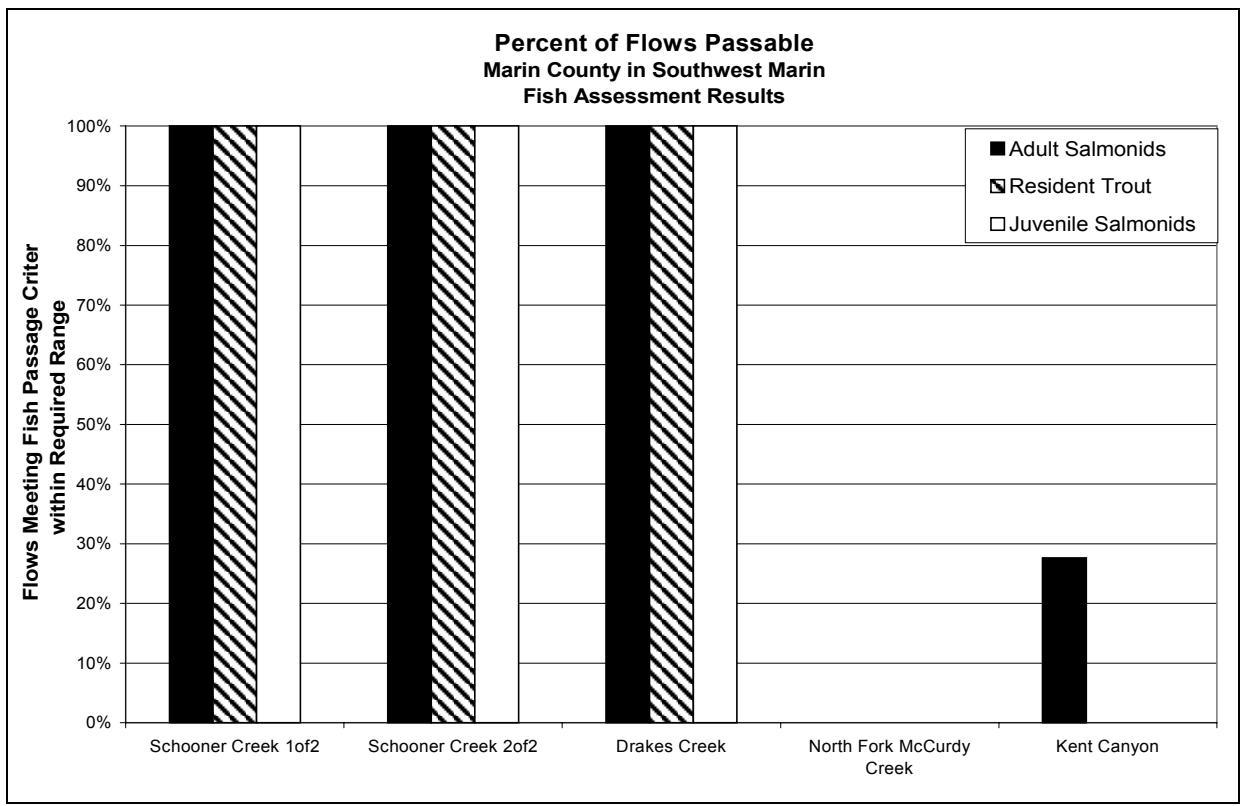
Figure 12. Percent passable as estimated by FishXing for four Marin County stream crossings on tributaries located in southwestern Marin County, by three groups of life stages.

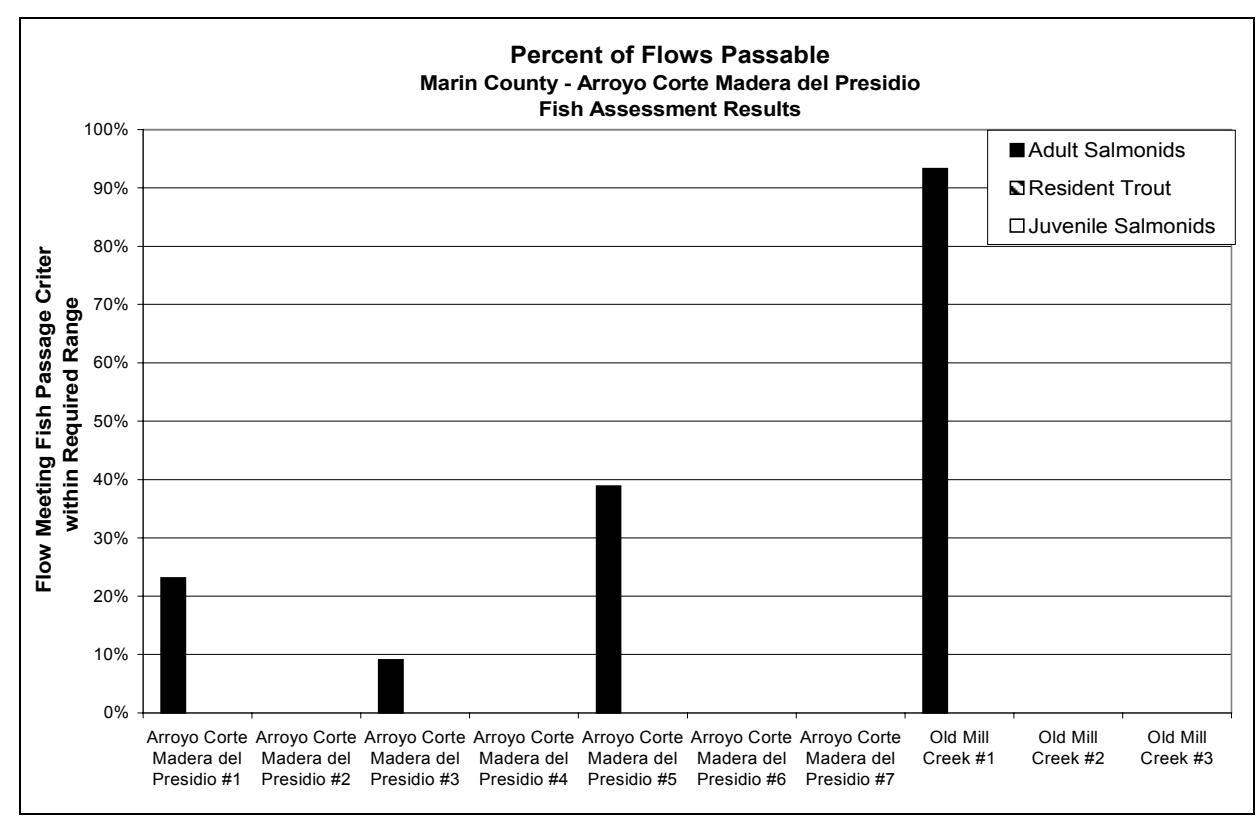
Figure 13. Percent passable as estimated by FishXing for 10 Marin County stream crossings within the Arroyo Corte Madera del Presidio watershed, by three groups of life stages.

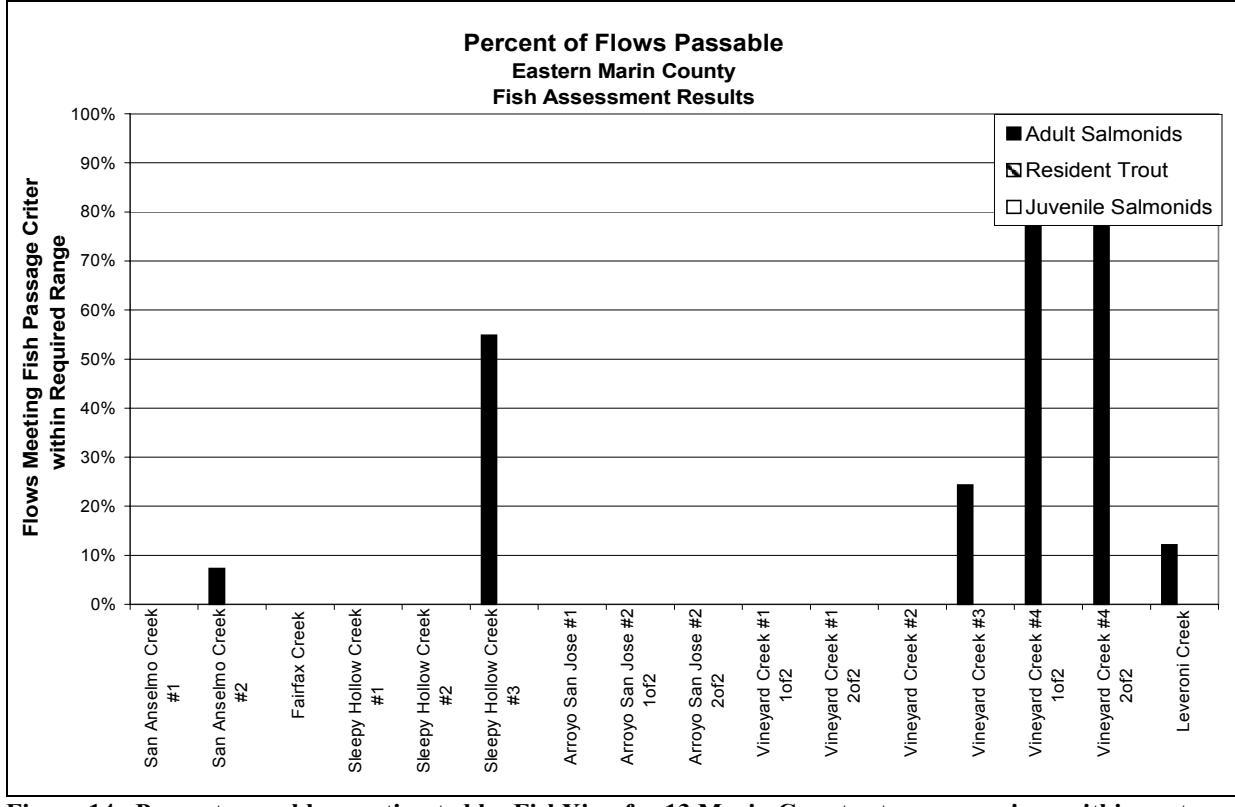
Figure 14. Percent passable as estimated by FishXing for 13 Marin County stream crossings within eastern Marin County watershed, by three groups of life stages.
