Flood Effects on Road-Stream Crossing Infrastructure: Economic and Ecological Benefits of Stream Simulation Designs

Flood Effects on Road–Stream Crossing Infrastructure: Economic and Ecological Benefits of Stream Simulation Designs

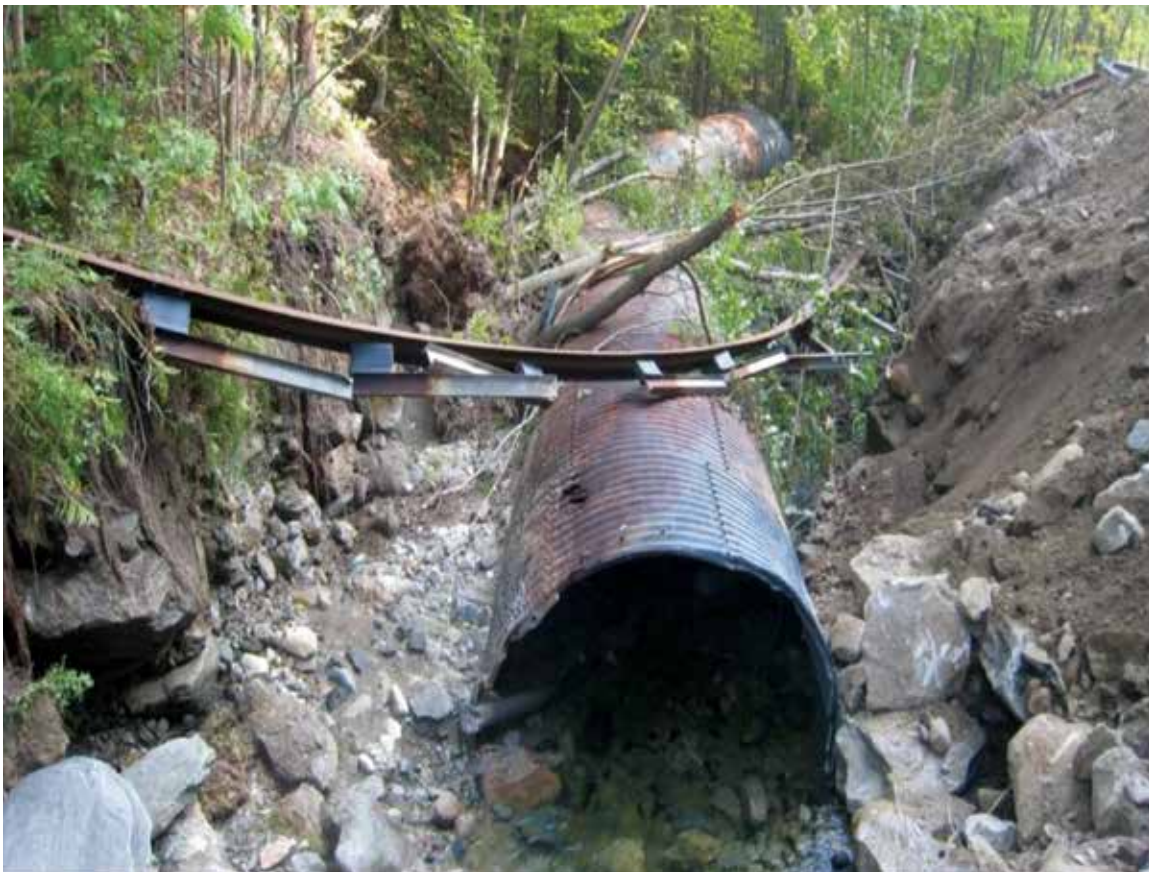
Figure 1. Road failure at a 3-m culvert placed within a 6-m bankfull width stream, Green Mountain National Forest. Photo credit: Dan McKinley, Green Mountain National Forest.

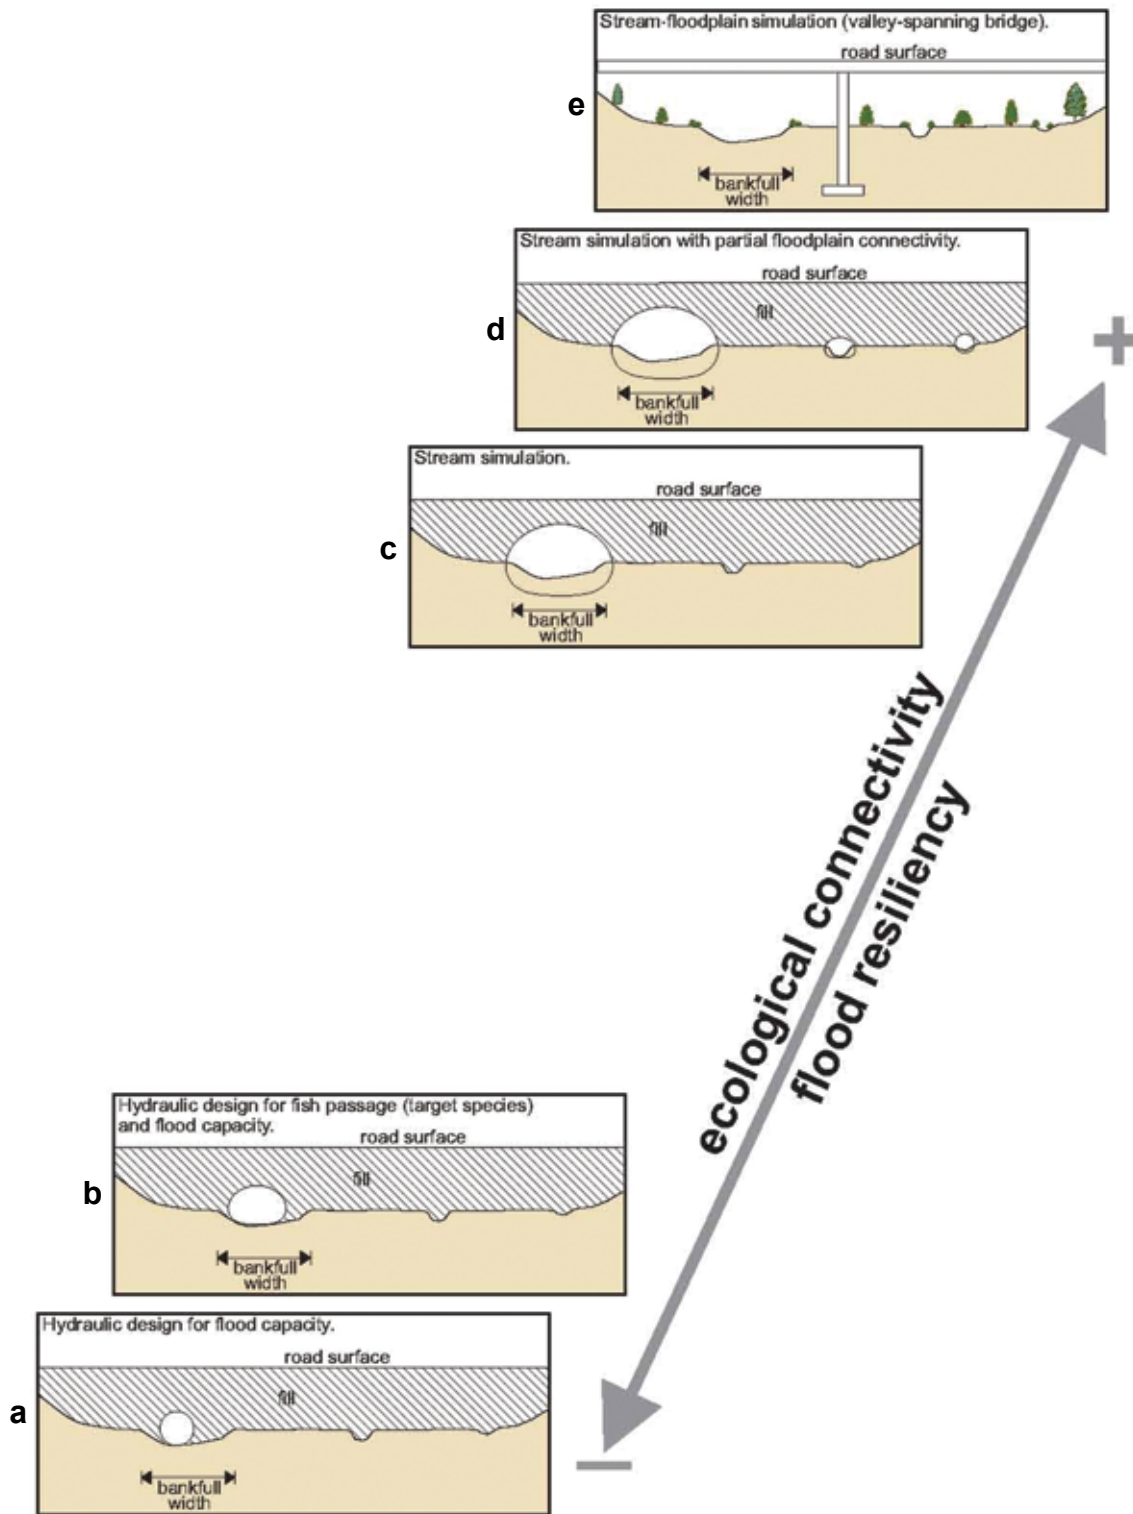
Figure 2. An ecological connectivity and flood resilience continuum for different design approaches at road-stream crossings (adapted from SSWG, 2008). The stream-floodplain simulation design (top graphic) provides passage for all aquatic and terrestrial species all at flow levels and minimal interference of stream and floodplain processes, resulting in greater ecological connectivity and flood resiliency. The stream simulation design (middle graphic) provides for fully functioning floodplain processes, passing floodwater, sediment and woody debris and all aquatic species for a broad range of flows. The hydraulic design for flood capacity (bottom graphic) only provides for partial functioning of stream processes, impedes passage of some floodwaters, sediment, and woody debris during high flows, and impedes passage of most aquatic species for most flows, consequently providing low ecological connectivity and flood resiliency.

and Washington (Orsborn et al. 2002; Clarkin et al. 2005). Prior to the 1970s, a hydraulic design approach to road–stream crossings focused on efficiently conveying flood flows with minimal or no concern for the movement and habitat needs of fish (Figure 2a). In the 1970s and 1980s, hydraulic design structures were modified to create hydraulic conditions that allowed for passage of adult fish including fishways, baffles, and weirs (Figure 2b; Cenderelli et al. 2011). Structures substantially narrower than the width of the adjacent natural channel, however, were only partially successful in allowing passage for the targeted adult fish species, and they did not address the passage needs of multiple species occupying the stream corridor at different life stages and flow conditions. Into the 1990s, hydraulic engineers continued to study and provide design advice to agency fisheries biologists. As Endangered Species Act listings for Pacific Coast salmonids increased in the 1990s and understanding of river and stream geomorphology among agency staff improved, inventories of road system crossings and design improvements to provide passage of all aquatic species, not just adult salmon and trout, increased. Recognizing the limitations of hydraulic design approaches for meeting the passage needs of multiple species occupying the stream corridor at different life stages and flow conditions, a stream simulation design approach was developed (Figures 2c–2e).

Long-term maintenance and replacement costs should also be considered. Hydraulic designs (Figures 2a and 3) that constrict the stream channel can incur a yearly maintenance cost from debris removal and pose a greater risk of unexpected replacement costs from failure during large magnitude floods (Furniss et al. 1997). In contrast, stream simulation designs that span the bankfull channel (Figures 2c–2e and 4) have demonstrated minimal or no annual maintenance costs and are flood resilient and are likely to last longer than their projected service life (Long 2010). Galvanized steel culverts installed using the stream simulation design method have an anticipated service life of 50 to 75 years because the constructed stream channel

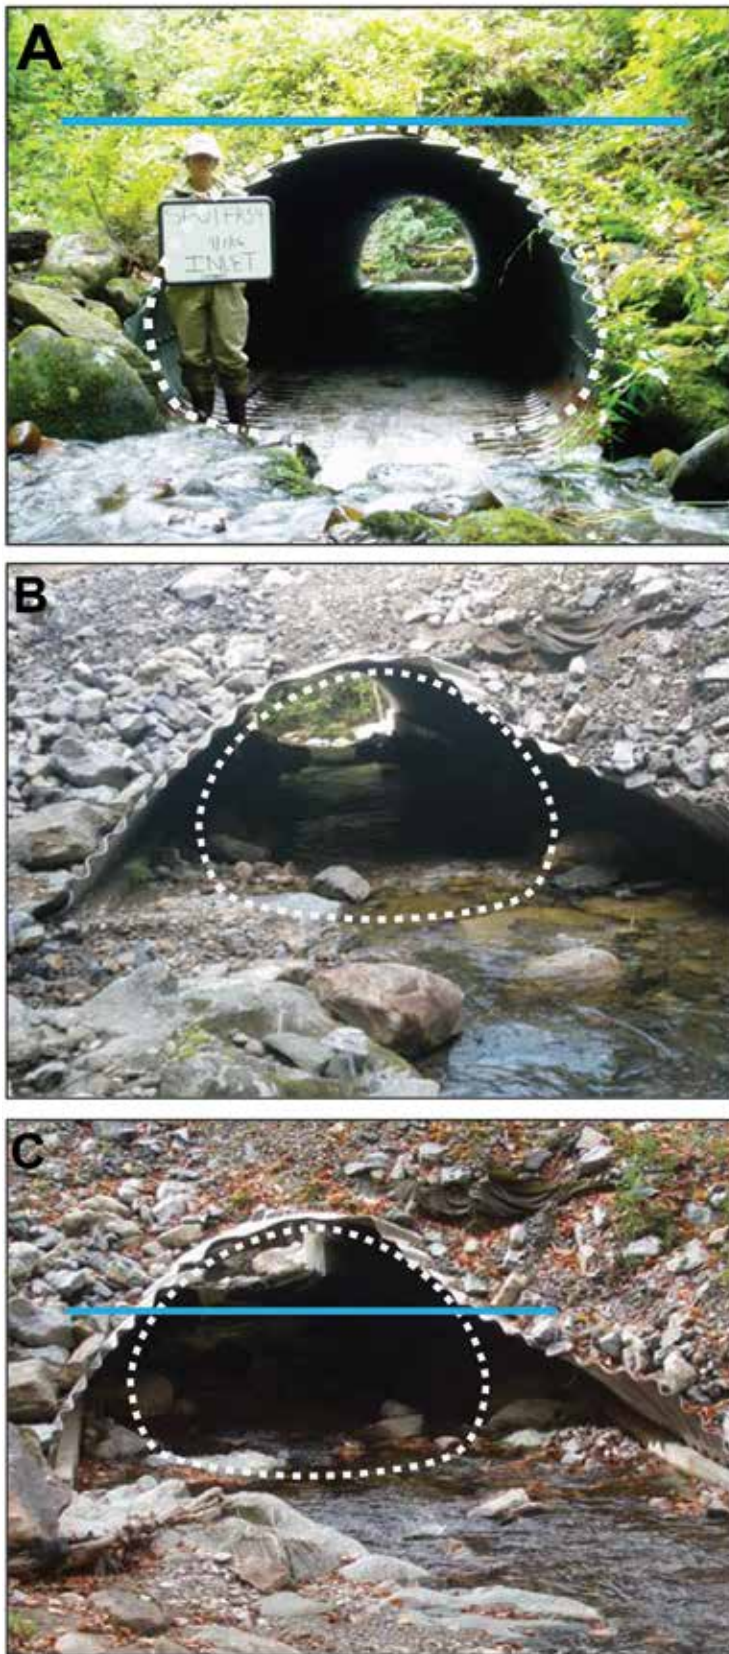
Figure 3. Sparks Brook road-stream crossing located on the Green Mountain National Forest, showing (a) original hydraulic design pipe-arch built in late 1960's, with a 2.5 m span and 1.9 m rise; (b) stream simulation design open-bottom arch structure built in 2010 with 4.5 m span, 1.62 m rise and footers extending 2.7 m below channel bed; (c) replacement structure after Irene flood. The blue line illustrates the actual peak flood water-surface elevation as well as the estimated peak flood elevation if the original culvert had been in place. Photo credit: Dan McKinley, Green Mountain National Forest.

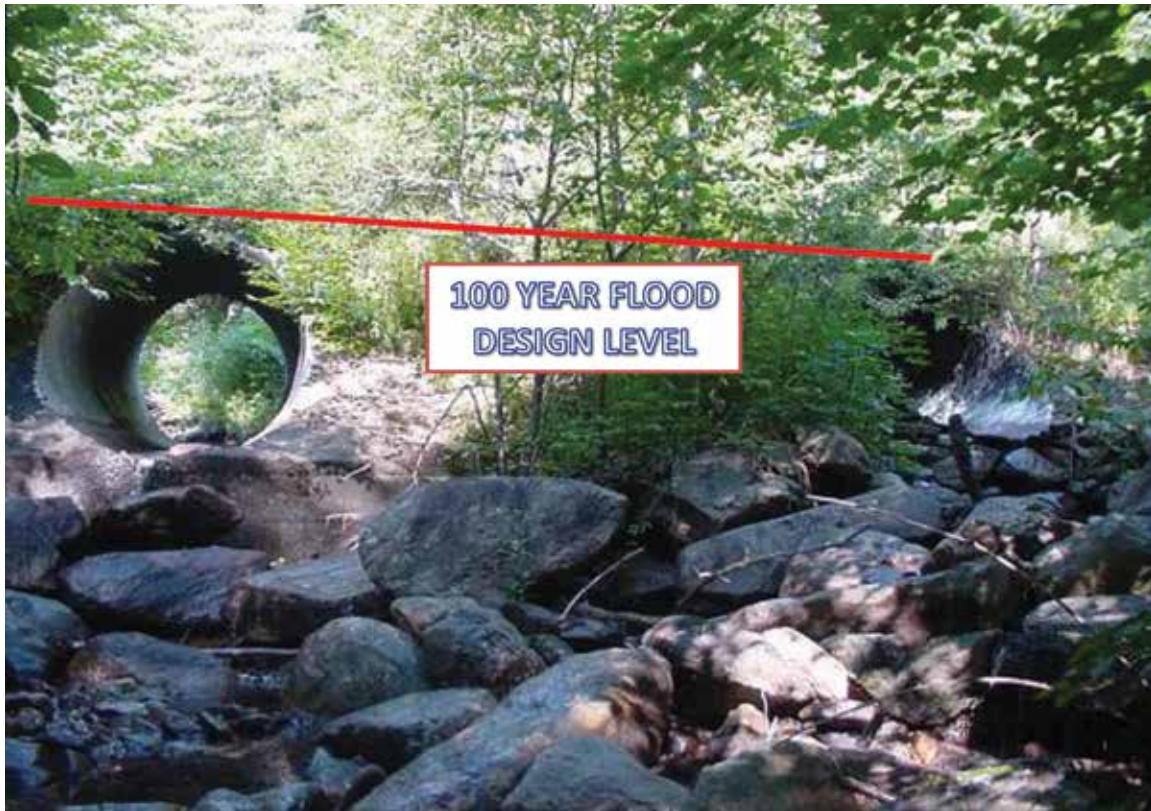
Figure 4. Typical hydraulic design double culvert over Jenny Coolidge Brook, May 2010. Green Mountain National Forest showing estimated height of 100-flood design discharge in red. Photo credit: Brian Austin, Green Mountain National Forest.

The hydraulic capacity design method differs from the stream simulation design method in fundamental ways (Figure 5). Stream simulation design determines the size of the structure based on the physical dimensions of the natural channel first and foremost and evaluates hydraulic capacity as a secondary check to ensure sufficient conveyance of the 100-year flood with additional clearance for debris transport. In contrast, traditional hydraulic design methods give no consideration of the actual physical dimensions of the natural channel when sizing the road–stream crossing structure. Hydraulic design structures are sized to pass a design flood (e.g., Q10 flood, Q25 flood, Q100 flood) with headwater-to-depth ratios typically at 1.0 or greater (Hotchkiss and Frei 2007). Design flood discharge estimates are usually determined using regional regression equations that typically have standard error estimates greater than 40%. Additionally, regional regression equations used to predict design discharge were typically developed for larger drainages and are not necessarily applicable to small drainages, which add to the uncertainty of the discharge estimates. Recent analyses and predictions under a changing climate suggest that the set of return interval floods underlying hydraulic capacity designs are no longer valid. In New England, trends in measures of precipitation intensity (Huntington et al. 2009) and frequency of larger precipitation events increased by 85% since 1948 (Madsen and Wilcox 2012), and the recent record-breaking storm events such as Tropical Storms Irene, Lee, and Sandy (Douglas and Fairbank 2011) and the projected increases in total annual precipitation (Intergovernmental Panel on Climate Change 2007) and rain on snow events (Douglas and Fairbank 2011) strongly suggest the need for changing flood discharge estimates.

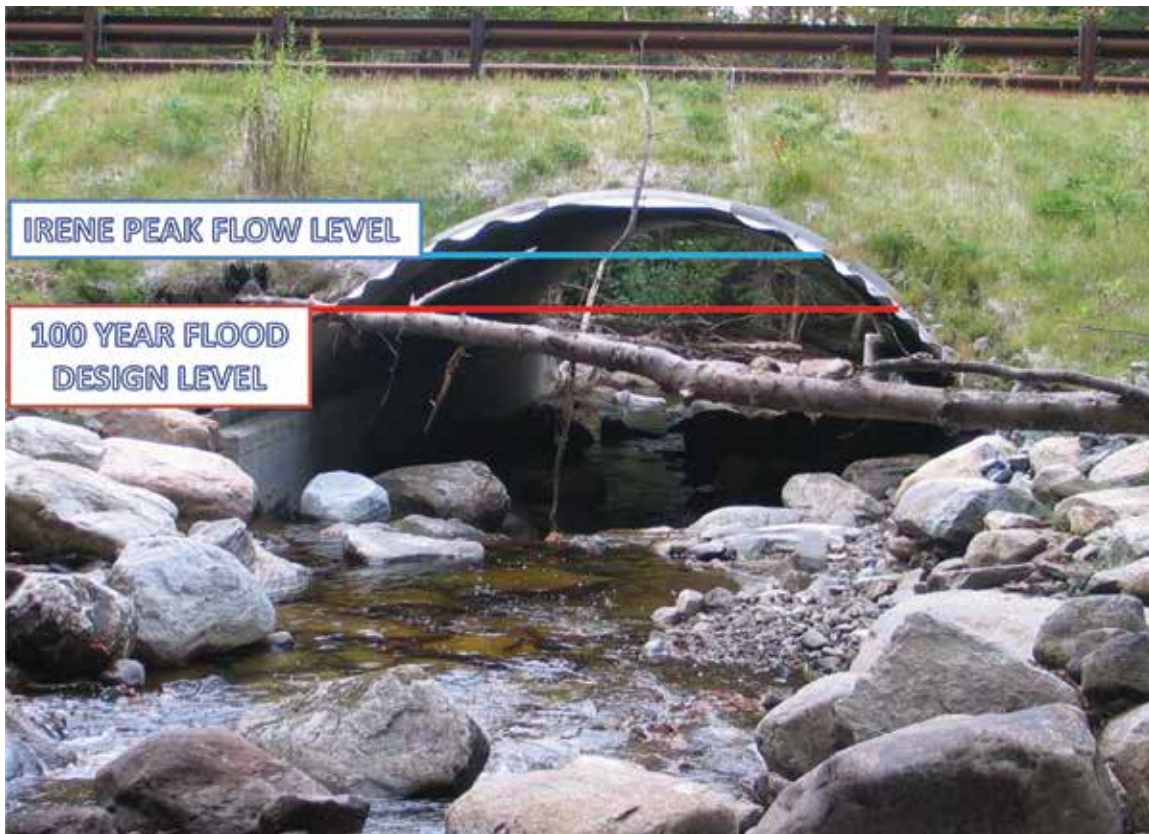
Figure 5. Stream simulation design culvert at Jenny Coolidge Brook, installed in June 2010, showing height of 100-year design discharge in red and height of Tropical Storm Irene flood level in blue. Photo credit: Brian Austin, Green Mountain National Forest.

In contrast to the extensive damage experienced by towns in the Vermont case study, two stream simulation design culverts that were installed on the GMNF before Irene not only survived the storm but incurred no maintenance or replacement costs. USFS fisheries and engineering staff had targeted the upgrade of these two hydraulically designed pipes on Forest Service roads for replacement in 2010 and 2011 because they were barriers to the upstream movement of eastern Brook Trout and other aquatic organisms and because they were identified as a risk for debris plugging and failure in large storm events. These two crossings located on Sparks Brook (Figure 3), immediately adjacent to the upper White River watershed, and on Jenny Coolidge Brook (Figures 4 and 5), also in the Connecticut River Basin, were designed to span the bankfull dimensions of the natural channel, resulting in structures with sufficient hydraulic capacity to convey flows in excess of the Q100 peak flow while providing additional headwater clearance for debris transport. Preliminary hydraulic analysis of Jenny Coolidge Brook estimates peak storm discharges during Irene exceeded the 500 year recurrence interval (R. Gubernick, USFS, personal communication). In addition, on Joe Smith Brook in the upper White River watershed, a hydraulic design culvert was recently replaced with a Q100 bottomless arch to provide greater flood capacity and a natural bottom for AOP. Though this road–stream crossing upgrade was not strictly a stream simulation design with regard to gradient, channel banks, and substrate size, the structure still spanned the bankfull dimensions of the natural channel and it also survived Irene undamaged. Three additional stream simulation crossings located on GMNF listed in Table 1 were still in the early stages of construction when Irene hit and were not included in the flood resiliency analysis but will allow
