## Coastal Fish Habitat Partnerships

Summer 2017 Newsletter

# Rhode Island Boatyards

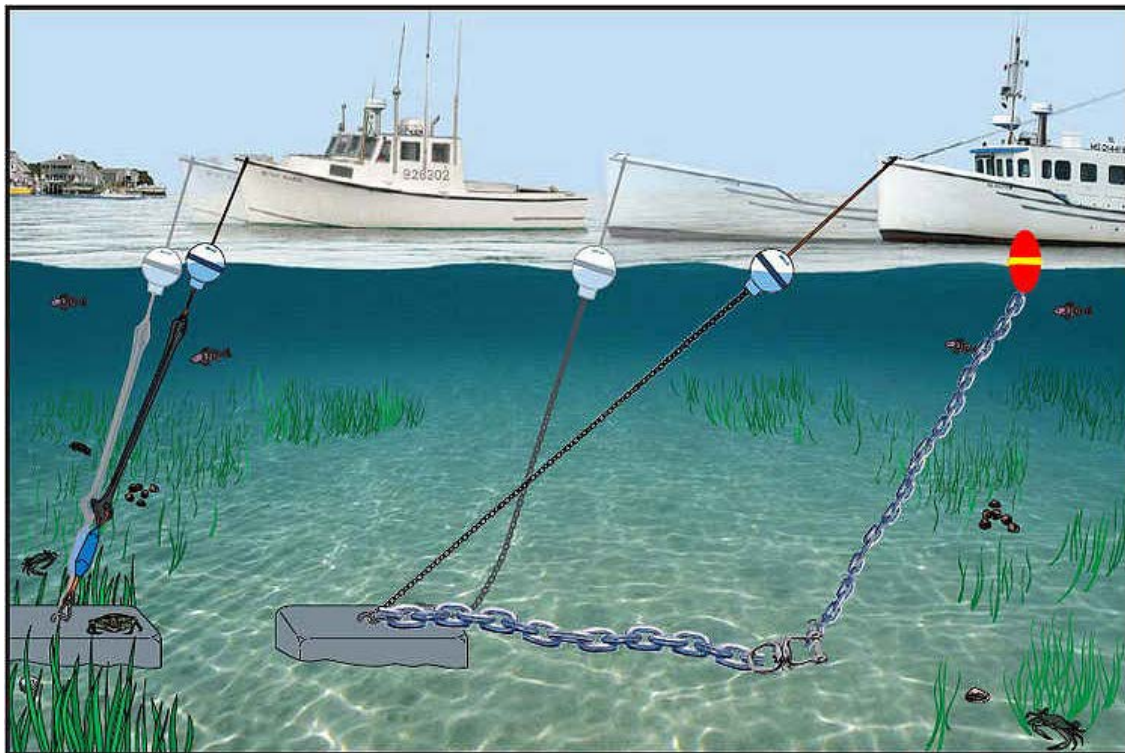
Conservation moorings (left) allow seagrass to thrive, whereas traditional moorings (right) create a halo of bare substrate. Photo credit:

Seagrass is vulnerable to a number of boating-related activities, including prop damage and the use of traditional chain moorings. When placed within or adjacent to seagrass beds, traditional chain moorings can drag on the bottom, severely damaging habitat through physical removal of seagrass shoots, causing a 'haloing' effect. Disturbance to the seafloor also suspends sediment, increasing turbidity and reducing water clarity. This diminishes the amount of light penetration critically important for eelgrass growth and survival.

To restore damaged seagrass and protect healthy beds, the Atlantic Coastal Fish Habitat Partnership (ACFHP) worked with partners (including Rhode Island Division of Fish and Wildlife, Jamestown Boat Yard, Conanicut Marine Services, Inc., Clarks Boat Yard, Aquidneck Mooring Company, and the Town of Jamestown Conservation Commission) to install four conservation boat moorings in three Jamestown, Rhode Island boat yards, replacing four traditional mooring systems. Conservation moorings use a buoyant bungee-like cord to minimize contact with the seafloor, thereby reducing physical damage to seagrass. Prior to installing the conservation moorings, the status of eelgrass habitat around each of the existing moorings was documented by divers on SCUBA. The moorings were installed in the summer of 2016, and preliminary monitoring for seagrass recovery has been positive.

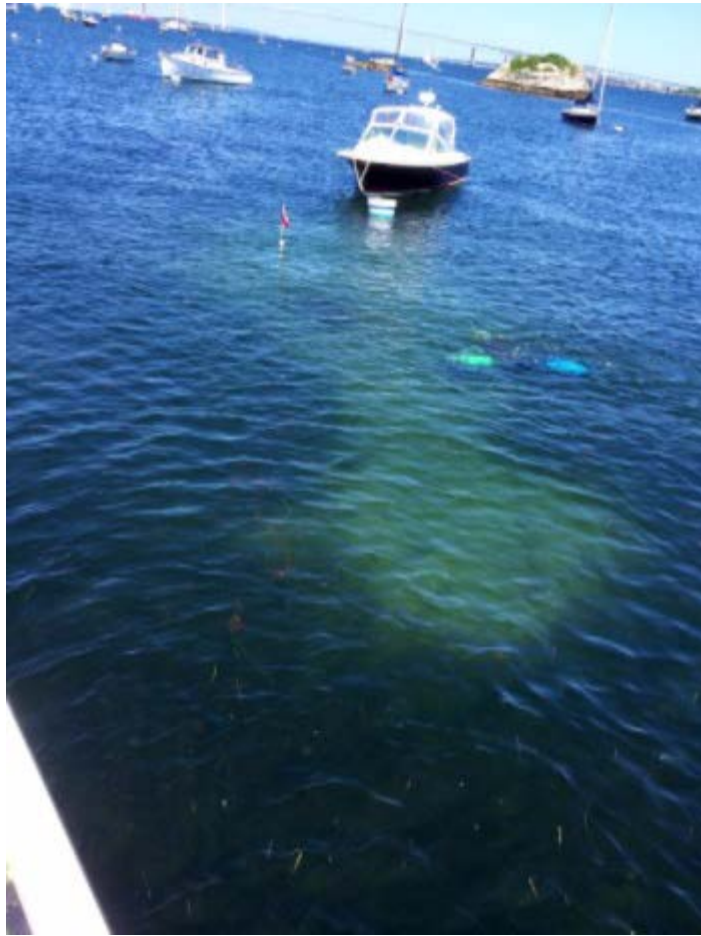
Seagrass haloing caused by traditional moorings in Jamestown, Rhode Island. Photo by Chris Powell.

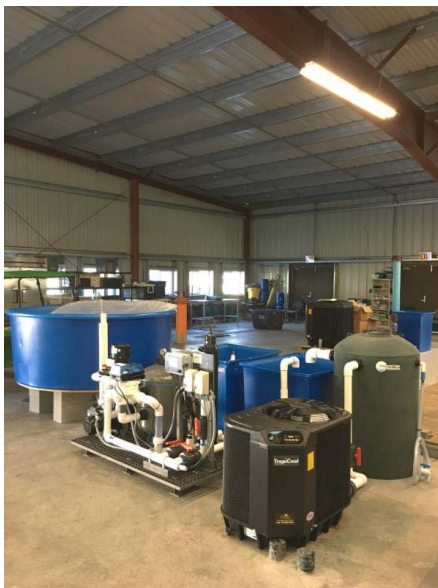
Testing equipment. Photo credit: NMFS.

The Forum supported acquisition of the acclimation and holding system, including a deeper tank with a chilled water loop, to perform the assessment, which will occur at the Don Clausen Fish Hatchery in Geyserville, California. The equipment was acquired in October of 2016, the system components were tested in February of 2017, and the jump test experiments began in May of 2017.
