Barrier Removal Effectiveness Monitoring

Glennbrook Gulch Dam Removal Project

By Leah Mahan, NOAA

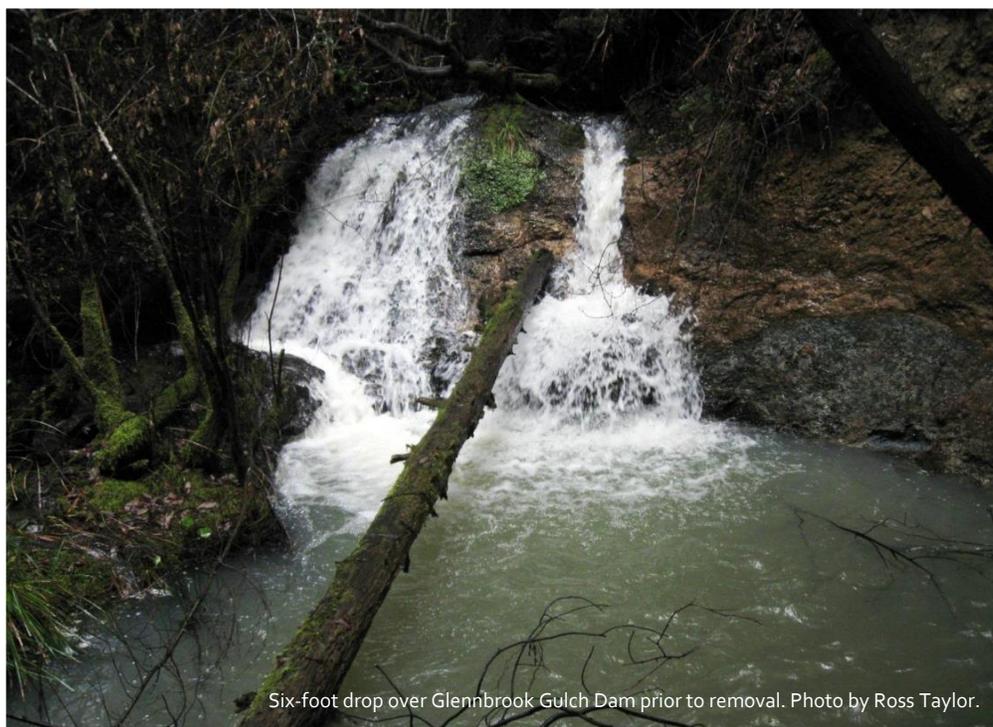
Six-foot drop over Glennbrook Gulch Dam prior to removal. Photo by Ross Taylor.

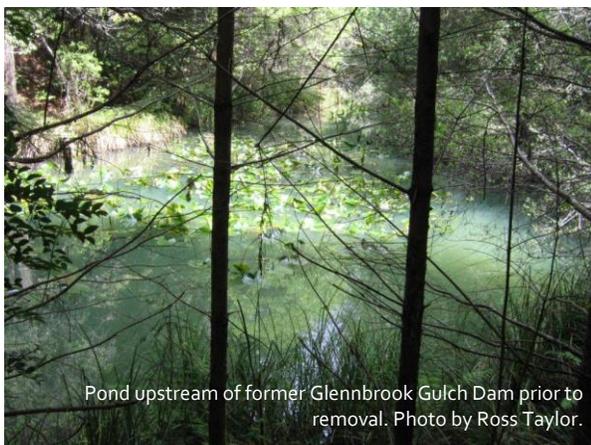
Pond upstream of former Glennbrook Gulch Dam prior to removal. Photo by Ross Taylor.
