Mill Creek Dam Fish Passage Project

California Fish Passage Forum

Barrier Removal Effectiveness Monitoring

Project Title: Mill Creek Dam Fish Passage

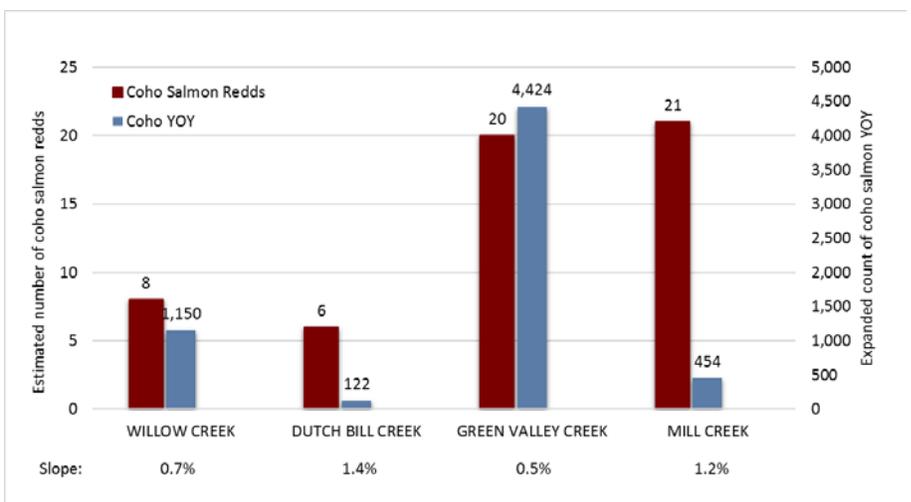
Figure X. Coho salmon redds observed in 2016–2017 spawner season along with coho young-of-year counts from 2017 snorkel surveys.

In 2017, 17 coho salmon, nine steelhead trout, no Chinook salmon, and five unknown salmonid redds, for a total of 31 salmonid redds, were observed during spawner surveys in Mill Creek.

Coho salmon were evenly distributed throughout most of the mainstem of Mill Creek during broodstock monitoring in 2017. A total of 145 pools were snorkeled, and 48 young-of-year, 96 expanded young-of-year, 159 parr, and 318 expanded parr were documented (note: Expanded count is the observed count multiplied by a factor of two). Mill Creek parr counts likely included fish from a hatchery smolt release that occurred two days prior to snorkel counts.

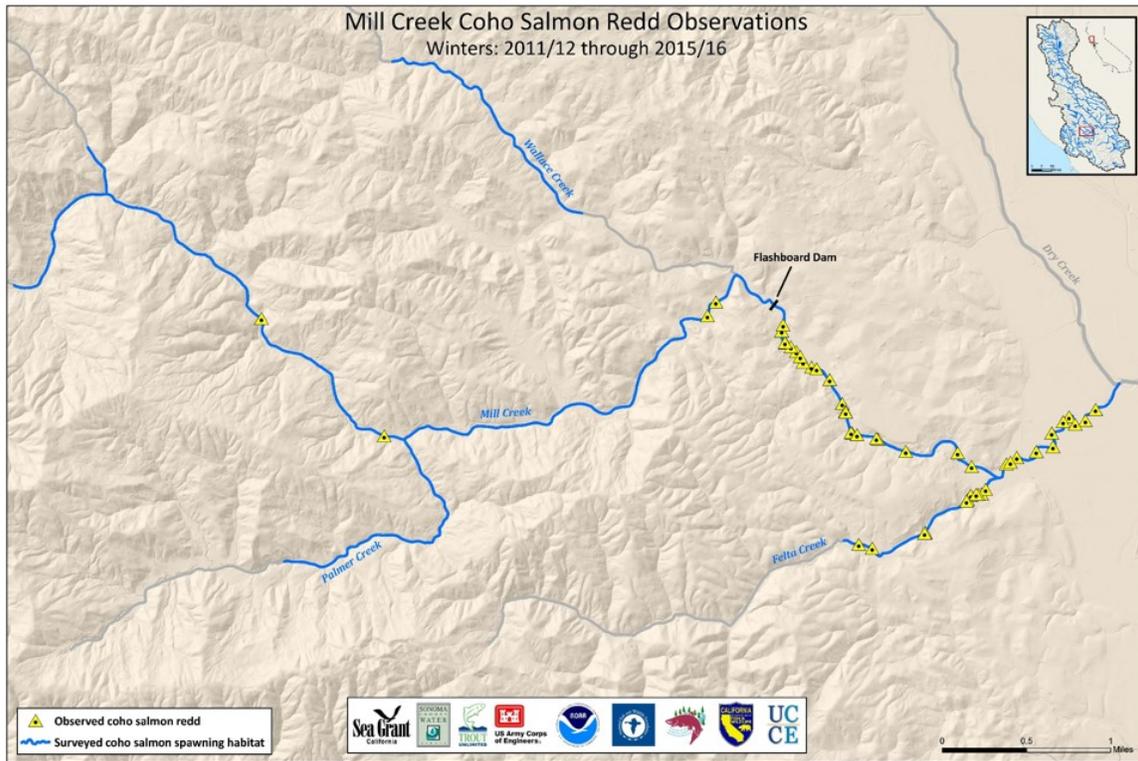
Map showing coho salmon redds in Mill Creek over the five winters prior to barrier remediation at the flashboard dam site. The vast majority of spawning activity occurred below the site, confirming the dam as a passage barrier to anadromous fish under most flow conditions. The reach of Mill downstream of the dam site dries extensively each summer, threatening rearing fish in most of that reach with almost certain mortality. Numerous adult coho were observed spawning upstream of the site in the winter of 2016/17—within weeks of the dam being remediated to allow full passage.
