APTOS CREEK WATERSHED ASSESSMENT AND ENHANCEMENT PLAN

April 2003

Maya T. Conrad, Project Manager
Coastal Watershed Council
P.O. Box 1459
Santa Cruz, CA 95060
www.coastal-watershed.org
office@coastalws.org

John Dvorsky, Project Manager
Swanson Hydrology & Geomorphology
115 Limekiln
Santa Cruz, CA 95060
www.swansonh2o.com

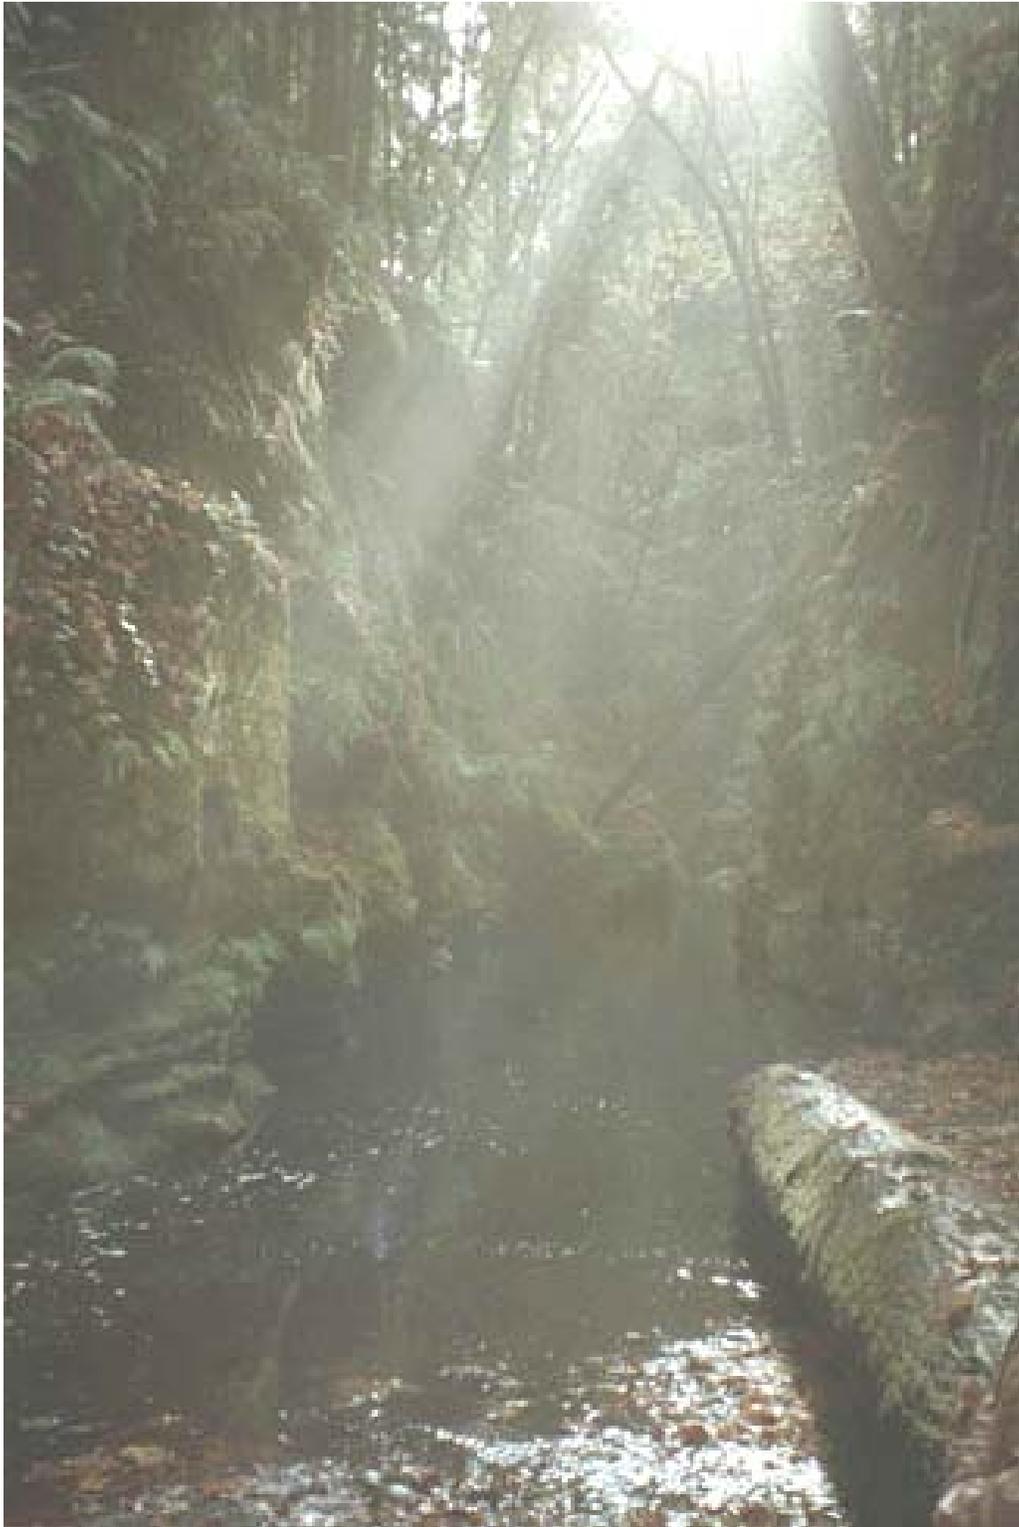
Figure 3. Typical bedrock pool in Aptos Creek, reach 3

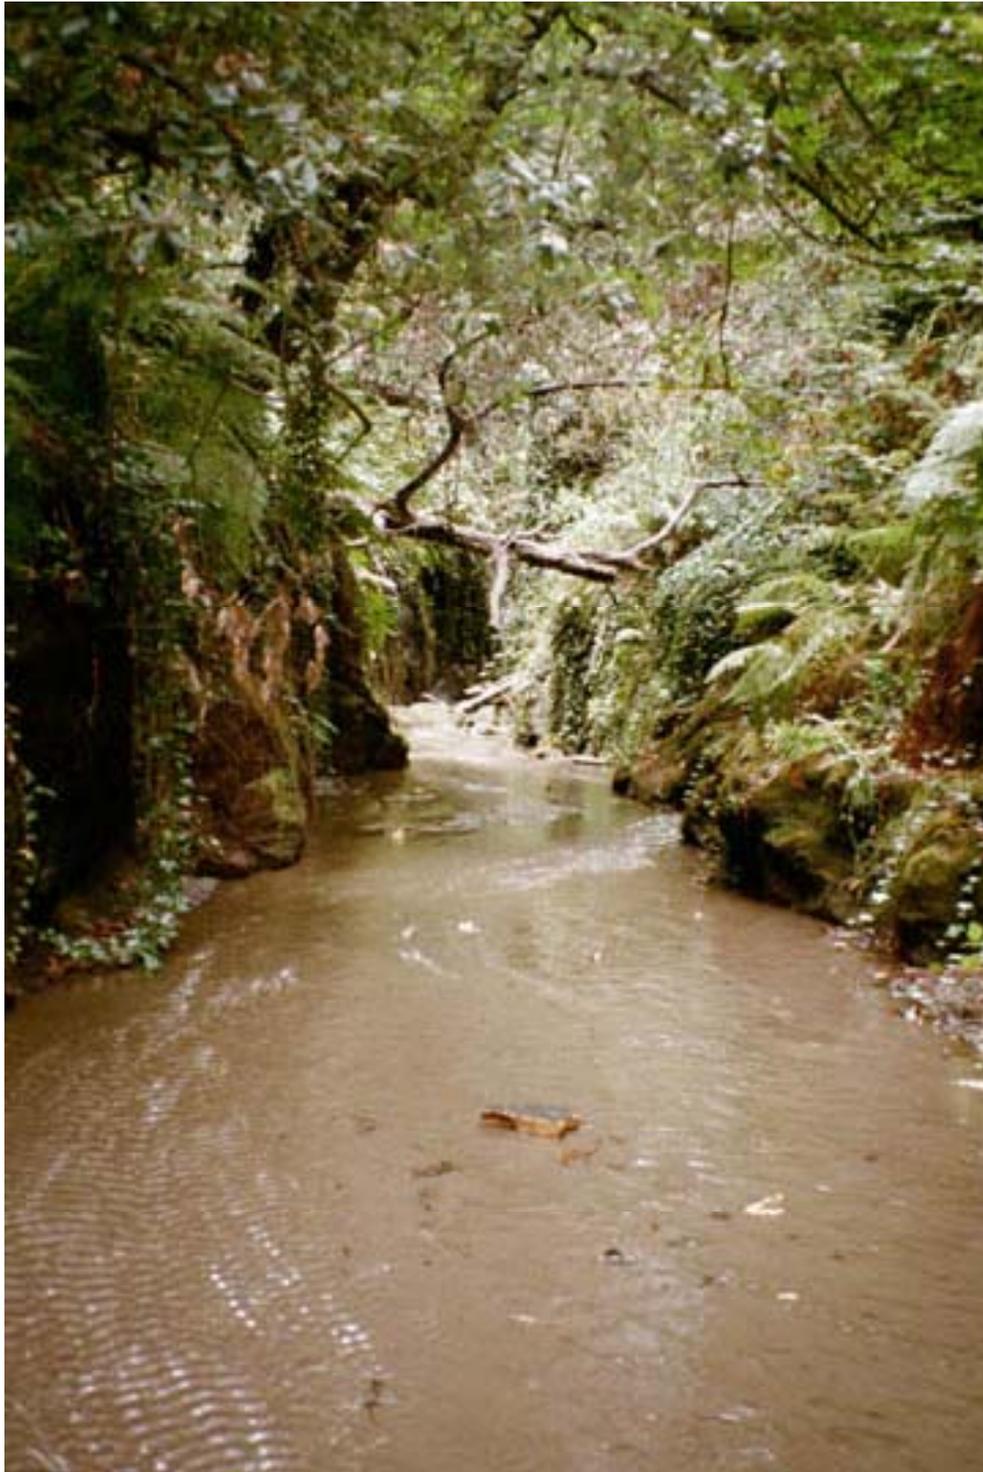
Figure 12. Riffle/Glide Habitat in Valencia Creek

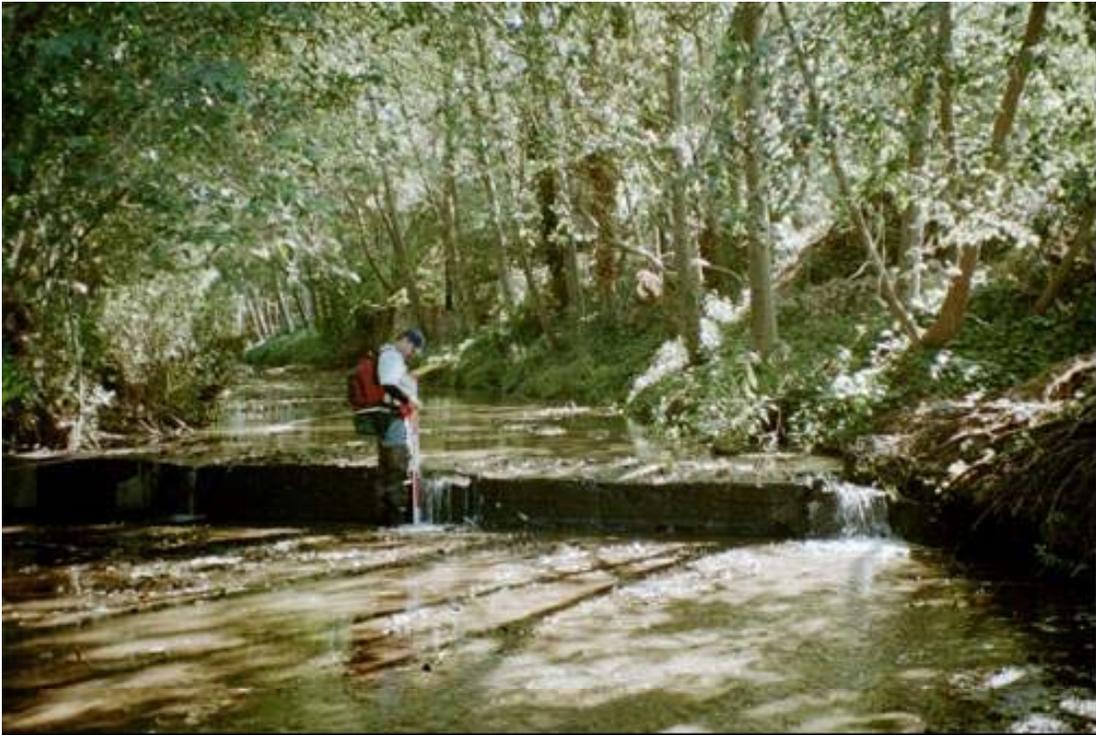
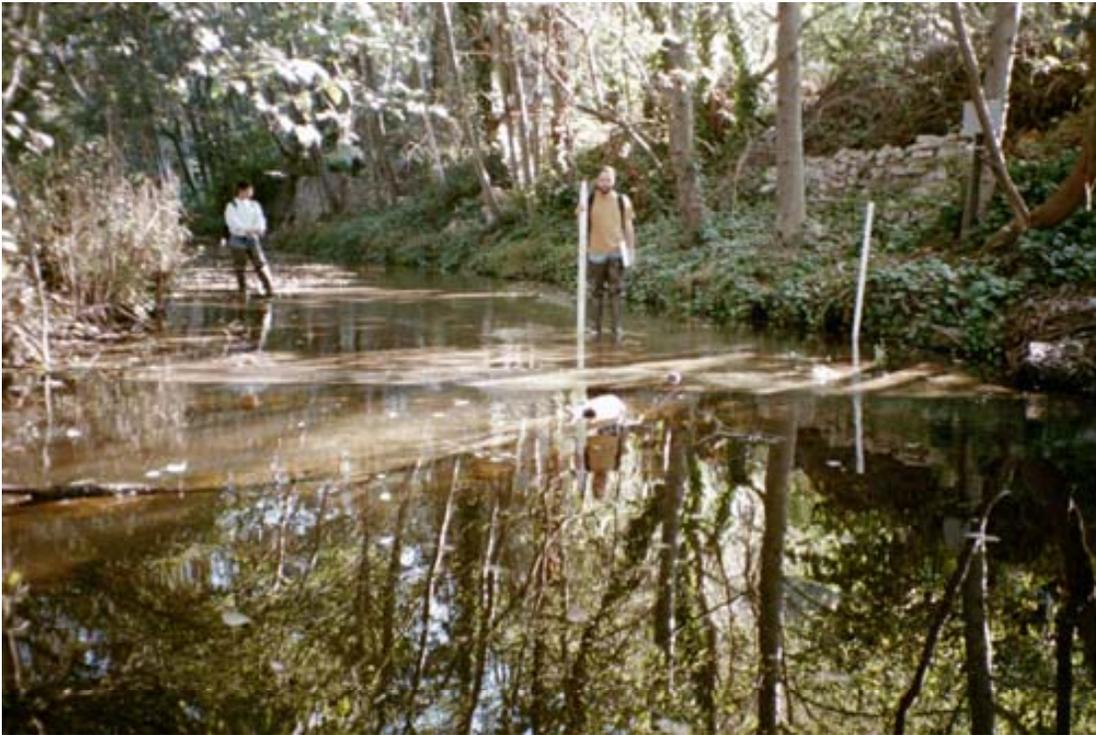
Figure 16. Weir at Spreckels Road

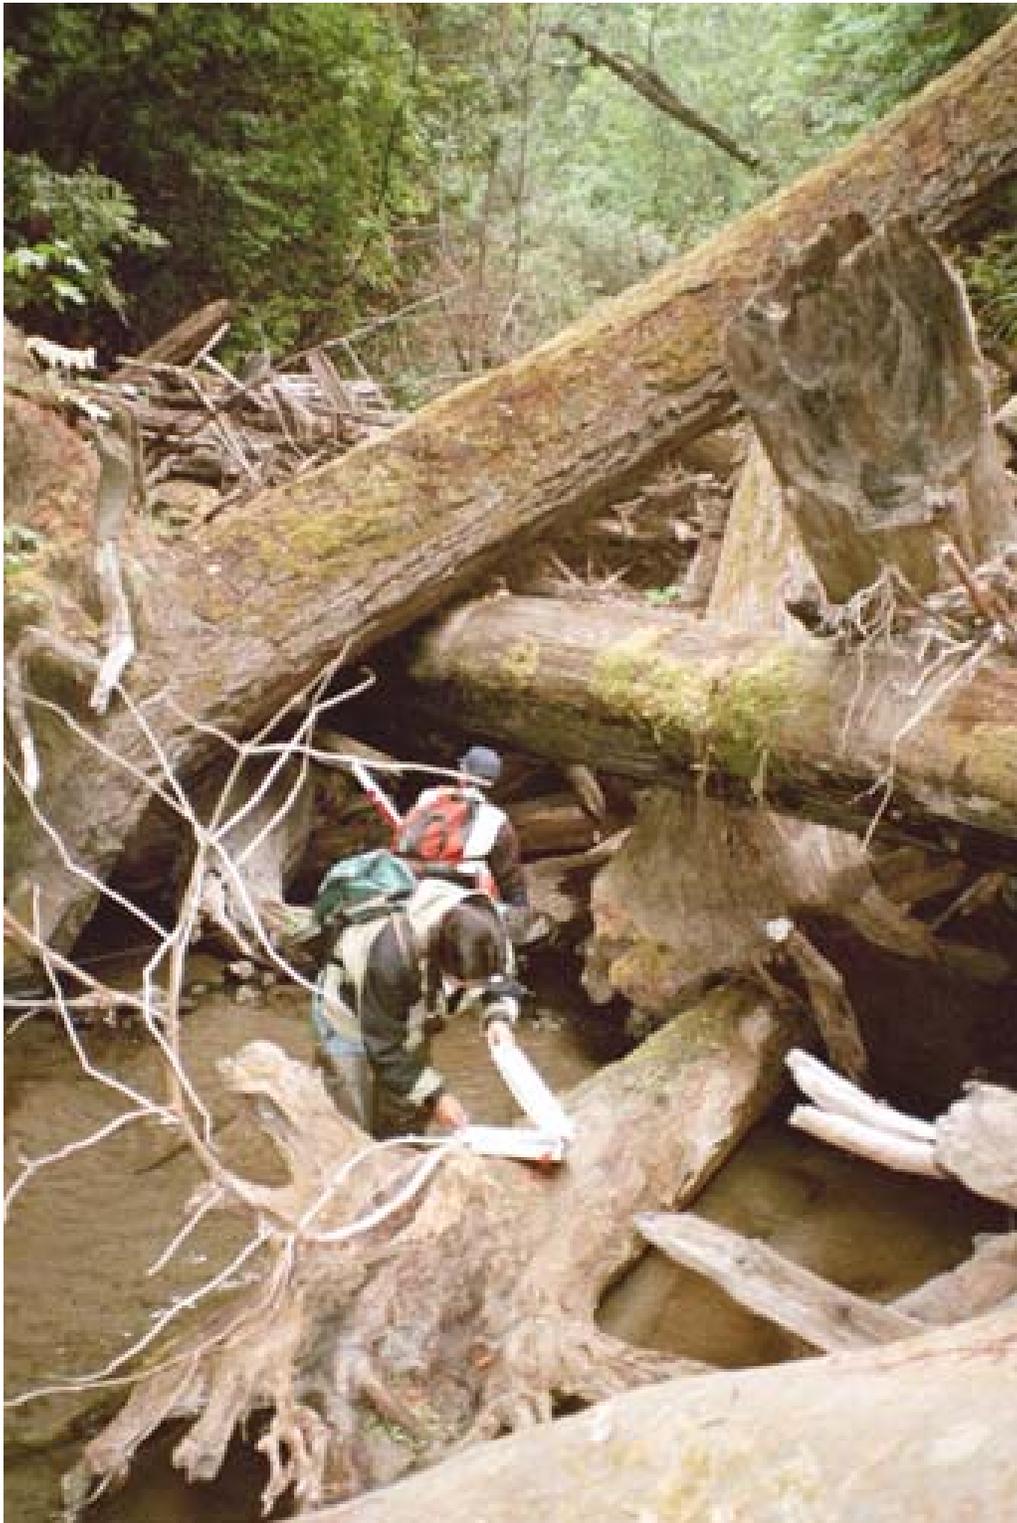
Figure 17. Large Debris Accumulation (LDA), Upper Aptos Creek

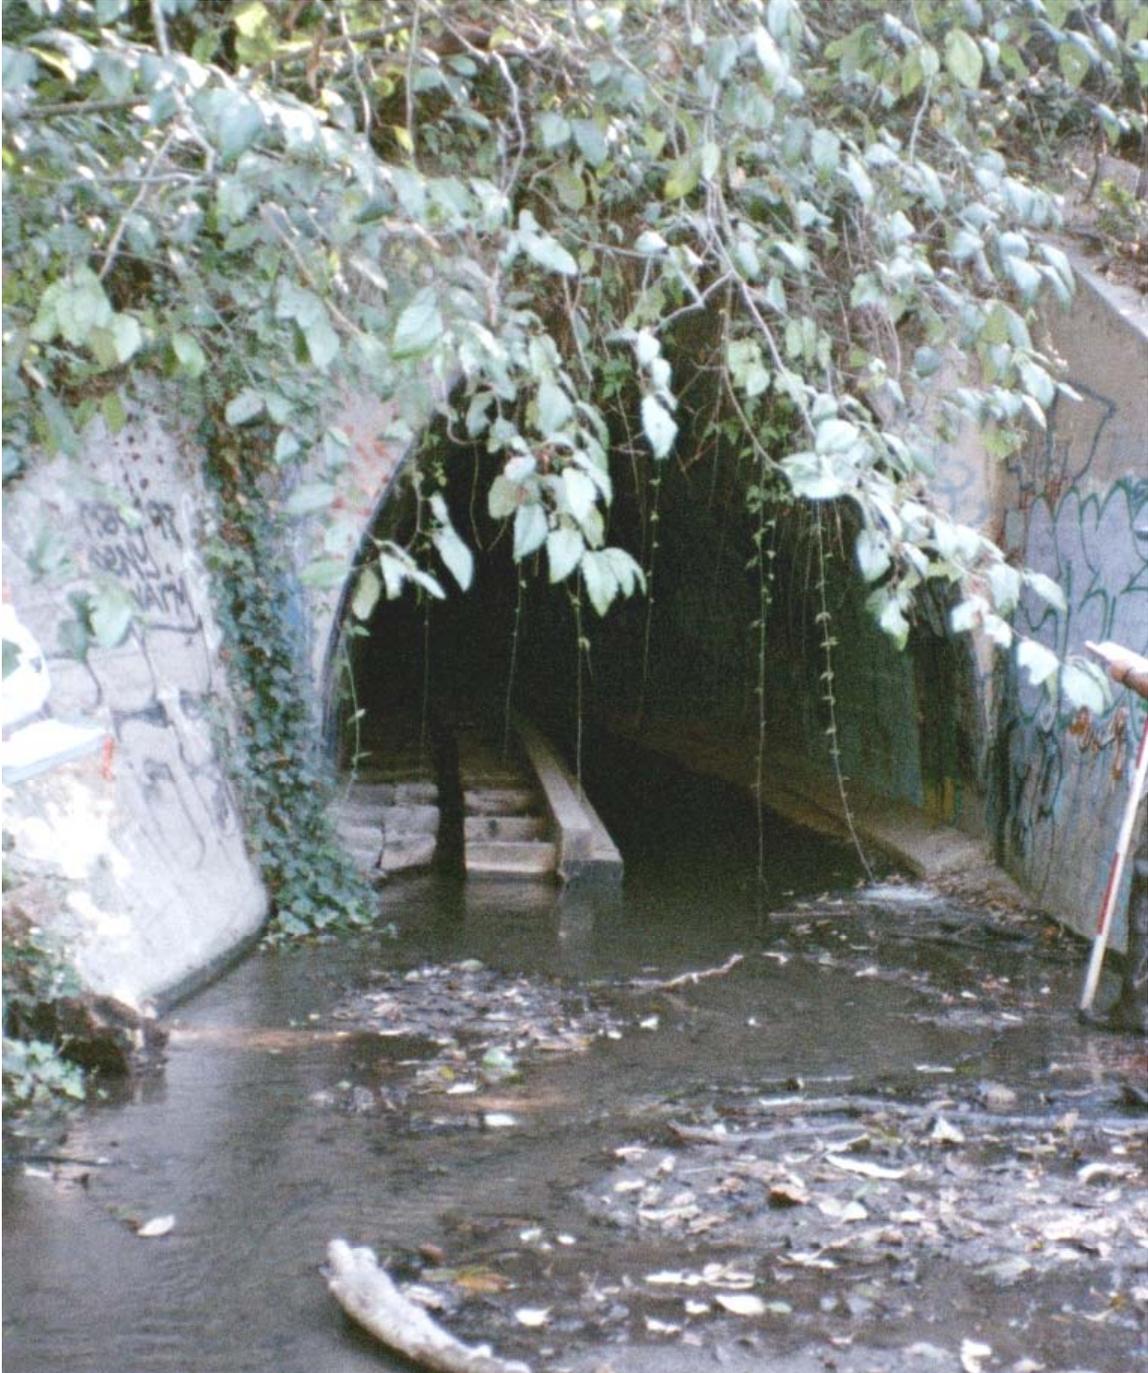
Figure 19. First Valencia Creek Culvert

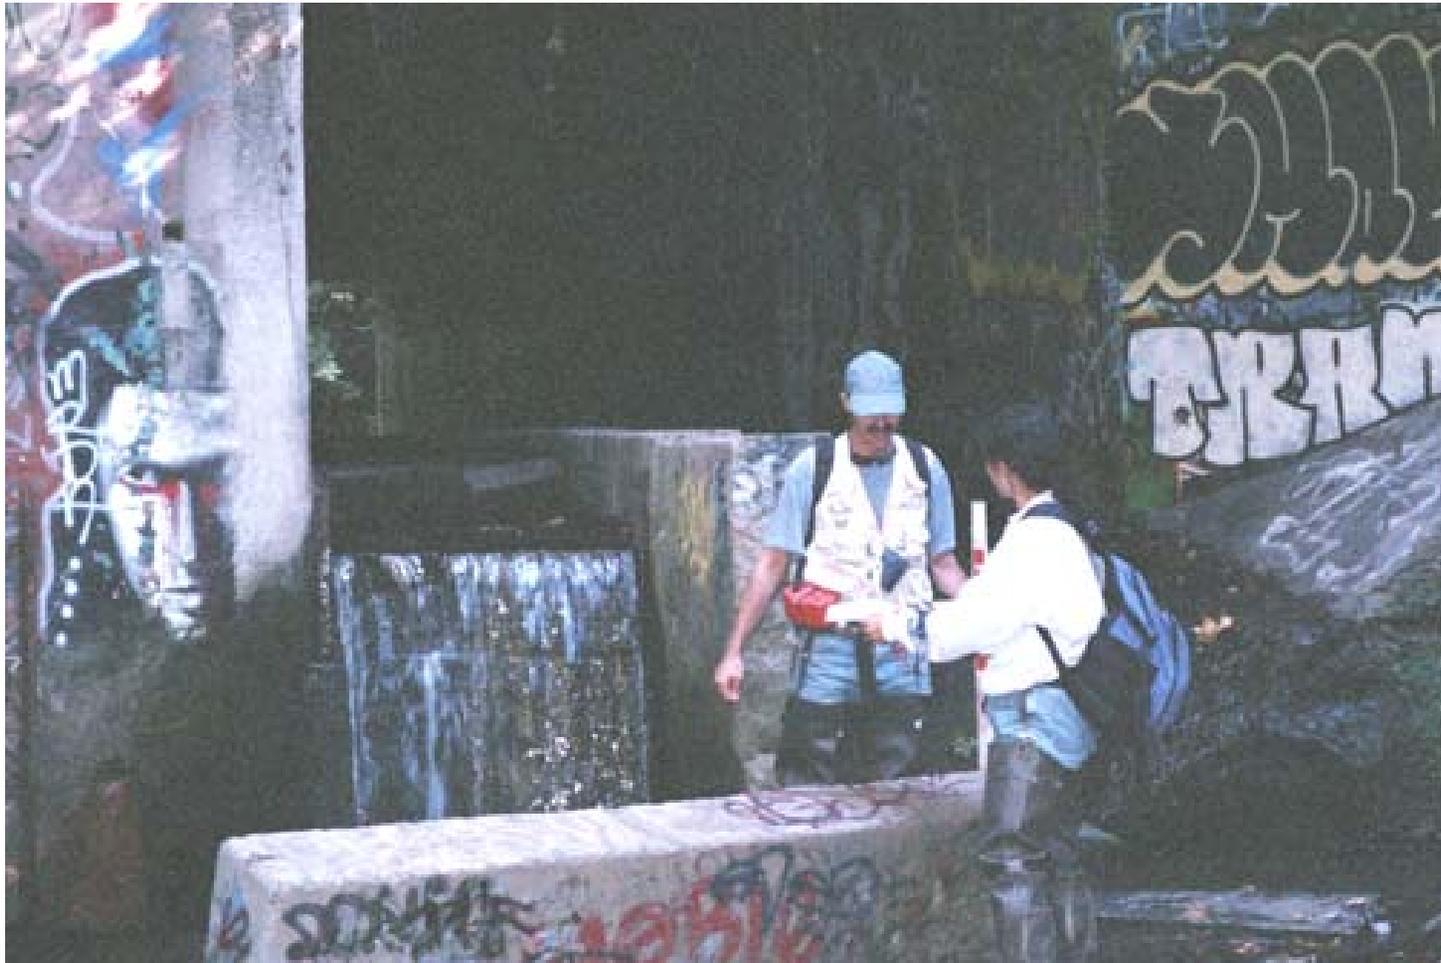
Figure 20. Third Valencia Creek Culvert

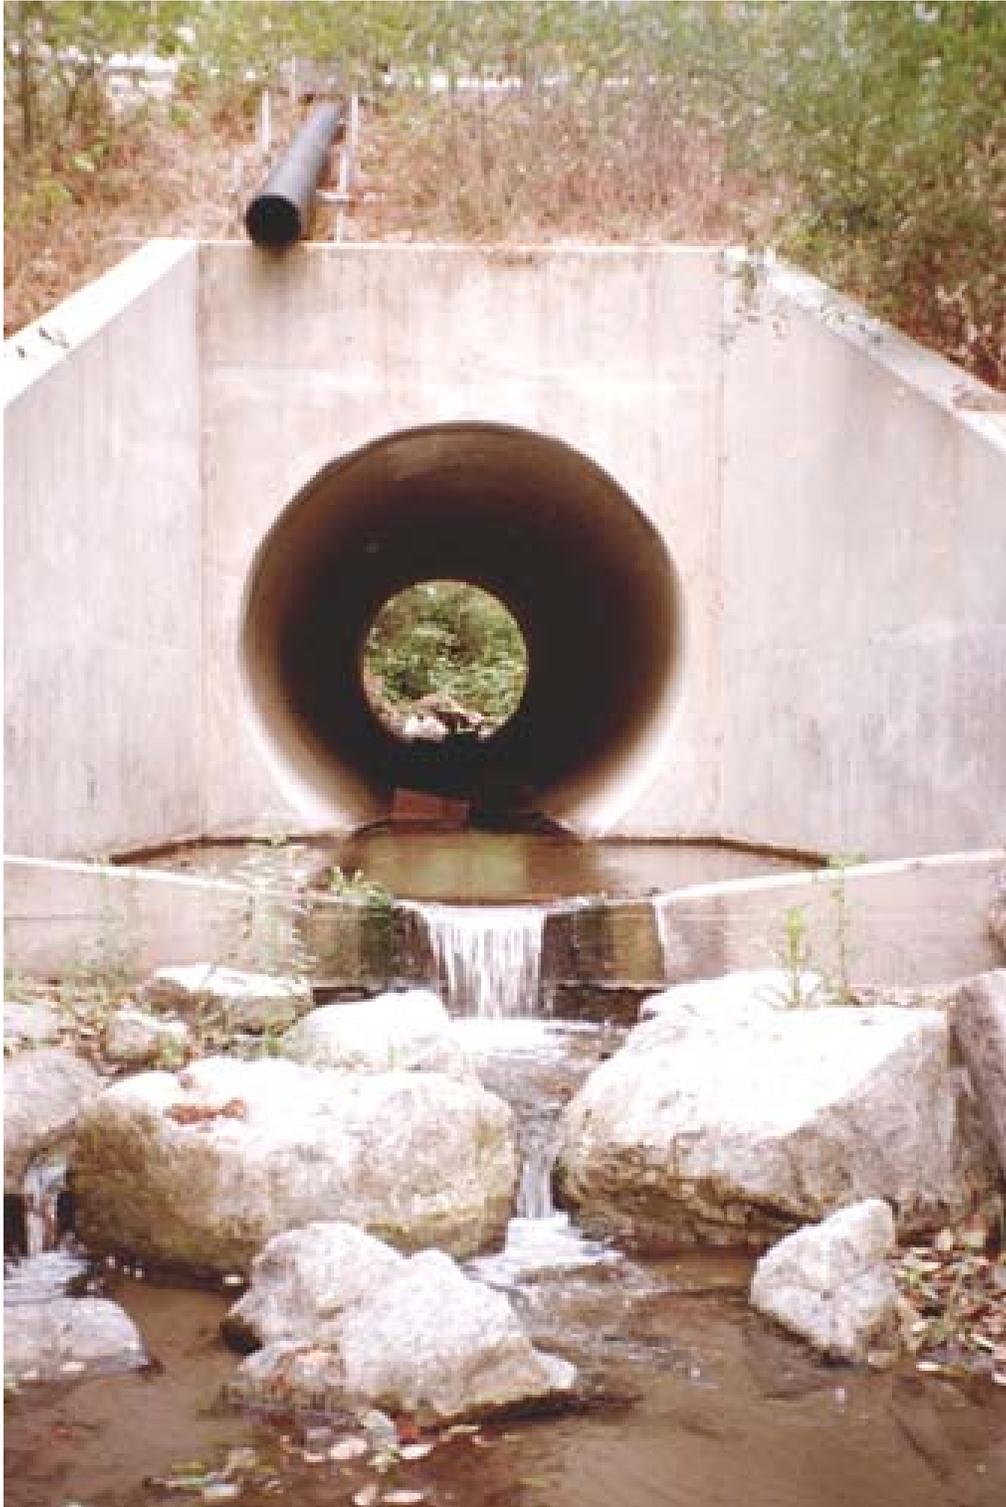
Figure 21. Fourth Valencia Creek Culvert, at Valencia Road
