**NORTH WESTERN PACIFIC RAILROAD - STREAM CROSSING INVENTORY AND  
FISH PASSAGE EVALUATION WITHIN THE EEL RIVER BASIN**

**FINAL REPORT**

**Ross Taylor and Associates (RTA)**

**December 2011**

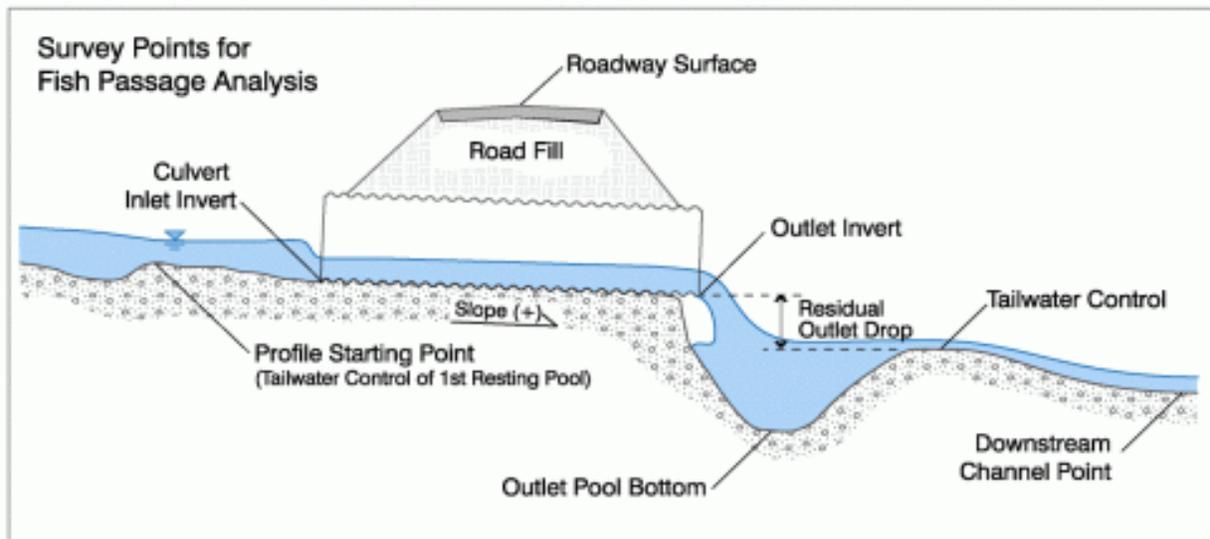
**Figure 1.** Diagram of required survey points through a culvert at a typical stream crossing.

1. crossing inlet (if culvert) or upstream edge of dam/weir,
2. crossing outlet (if culvert) or downstream edge of dam/weir,
3. maximum pool depth within five feet of the outlet,
4. outlet pool tail-water control,
5. at least one point downstream of the tail-water control, and
6. a cross-section at the tail-water control.

Each cross-section was comprised of approximately eight to 15 elevations from approximately the left bank-full channel margin to the right bank-full margin. A tape was typically stretched across the cross-section to assist the rod person in accurately selecting points along the cross-section (Figure 2). These cross sections allowed for more accurate modeling of changes in tail-water elevations over varying stream discharges with the FishXing software.

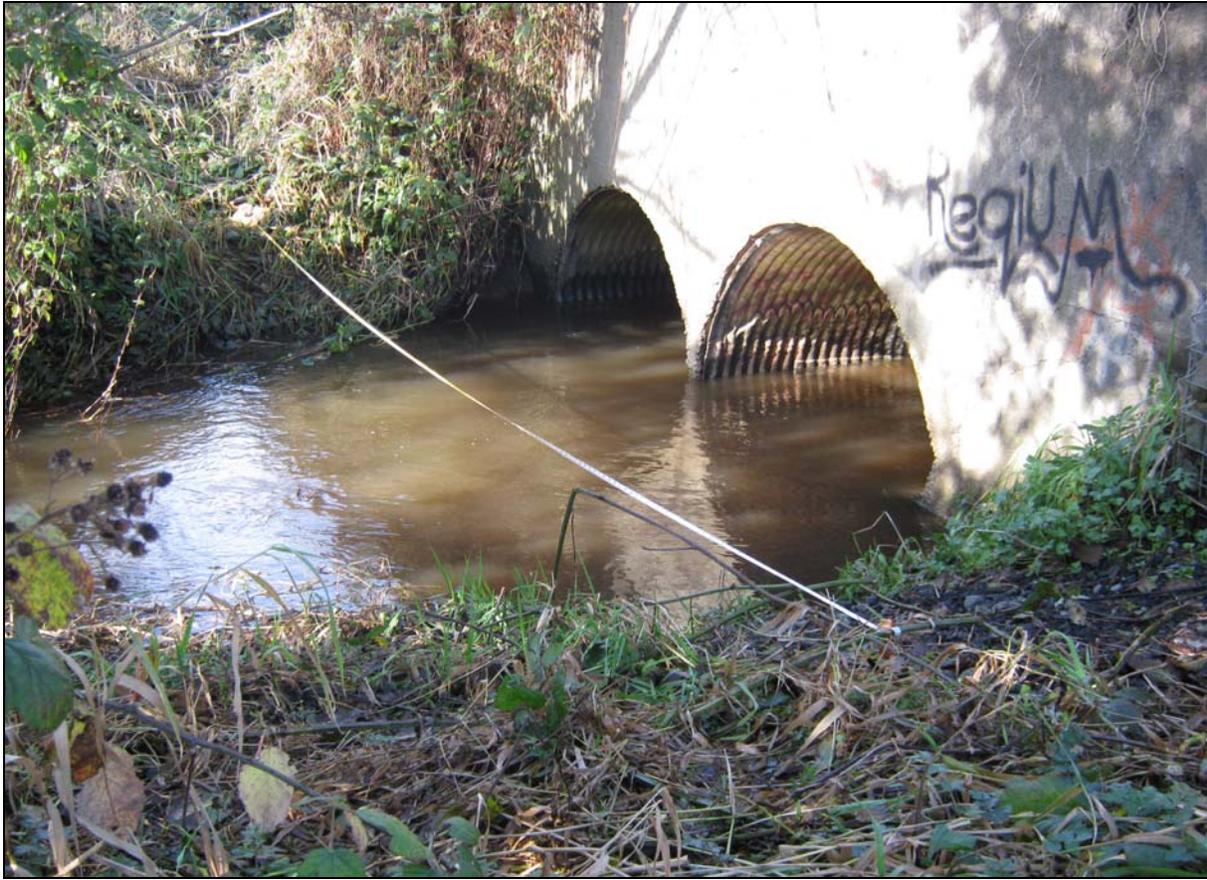
**Figure 2.** Example of tape location for measuring the tail-water cross-section.

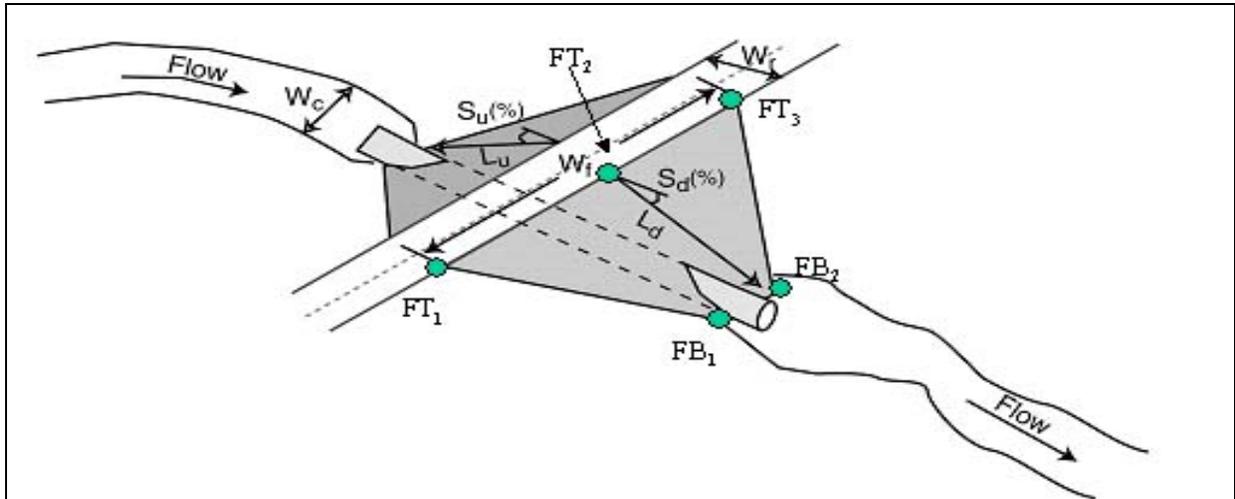
**Figure 3.** Road fill measurements (modified from Taylor and Love 2003).

At minimum, 10 survey points were used to estimate the fill volume. The five points, FB<sub>1</sub>, FB<sub>2</sub>, FT<sub>1</sub>, FT<sub>2</sub>, and FT<sub>3</sub> (Figure 3) were measured on both the upstream and downstream fill slope. These ten points were then used to calculate the lengths (L<sub>d</sub>, L<sub>u</sub>, W<sub>r</sub>, W<sub>f</sub>, and W<sub>c</sub>) and slopes (S<sub>d</sub> and S<sub>u</sub>) indicated in Figure 3. The fill volume was calculated using these values and equations 1 through 4 as outlined on page 12 of the *California Salmonid Stream Habitat Restoration Manual* (Taylor and Love, 2003). The fill displaced by the culvert volume was then subtracted from the fill volume estimate.

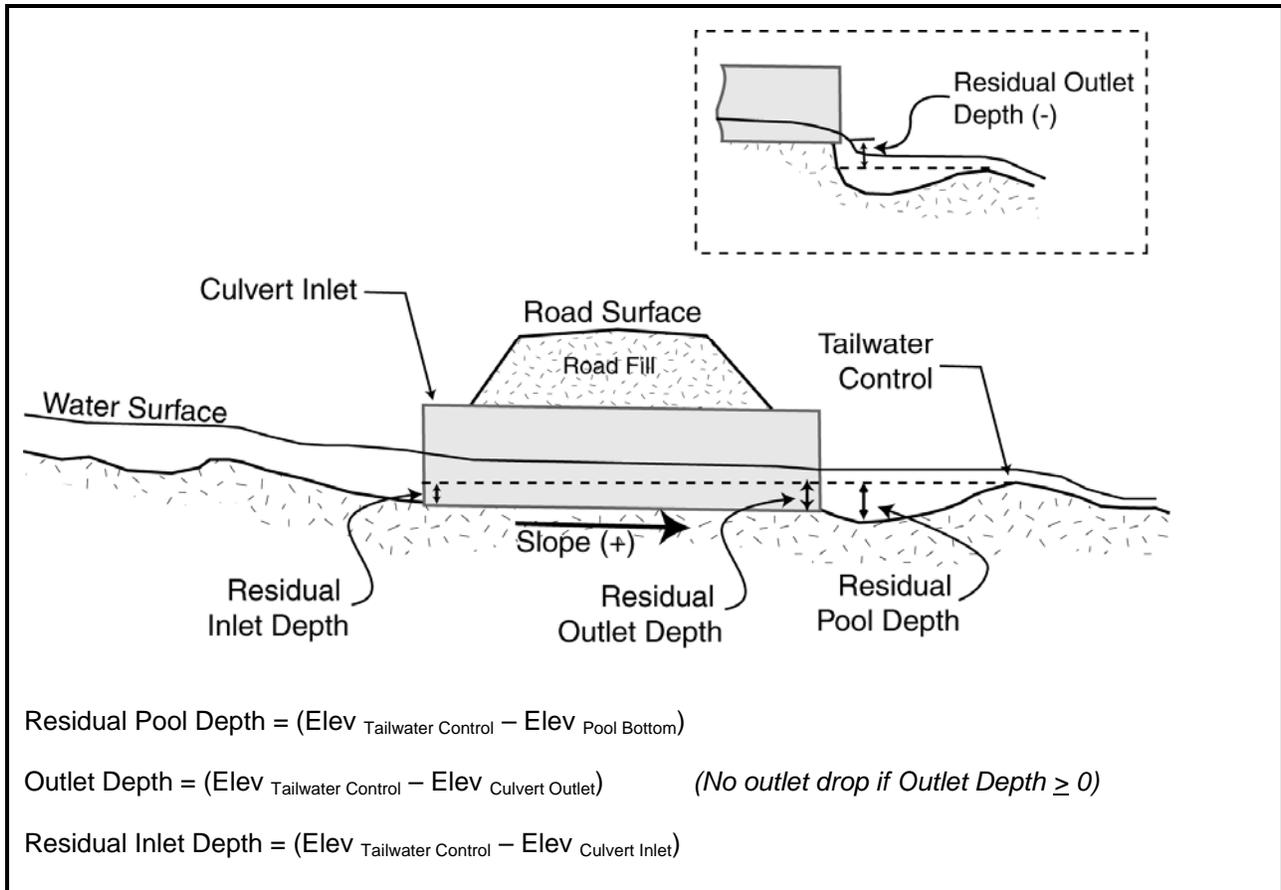
**Figure 4.** Measurements used in **GREEN-GRAY-RED** filtering criteria.

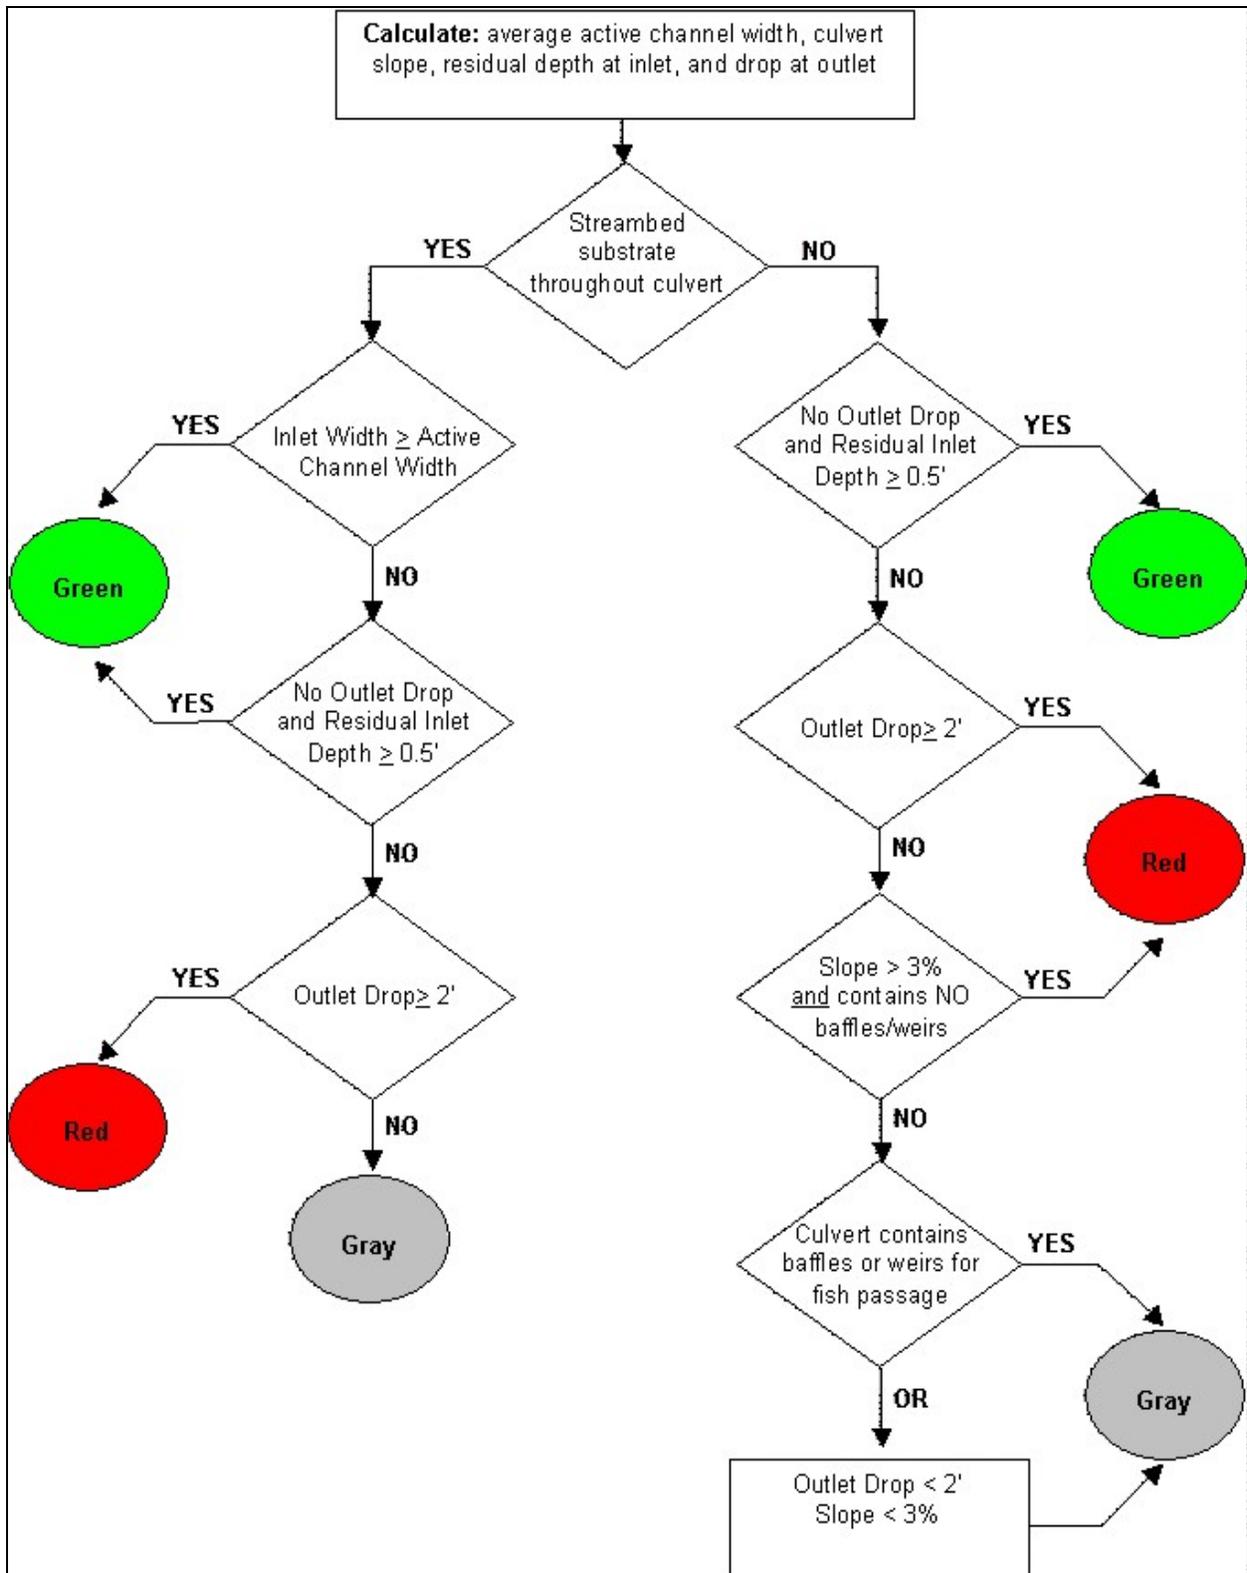
Figure 5. GREEN-GRAY-RED first-phase passage evaluation filter.

A spreadsheet macro was utilized that followed the CDFG flowchart to determine a stream crossing's status as **GREEN**, **GRAY**, or **RED** (Figure 5). Depending on geographic location within California, species of interest will vary. Within anadromous-bearing watersheds, CDFG has determined that crossings classified as **GREEN** must meet upstream passage criteria for both adult and over-wintering juvenile salmonids at all expected migration flows.

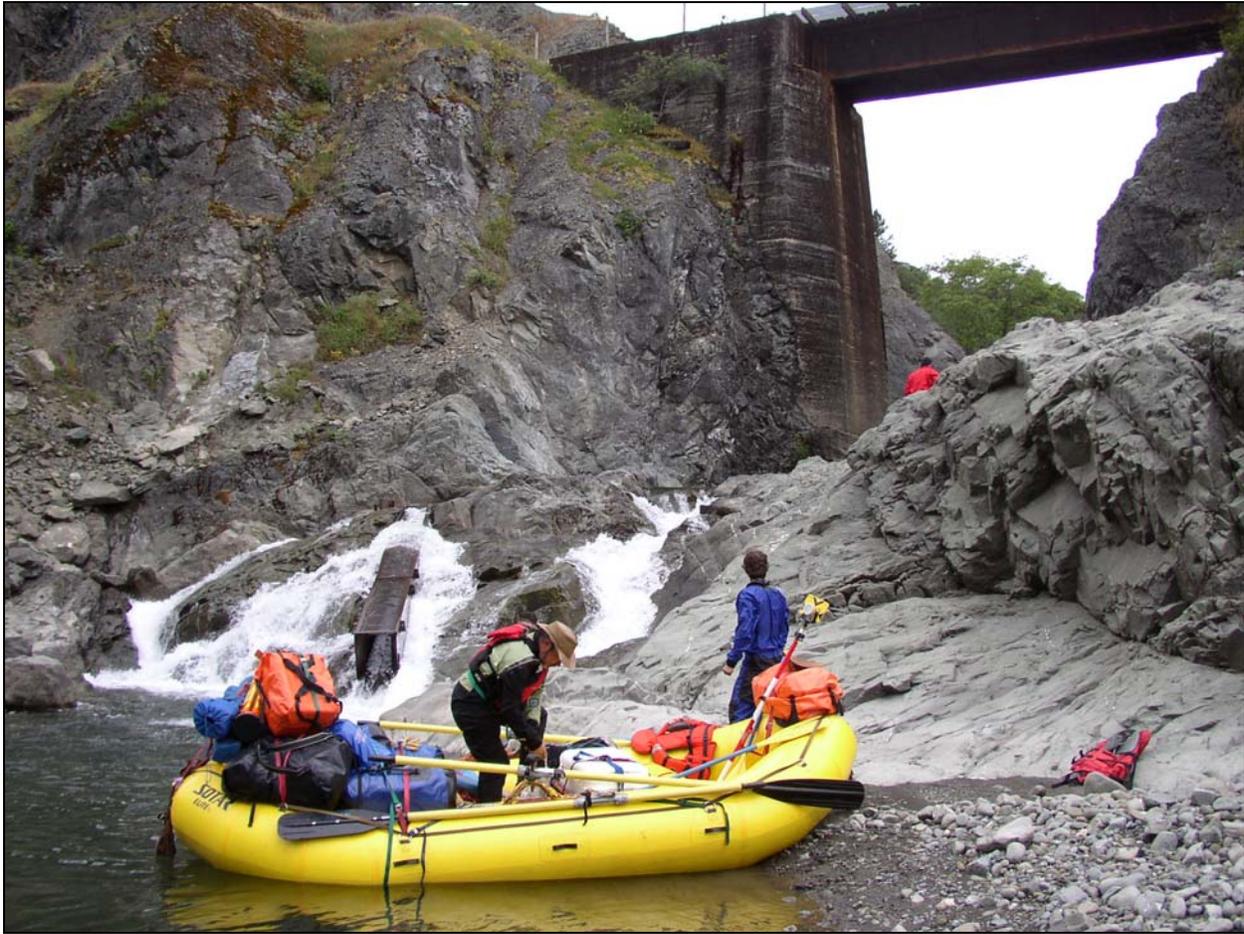
The barrier at the mouth of Woodman Creek was formed when the NWPRR filled-in the creek's channel with the railroad prism and re-routed the channel over a bedrock drop (Figure 6). The extensive railroad fill prism was apparently needed to maintain a relatively continuous grade as the railroad exited a tunnel just south (or upstream) of Woodman Creek's confluence with the Eel River. The longitudinal profile surveyed by RTA on May 23, 2010 depicts the two-stage character of this bedrock drop (Figure 7). Starting at the downstream end of the longitudinal profile, the small pool at the base of the bedrock drop had a depth of 2.9 feet and the first drop was 12.3 feet high (Figure 7). As measured on 5/23/10, the uppermost drop was 7.2 feet over a 52.7-foot reach of channel (Figure 7). The maximum pool depth below the upper drop was 4.3 feet (Figure 7).

A steep-pass style weir was installed on the lower bedrock drop with CDFG funding in the mid-1980s. Part of the installation process included chipping the bedrock face to accommodate the weir; no additional rock work was done due to NWPRR's concerns with compromising the integrity of the trestle and tunnel (Grass, pers. comm.). Over the next 20 years, the weir was visited approximately once annually for maintenance by Alan Grass (CDFG biologist) who would walk nearly five miles down the tracks from Dos Rios to clean bedload and woody debris out of the baffles. The overall performance of the steep-pass weir was poor, because the weir easily plugged and was difficult to effectively clear during elevated flows when fish movement was expected (Grass, pers. comm.). At the time of installation, the downstream end of the steep-pass weir was submerged in the lower pool; however channel adjustments at the confluence have resulted in exposing the lower end of the weir (Grass, pers. comm.). During the 20 year-period when the weir was maintained no spawner surveys were conducted to determine if salmon or steelhead were successfully accessing Woodman Creek; however landowners within the watershed periodically observed adult steelhead (Grass, pers. comm.). The 1997 Eel Basin Railway Fish Passage report described the steep-pass weir as in good condition (HCRRD, 1997). However; the weir was rusted, filled with bedload, and some baffles were crushed during RTA's 5/23/10 site survey.

**Figure 6.** Bedrock drop at mouth of Woodman Creek on May 23, 2010.

Treatment of the Woodman Creek barrier should consider several options, including 1) partial removal of railroad fill and re-establishing the natural creek channel; 2) construction of a properly designed concrete fishway at the location of the bedrock drop; or 3) partial blasting and/or re-working of the bedrock drop to form step-pools. Each alternative has benefits and trade-offs; however RTA recommends #1 as the best for long-term restoration of fish passage that would also be relatively low-maintenance (Table 8). Fill volume dimensions and estimates for the railroad fill prism and the elevated bench located on the west side of the tracks (and north of Woodman Creek) are located in Appendix A. As mentioned in the Methods section, these volume estimates should be considered “order of magnitude” accurate and could provide a cursory estimate of fill removal required to re-establish Woodman Creek’s lower channel. RTA recommends that a more thorough topographic survey is completed at Woodman Creek for development of any treatment design plans and detailed budgeting of heavy equipment costs.

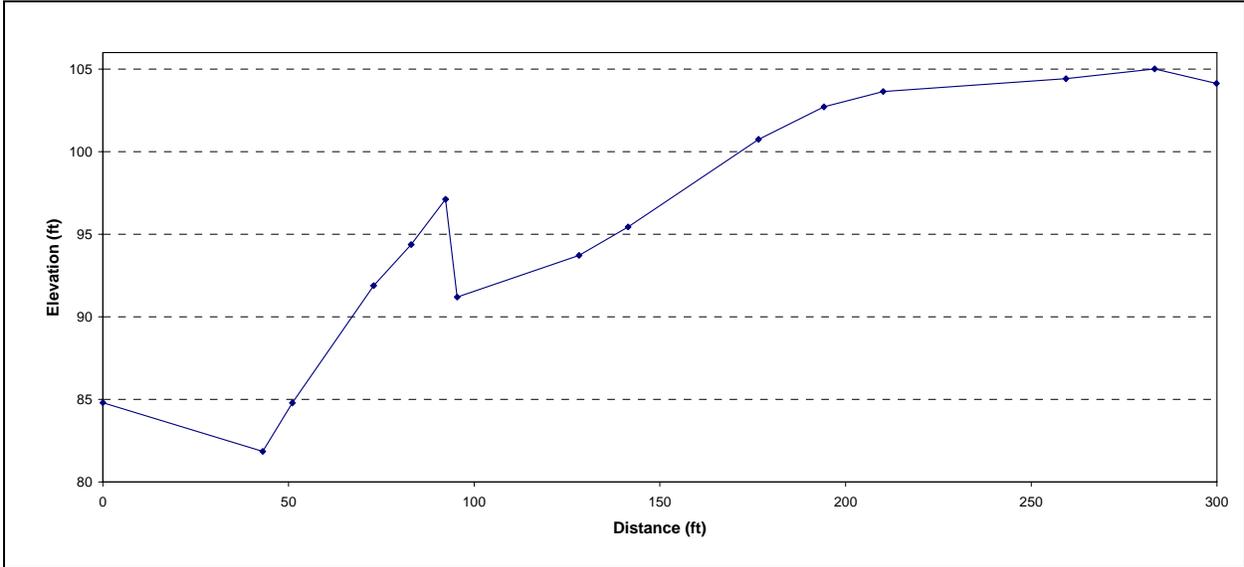
**Figure 7.** Longitudinal profile of the bedrock drop and immediate upstream channel on Woodman Creek, tributary to the Eel River, surveyed on 5/23/10.

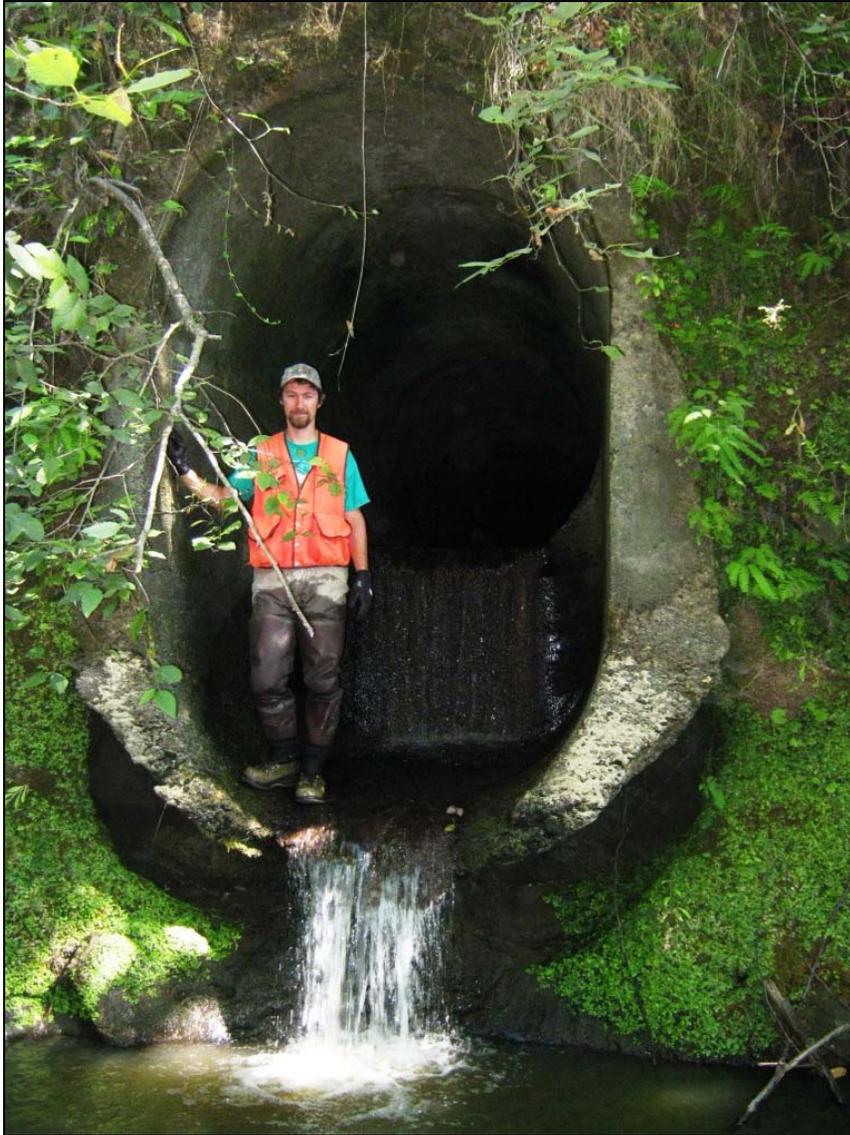
**Figure 8.** Two-stage drop at the outlet of site #NWPRR-243.38, photo taken on 8/17/11.

RTA recommends that removal of the railroad culvert and re-establishment of the natural channel is the best long-term solution to providing unimpeded passage into Bridge Creek. During the RTA site visit, the existing culvert and associated fill prism appeared to be in poor condition and would most likely require replacement if rail service was re-established. As in the earlier project concept, a new railroad crossing such as a bridge or trestle could then be installed when (or if) the NWPRR re-opens the rail line.

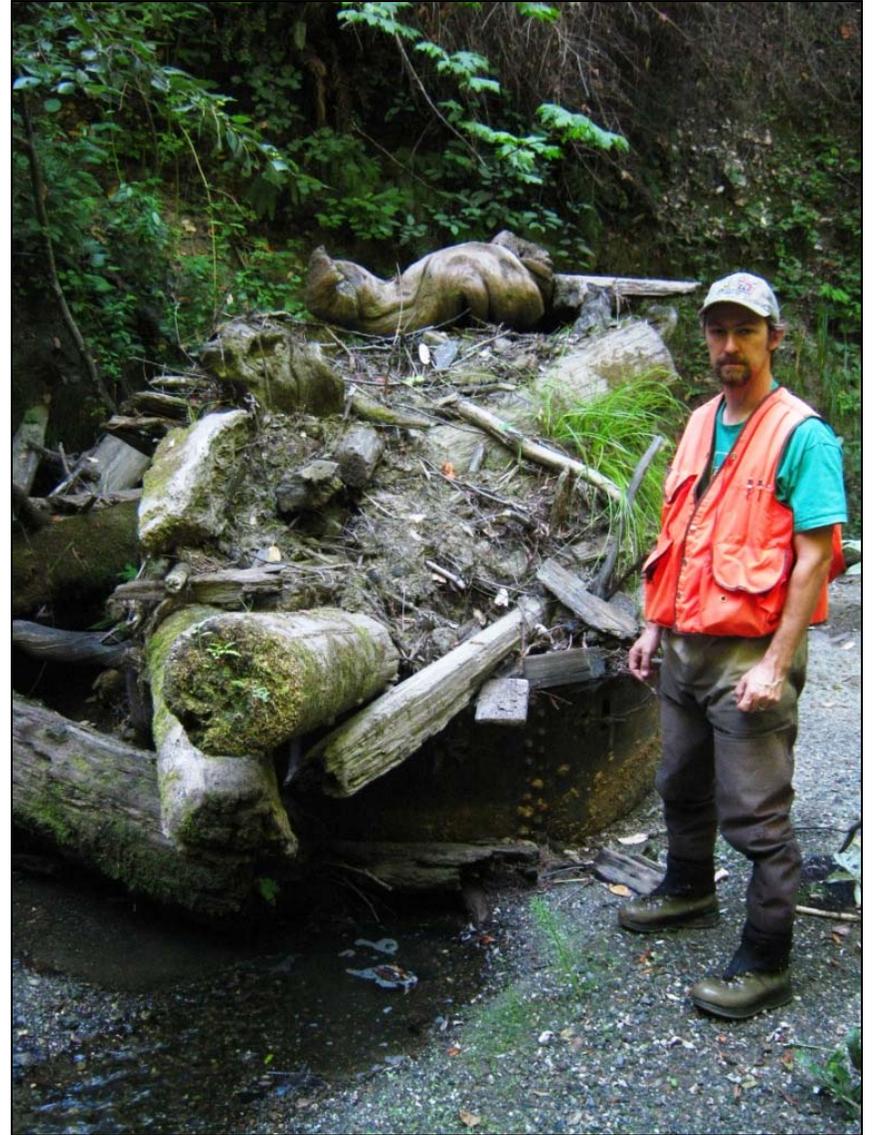
**Figure 9.** Debris on inlet standpipe of site #NWPRR-243.38, photo taken on 8/17/11.
