# Trabuco Creek Fish Passage Project - Interstate 5 Bridge Array

Cal Fish Passage Forum 8-9-2018 Jacobson (CalTrout)

# Existing Conditions & Alternatives Analysis

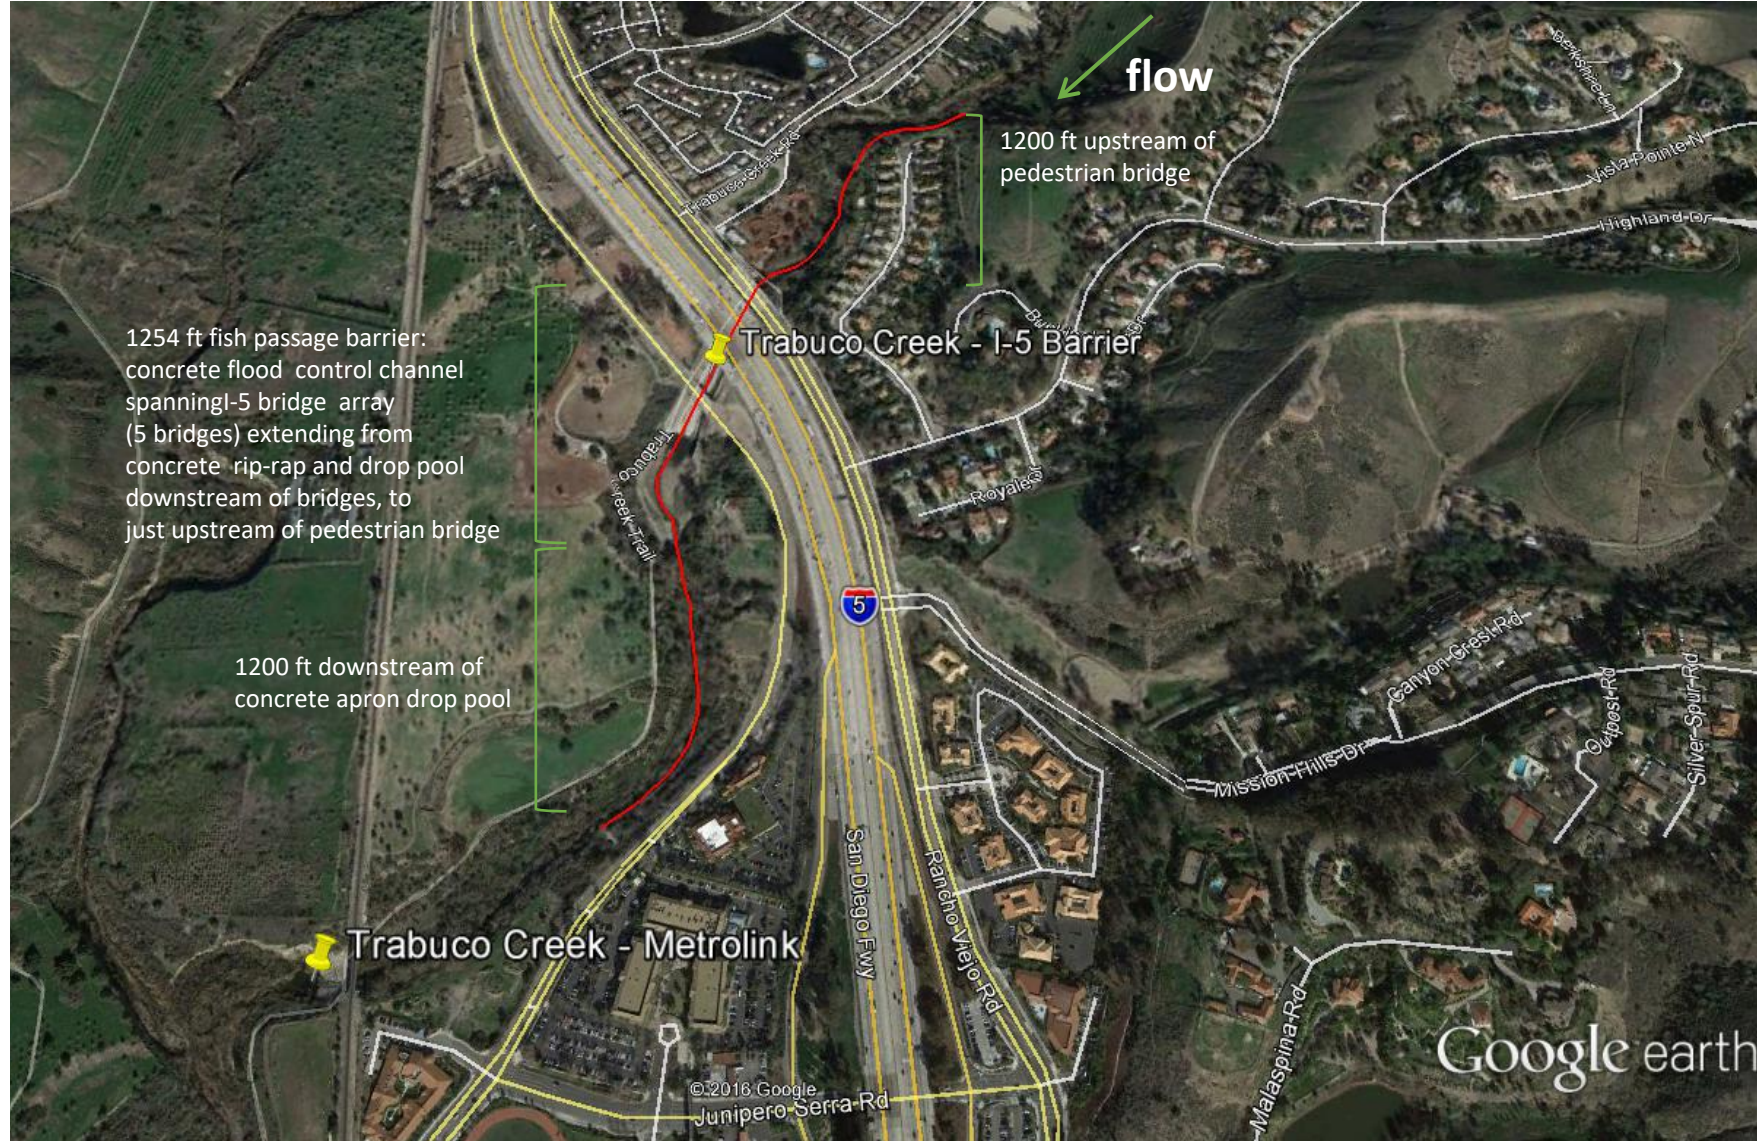
Trabuco Fish Passage Barrier Project Area (red line) including 1200 ft downstream and upstream of I-5 Bridge Array barrier (shown as central section). Metrolink barrier downstream shown for reference.

**Project Site:** The area beneath the five bridges consists of twin rectangular flood control channels with centerline V-notches extending into a concrete stilling basin west of Camino Capistrano, downstream through a grouted riprap channel, terminating in a grouted apron drop of ~2 feet into boulder cluster and more natural soft-bottom channel (~1254' total)

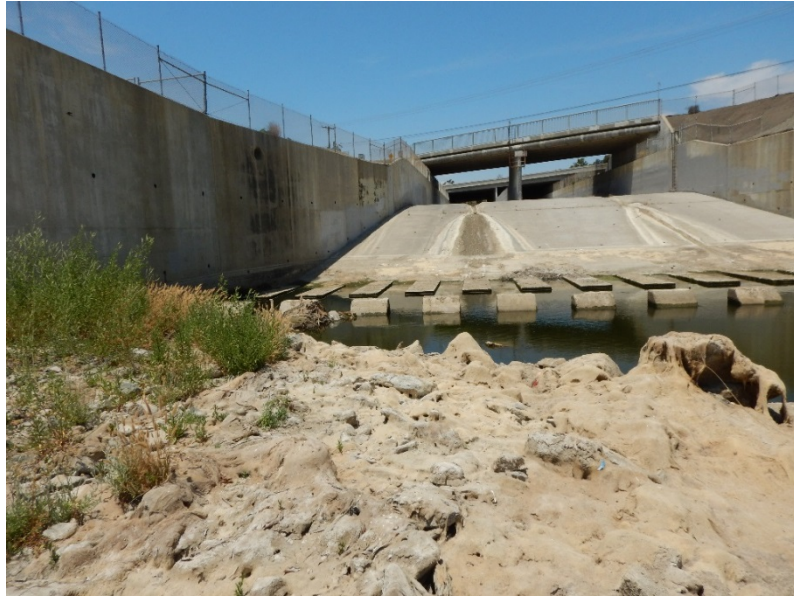
View to NE directly at flood control channel below CC bridge

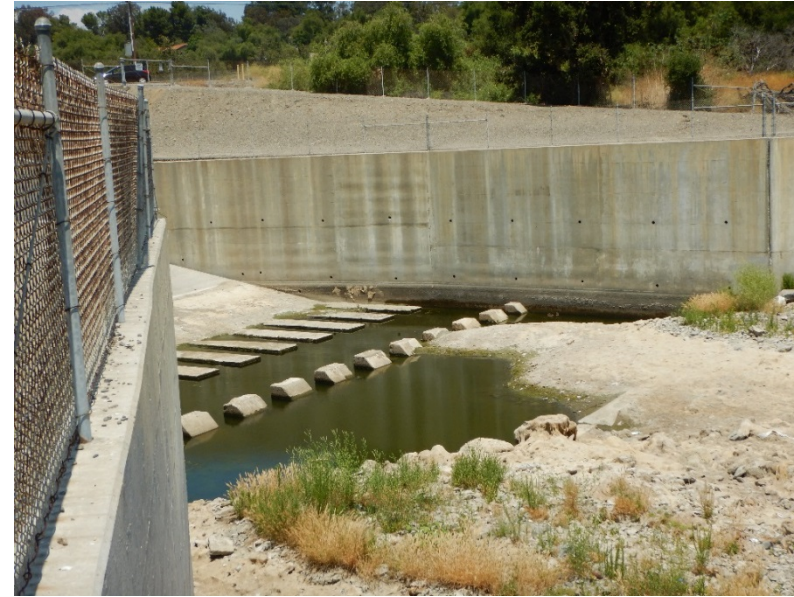
View to E from edge of retaining wall

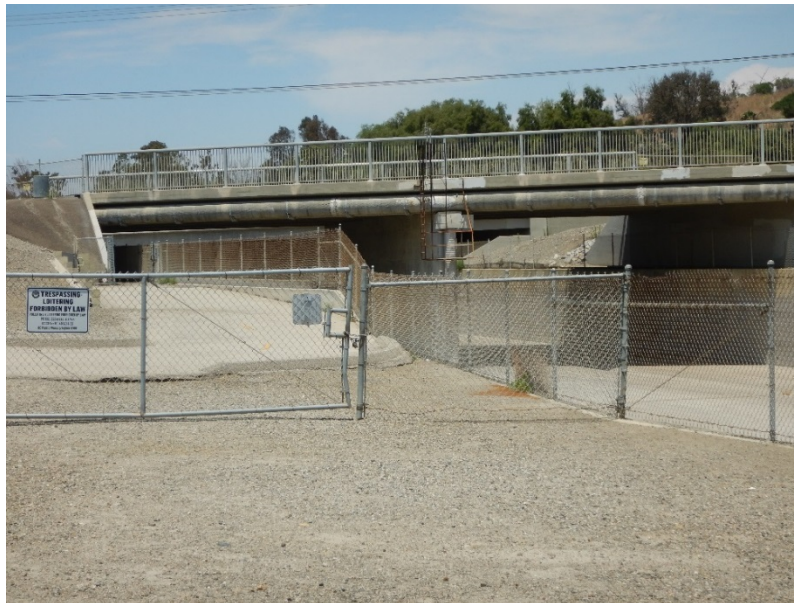
View to NE looking upstream at CC bridge

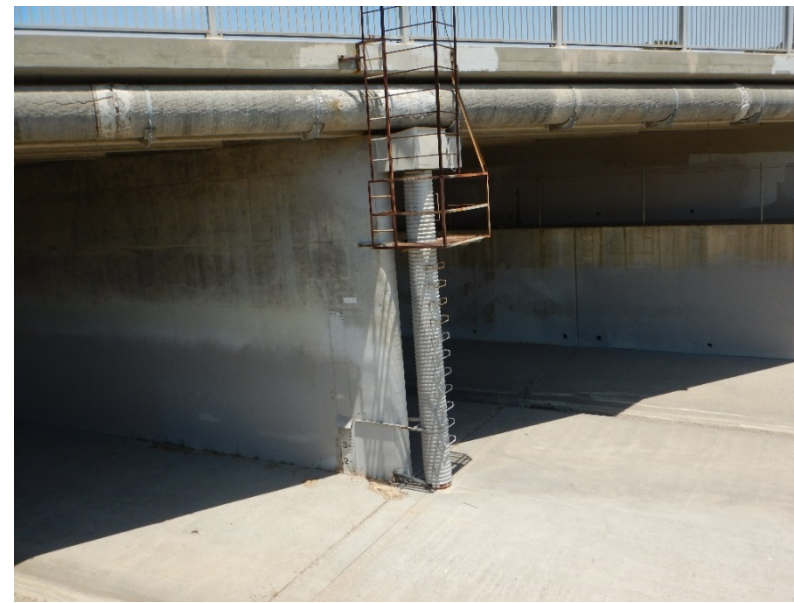
View to E looking at flood control channel

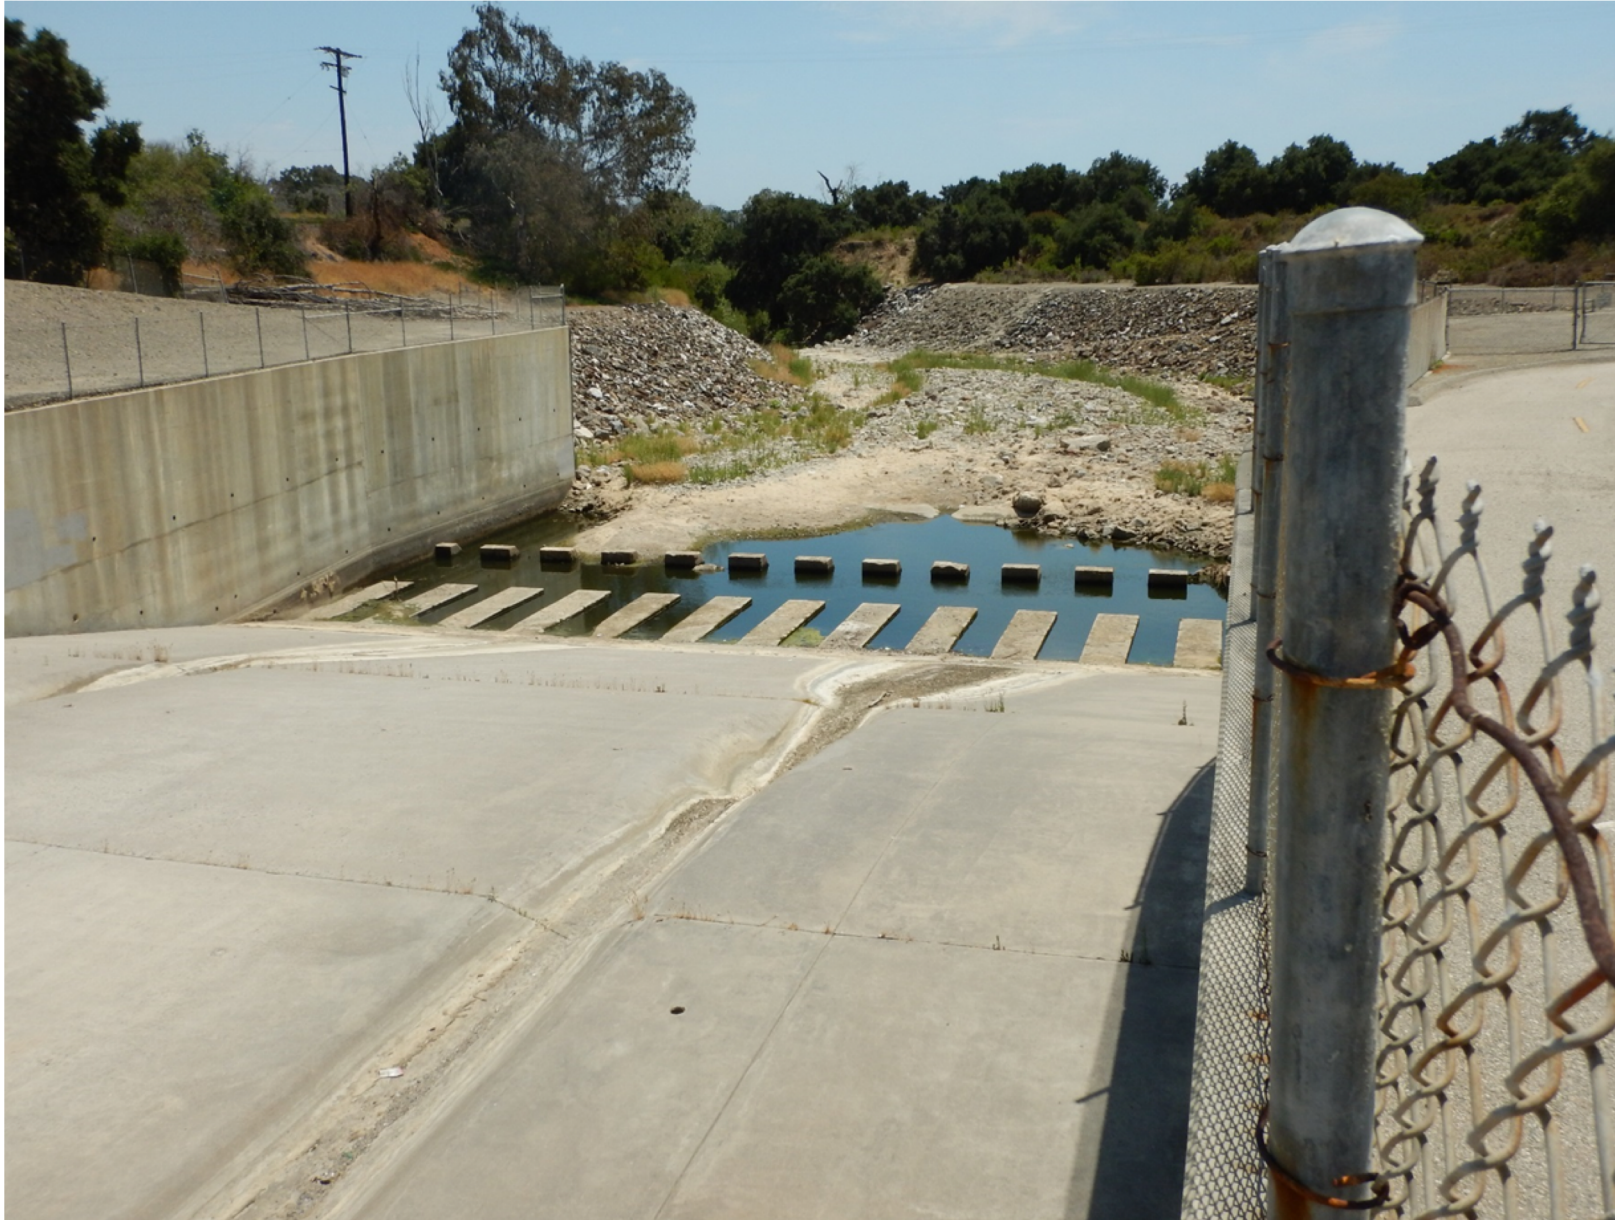
View from end of flood control channel looking downstream at Trabuco Creek channel

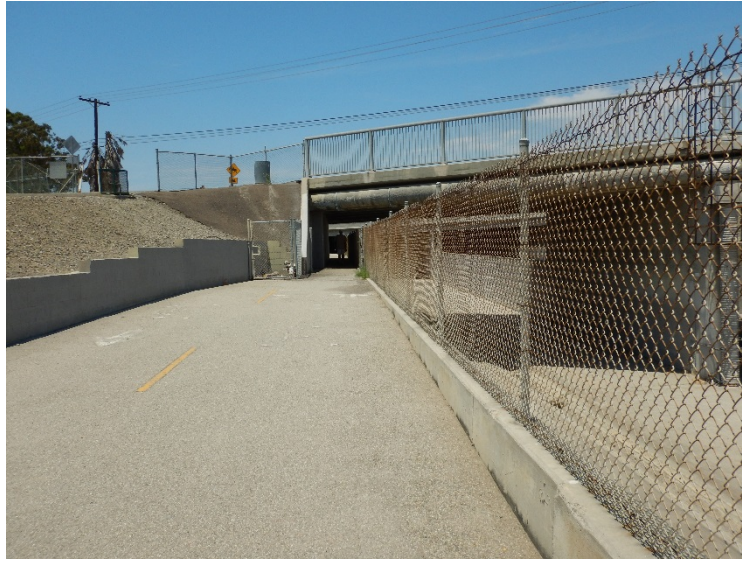
View of CC bridge, looking upstream

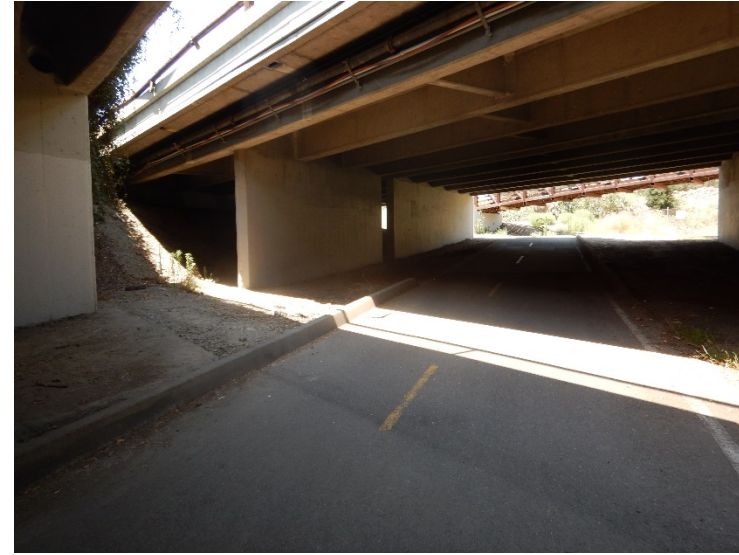
Under I-5 NB on bike path looking upstream

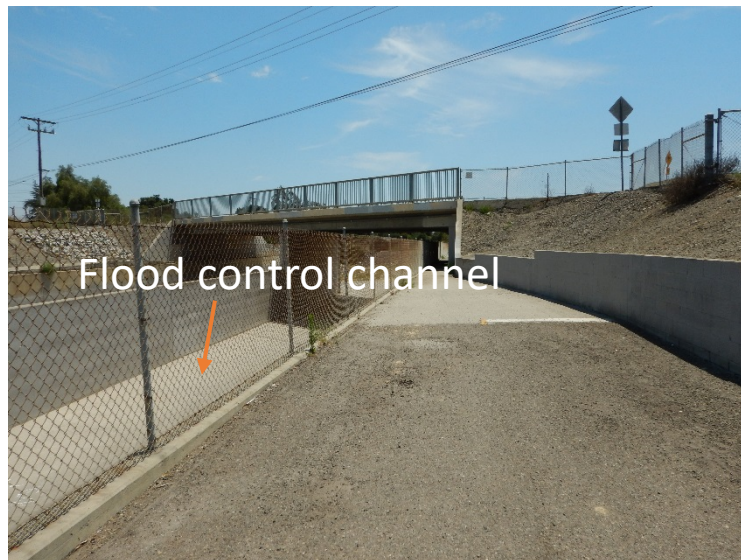
View of CC bridge, looking downstream

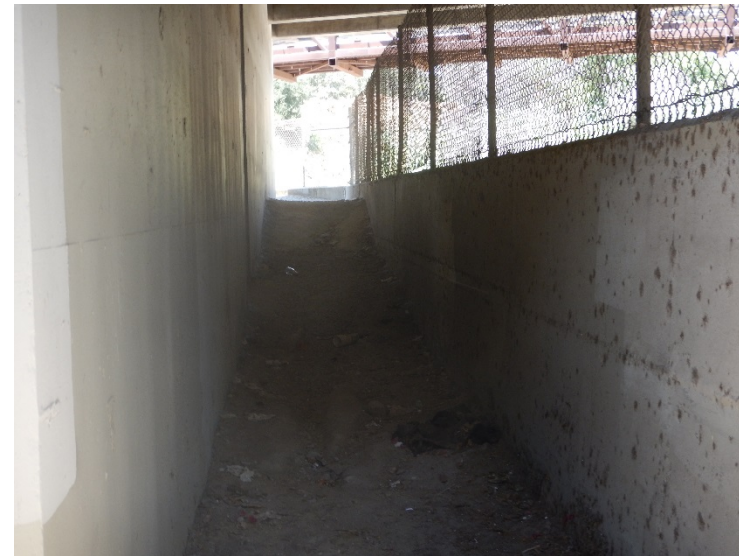
Under I-5 NB looking upstream at access path

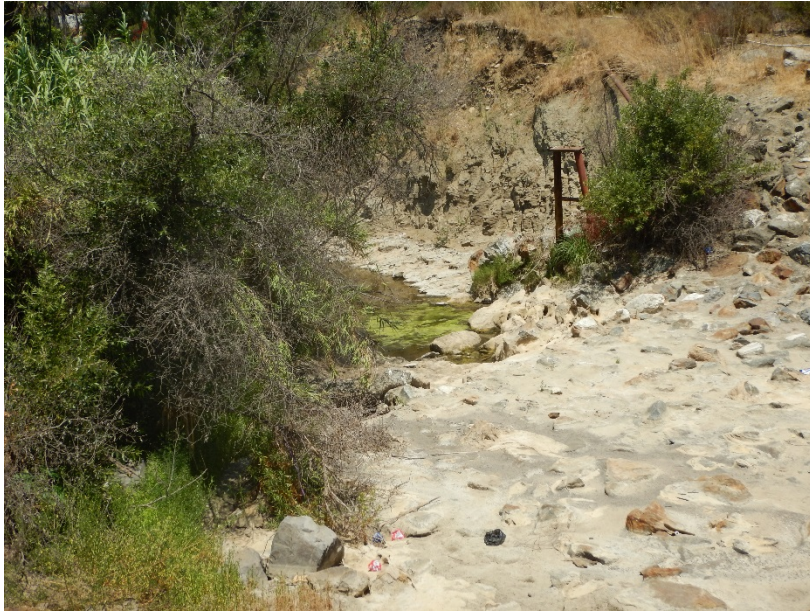
Upstream end of project site

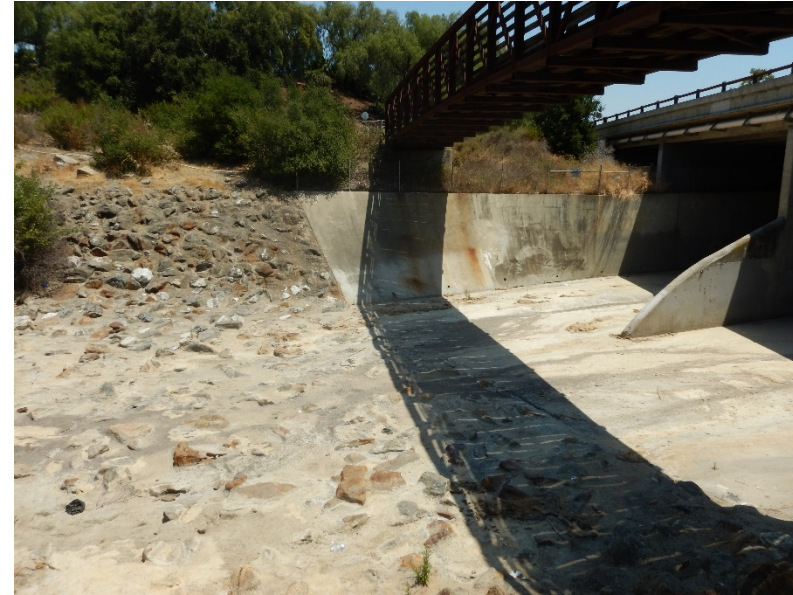
Start of flood control twin channels

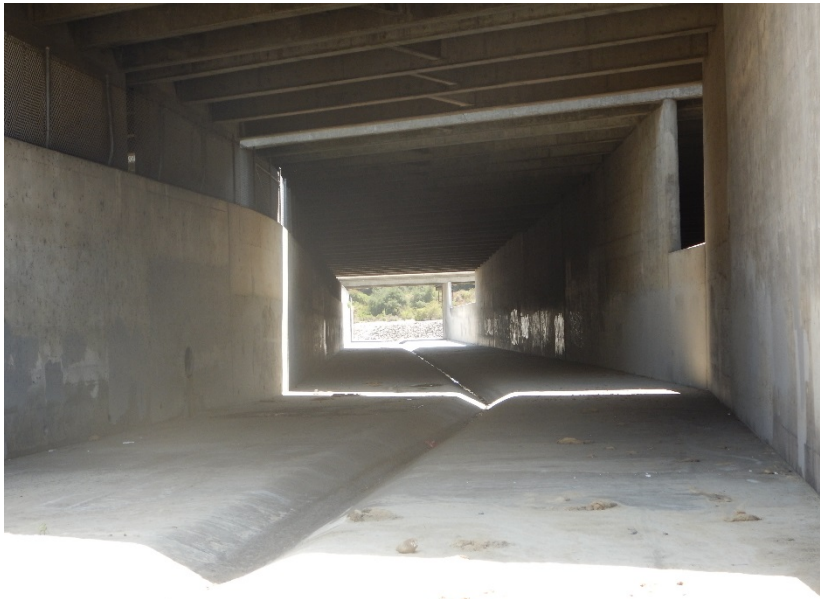
View looking downstream into E channel

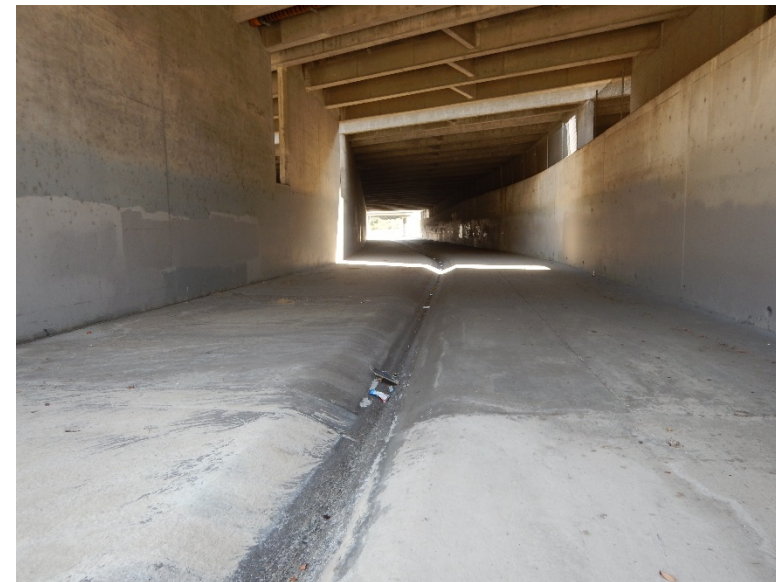
View looking downstream into W channel

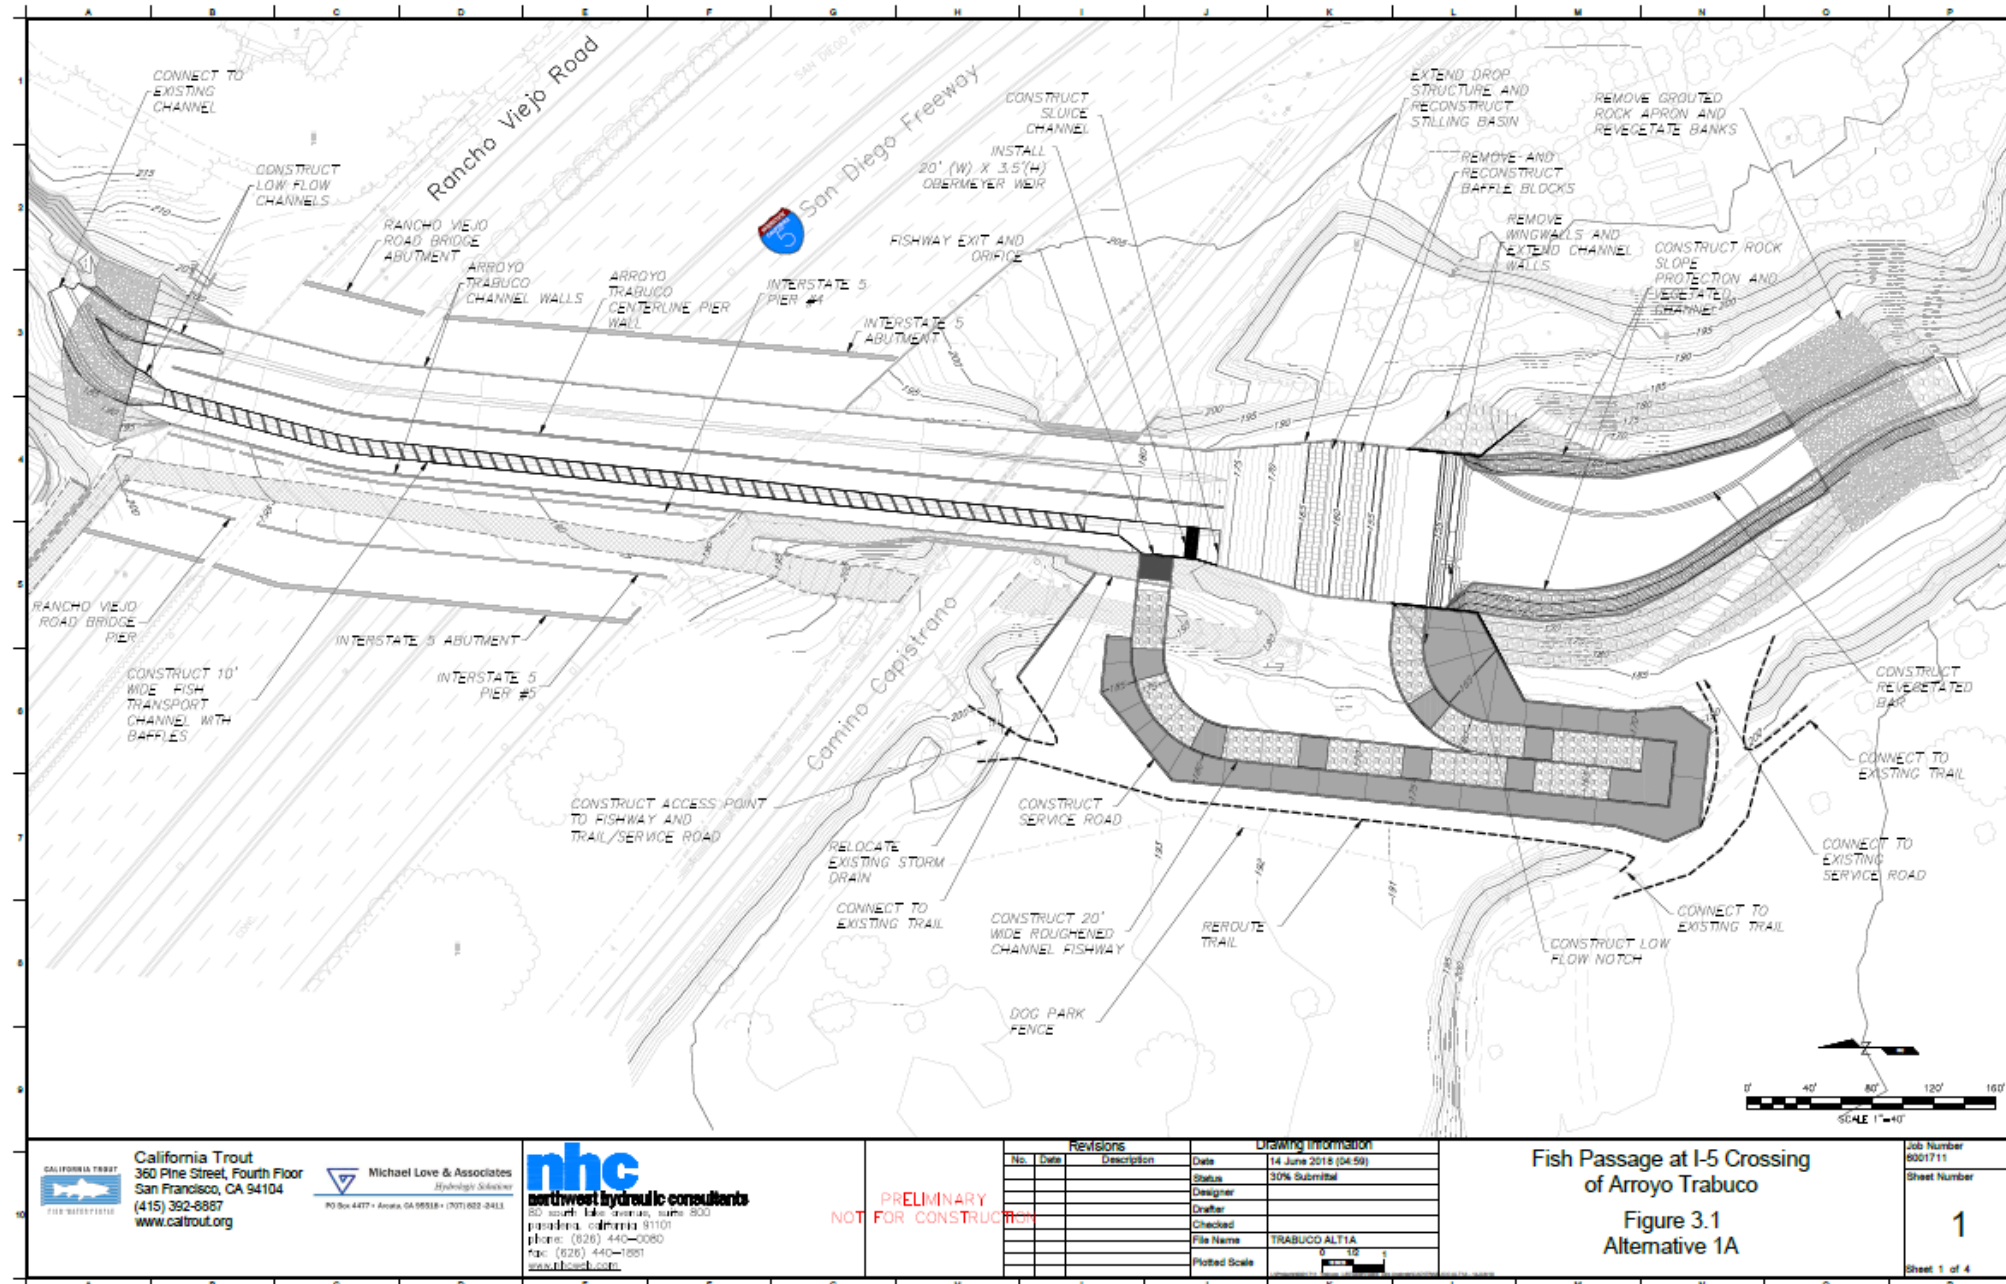
# ALTERNATIVE 1A: WEST BANK BYPASS ROUGHENED CHANNEL WITH INSTREAM FISH TRANSPORT CHANNEL

**Overview:** The bypass roughened channel fishway lies on west (river right) bank of the stream to provide fish passage.

- Constructs a 545-foot long rock-filled roughened channel switchback bypass fishway with entrance at the stilling basin and exit at the top of the drop structure transitioning into the fish transport channel;

- Constructs a 655-foot long concrete fish transport channel recessed into the floor of the concrete channel R bay, extending from the fishway exit located at the top of the drop structure to the upstream end of the concrete channel inlet apron, upstream of the Rancho Viejo Road crossing;

- Remove grouted rock apron downstream of the outlet drop structure
- Lower channel 8 feet between the outlet drop structure and grouted rock apron to match the ds elevation

- Extend existing concrete drop structure at its existing slope of 22.5% to accommodate 8 feet of fall.
- Construct new concrete apron and dentates at the base of the extended drop structure.

- Place ESM between concrete retaining walls to form chutes and pools.

- Overall drop = 20.5 feet
- Overall length and slope of roughened channel = 655 feet at 3.2%
- Roughened channel width = 20 feet
- Length and slope of roughened channel chutes = ~49 feet at 4.5%
- Length and residual depth of pools = 18 feet long and 3 feet deep; Turn pool is 40 ft long, residual depth 5 ft
- New retaining walls 15 to 30 feet high
- Service road along one side of fishway
- Trail rerouted along west side of fishway
- Potential issues: debris and sediment clog baffles in fish Tx channel; possible stranding during low flow; orifice clogs

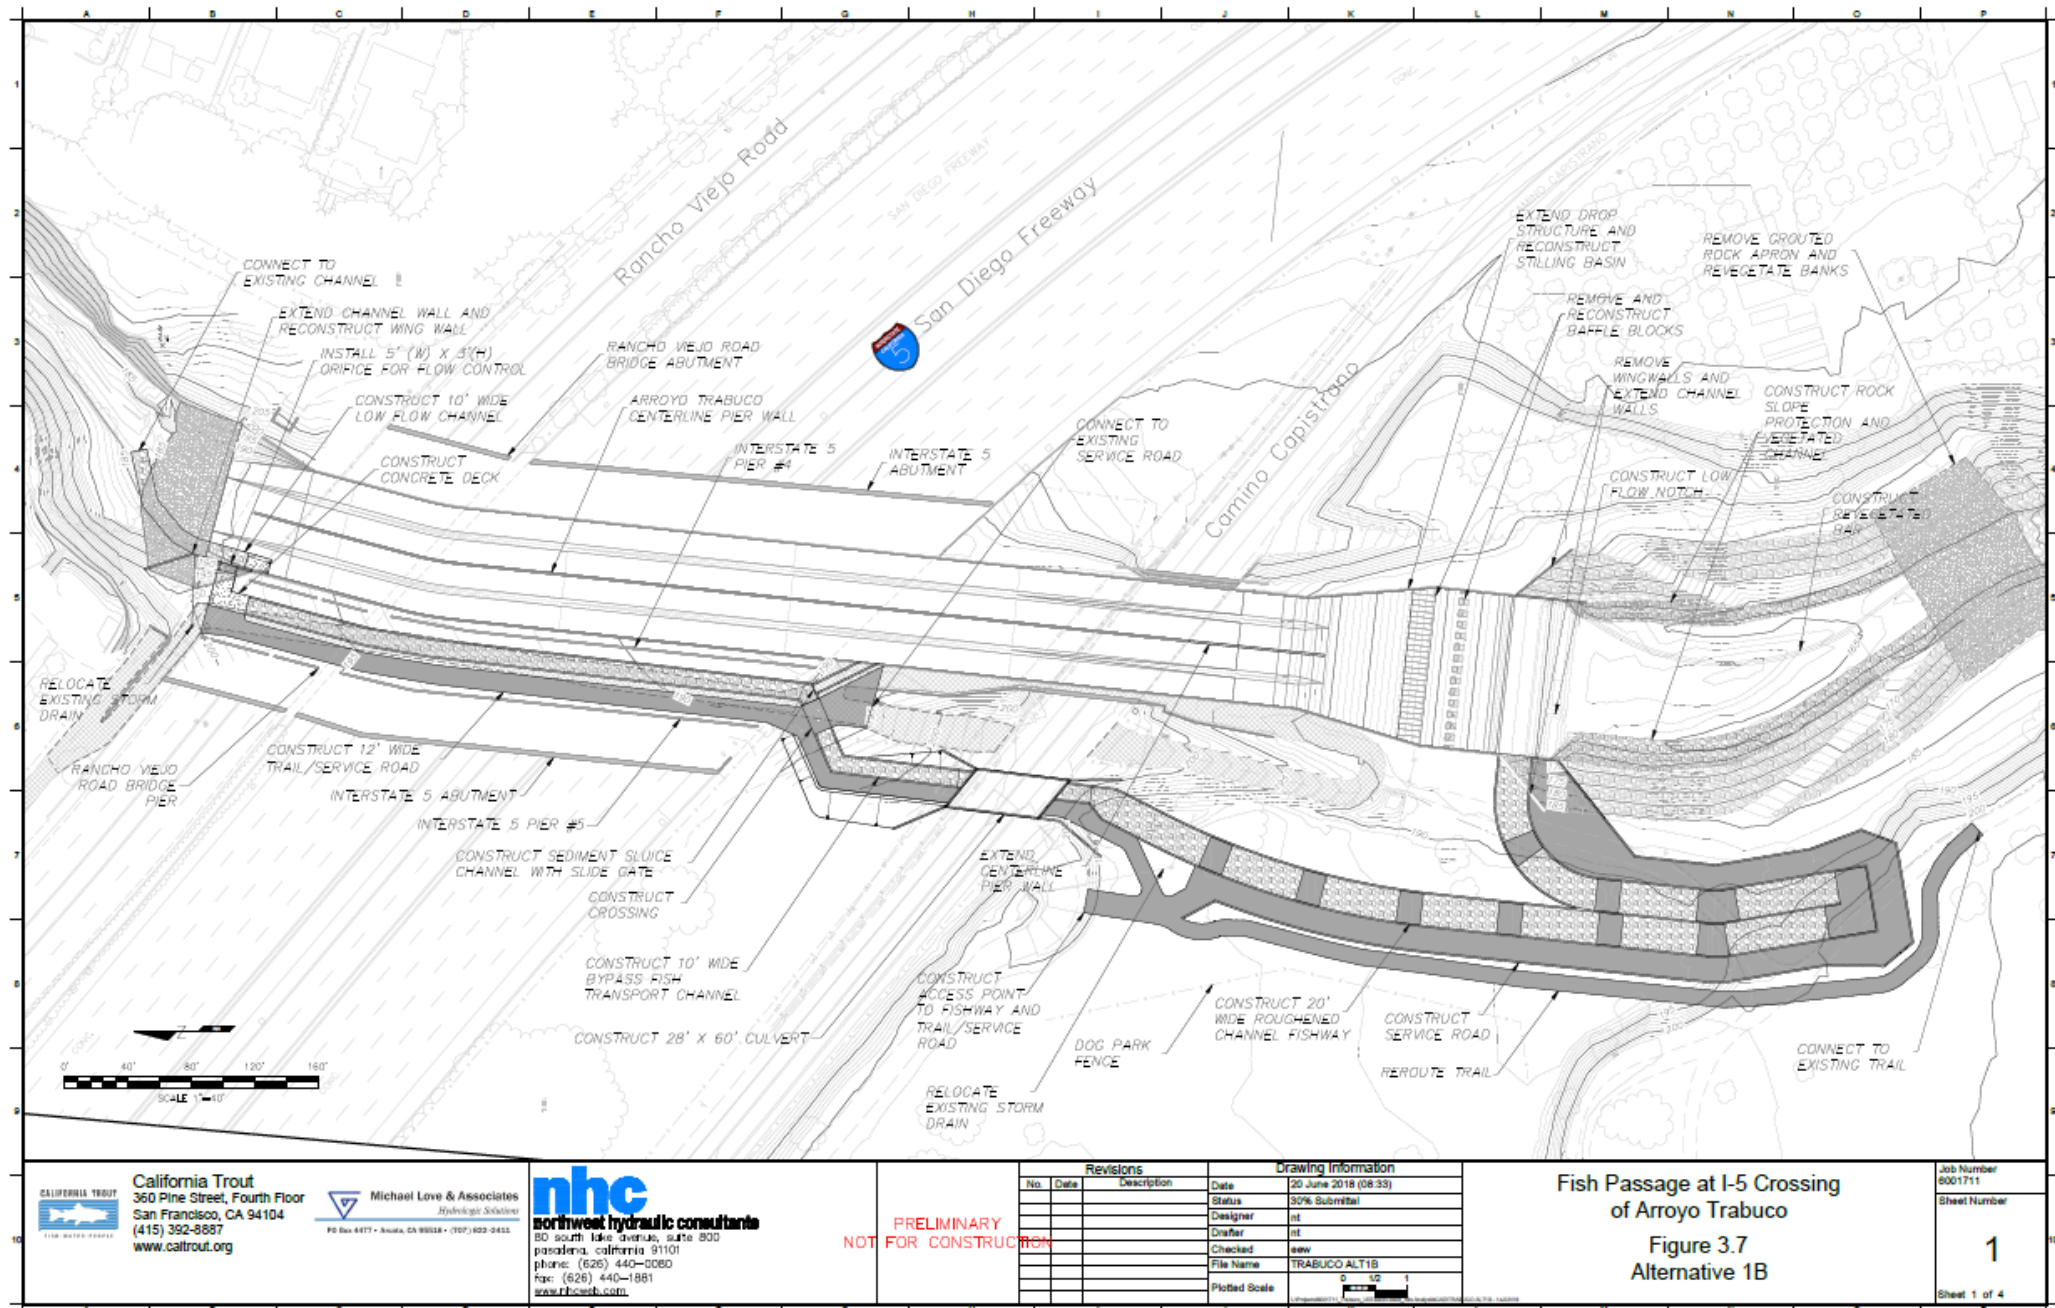
Fish Passage at I-5 Crossing  
of Arroyo Trabuco  
Figure 3.7  
Alternative 1B

**Overview:** Alternative 1b is similar to alternative 1a but uses a transport channel outside the existing flood control channel. The transport channel would cross under Camino Capistrano and pass through the bridge bays at I-5 and Rancho Viejo Road where the service road/trail is currently located. The transport channel is graded at lower slope than the existing concrete channel and the roughened channel fishway is lengthened to compensate for this difference. The transport channel would exit through a new wall near the upstream side of the Rancho Viejo Bridge.

The Camino Capistrano crossing would be through a culvert with adequate span to also accommodate a pedestrian and equestrian trail, providing an alternative to crossing the road at grade or through the narrow walkway at the Camino Capistrano bridge abutment. Service road layout varies somewhat from Alternative 1a to accommodate this layout, and the existing ramp on the south side of Camino Capistrano would be maintained.

Compared to Alternative 1a, the primary differences in the roughened channel fishway characteristics are: Overall drop = 24.5 feet; and Overall length and slope of roughened channel = 748 feet at 3.2%

- The design of the chutes and pools is about the same as for Alternative 1a.
- Dimensions = 10 feet wide by variable depth to match existing ground constructed of reinforced concrete
- Overall length and slope of transport channel = 650 feet at 0.16%
- Rock lining for roughness
- 20-foot wide pneumatic gate (Obermeyer type) to push flow into fishway
- 3 foot by 5 foot opening for fishway exit to transport channel

- Infrastructure:** Rancho Viejo Road, San Diego Freeway, Interstate 5, and Camino Capistrano.
- Proposed Construction:**
  - CONSTRUCT LOW FLOW CHANNELS

- CONSTRUCT 10' WIDE FISH TRANSPORT CHANNEL WITH BAFFLES
  - ARROYO TRABUCO CENTERLINE PIER WALL
  - INTERSTATE 5 PIER #4
  - INTERSTATE 5 ABUTMENT
  - ARROYO TRABUCO CHANNEL WALLS

- CONSTRUCT ACCESS POINT TO SERVICE ROAD
  - INSTALL 8'(W) X 5'(H) ORIFICE
  - INSTALL 20' (W) X 3.5' (H) OBERMEYER WEIR
  - CONSTRUCT SLUICE CHANNEL
  - CONSTRUCT 25' WIDE ROUGHENED CHANNEL FISHWAY AND 15' WIDE SERVICE ROAD

- REMOVE GROUTED ROCK APRON WITHIN GRADING
  - CONSTRUCT FISH BARRIER
  - EXTEND CENTERLINE PIER WALL
  - RANCHO VIEJO ROAD BRIDGE PIER
  - INTERSTATE 5 ABUTMENT

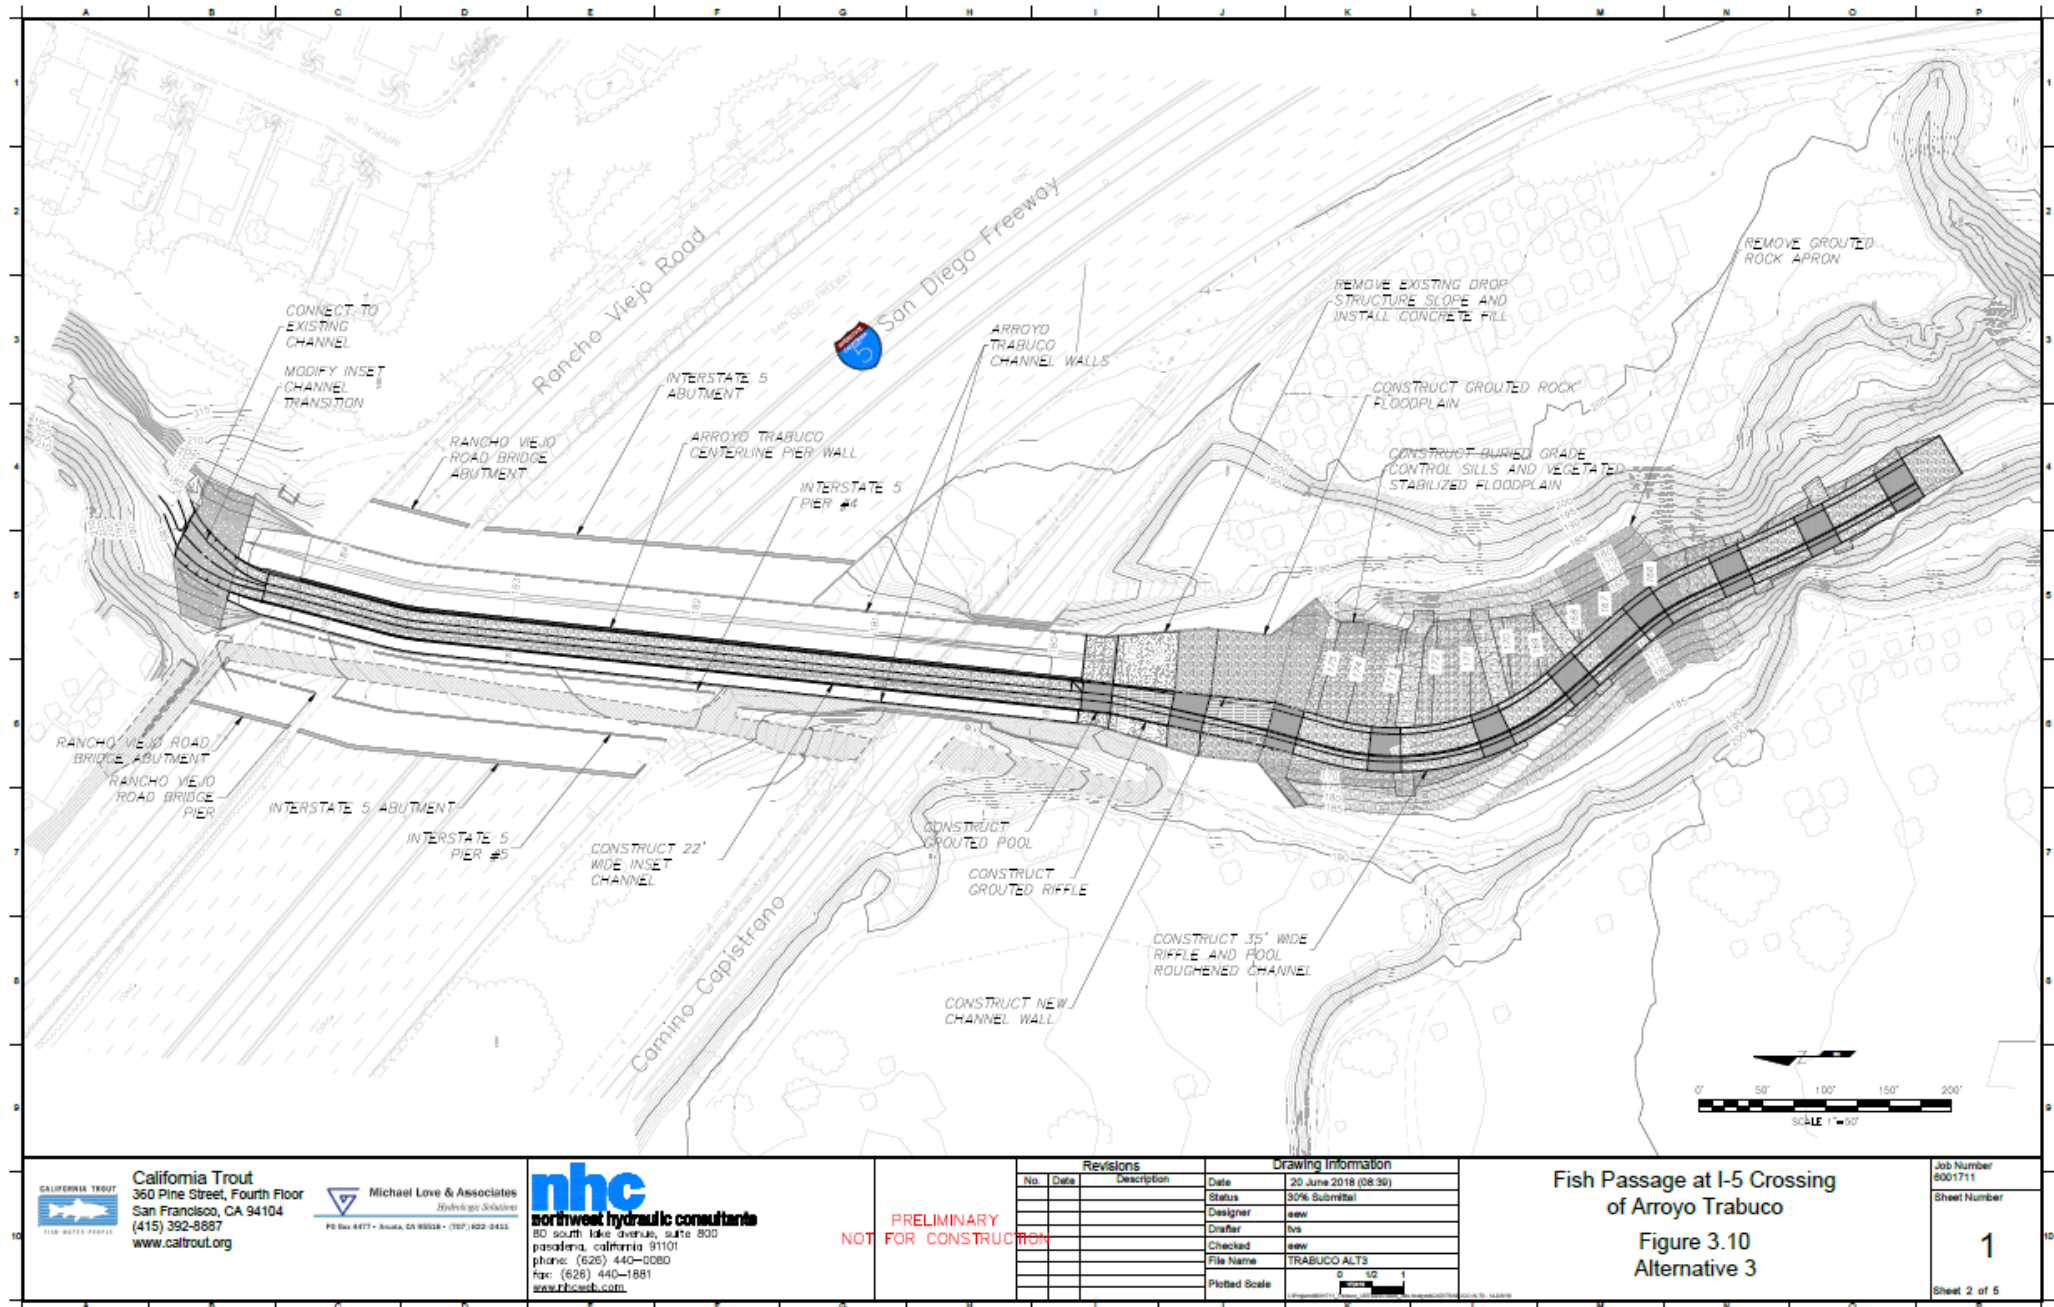
Figure 3.10  
Alternative 3

Alternative 3 constructs passage improvements within the existing channel system, eliminating the need for a bypass or diversion. The fish passage channel downstream of the existing drop structure would be a roughened channel approximately 35 feet in width and passage through the concrete channel would be provided by an inset channel in the west (right) bay of the concrete channel approximately 22 feet in width, extending under the bridges for Camino Capistrano, I-5, and Rancho Viejo Road.

Removes the in-channel portion of the grouted rock apron located downstream of the drop structure; Constructs 725-foot long, 35-foot wide, roughened channel with chutes and pools downstream of the drop structure;

Constructs a variable-width stabilized floodplain adjacent to the roughened channel;

Removes/buries the existing drop structure so that the roughened channel upstream invert can match the invert of the inset channel at the outlet of the right bay;

Constructs a 650-foot long, 22-foot wide inset channel in the concrete channel;

Constructs a transition channel through the existing concrete and grouted rock channel apron at the inlet to the concrete channel to connect to the natural channel upstream.

Potential issues: footing proximity to I-5 bridge pier on L wall; downstream scour. WSE increase in middle of project but does not affect life or property.
