California Fish Passage Forum

Project Name	Little Case Fish Passage Project
Lead Organization	Eel River Watershed Improvement Group
Name of Project Lead/Point of Contact	Isaac Mikus
Contact Email	isaac@erwig.org
Phone Number	(707) 845-8119
Location of Project	39.68385° N, -123.51815° W
Attach a map of your project	<div>  03070LittleCaseTopoMap.pdf</div>

Final Basis of Design Report – Little Case Creek Restoration Feasibility Study: Barrier Removal and Fish Passage Design Project

LITTLE CASE CREEK BARRIER REMOVAL AND FISH PASSAGE DESIGN PROJECT

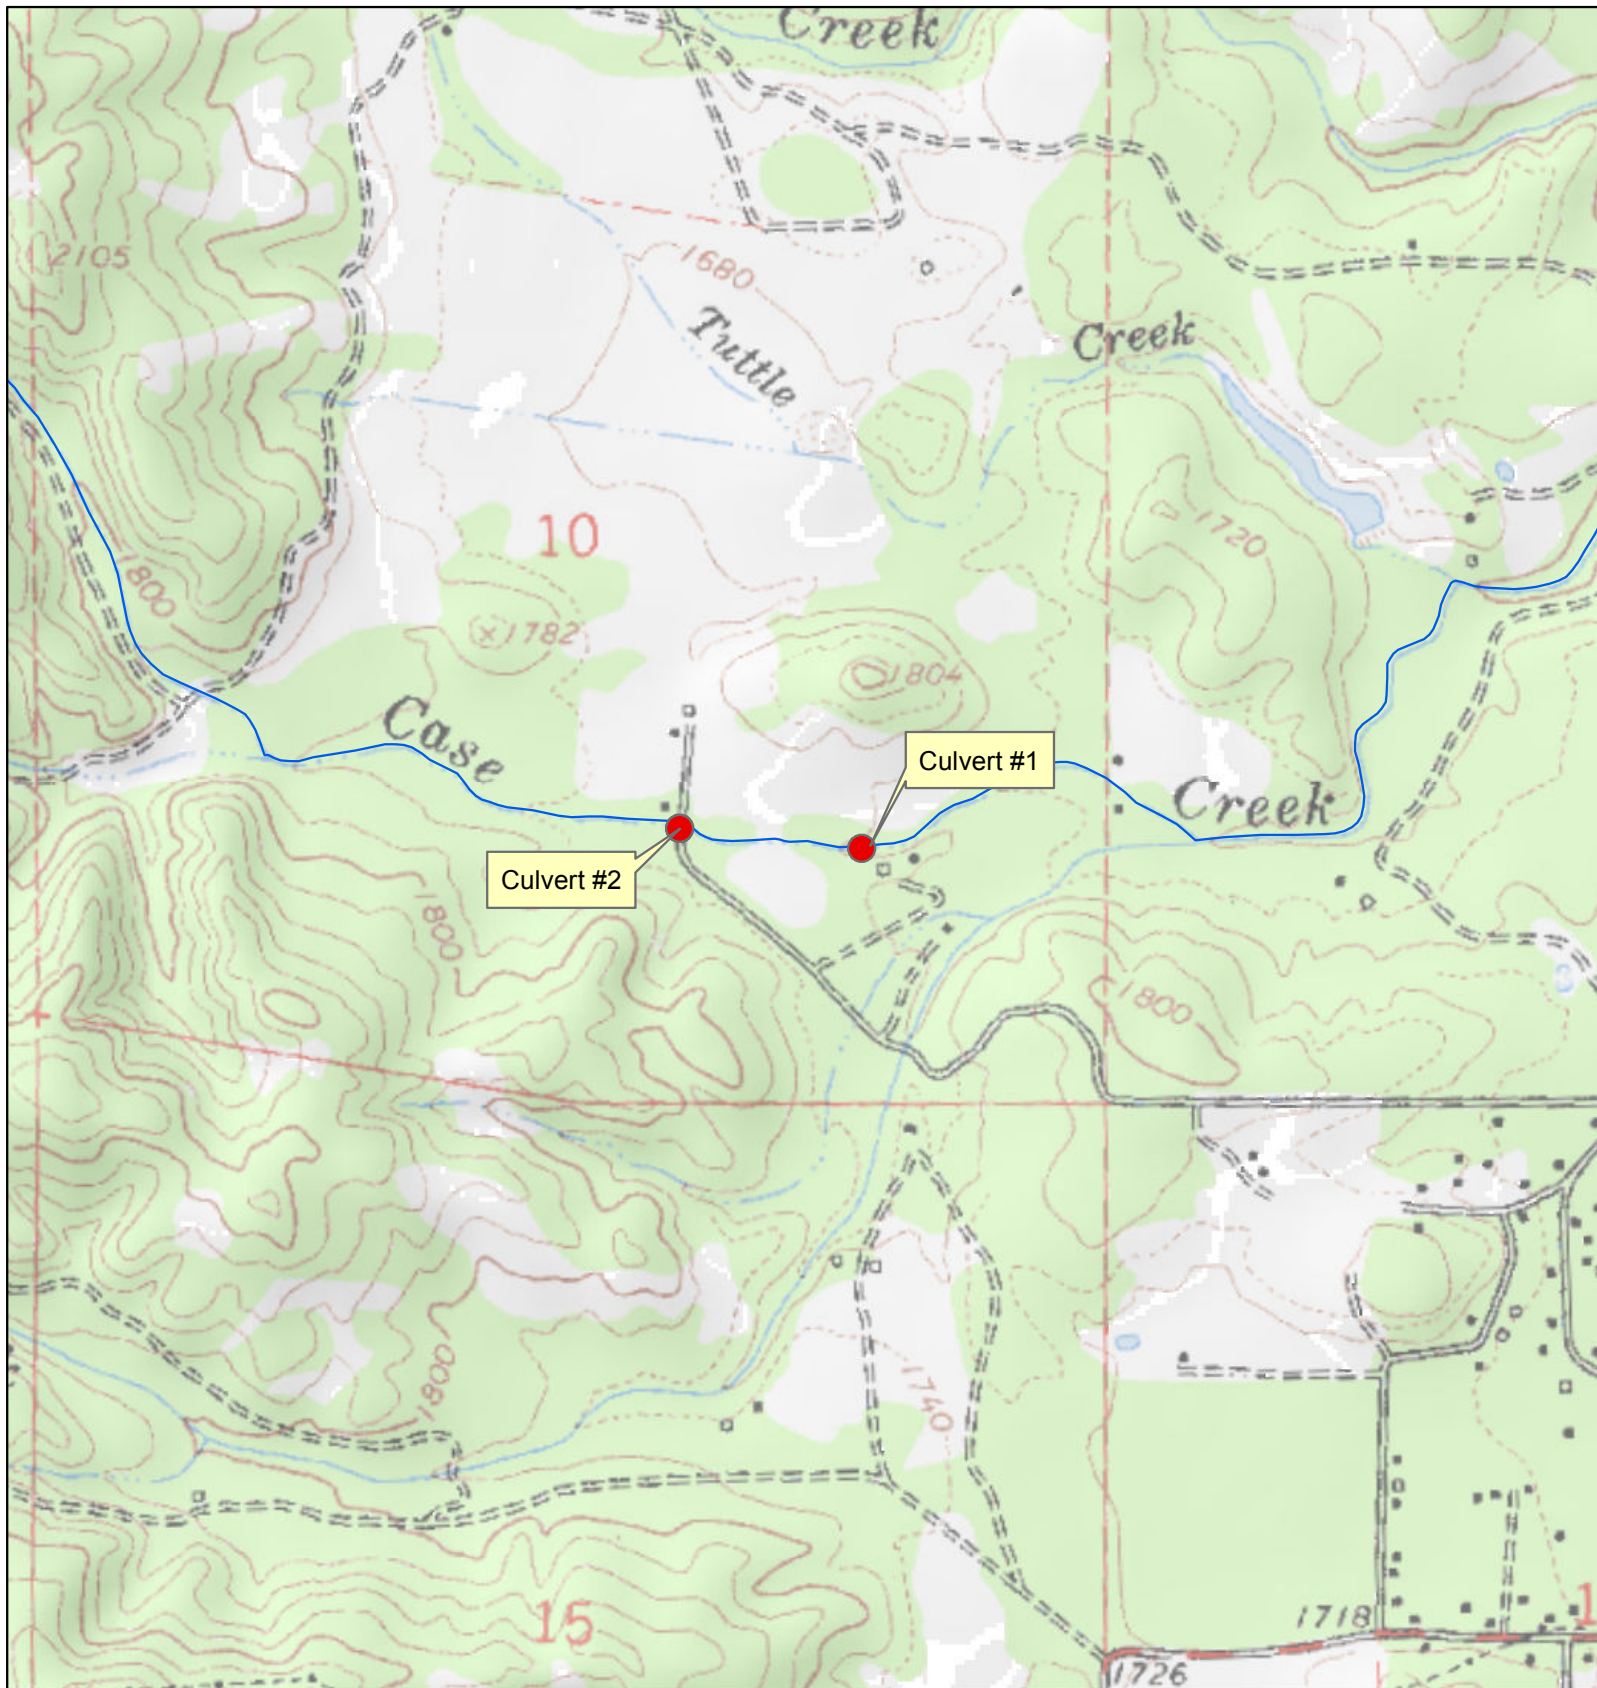
Little Case Two Barrier Removal Planning Project

Cahto Peak Quad, Mendocino County

— Little Case Creek

■ Culvert Locations

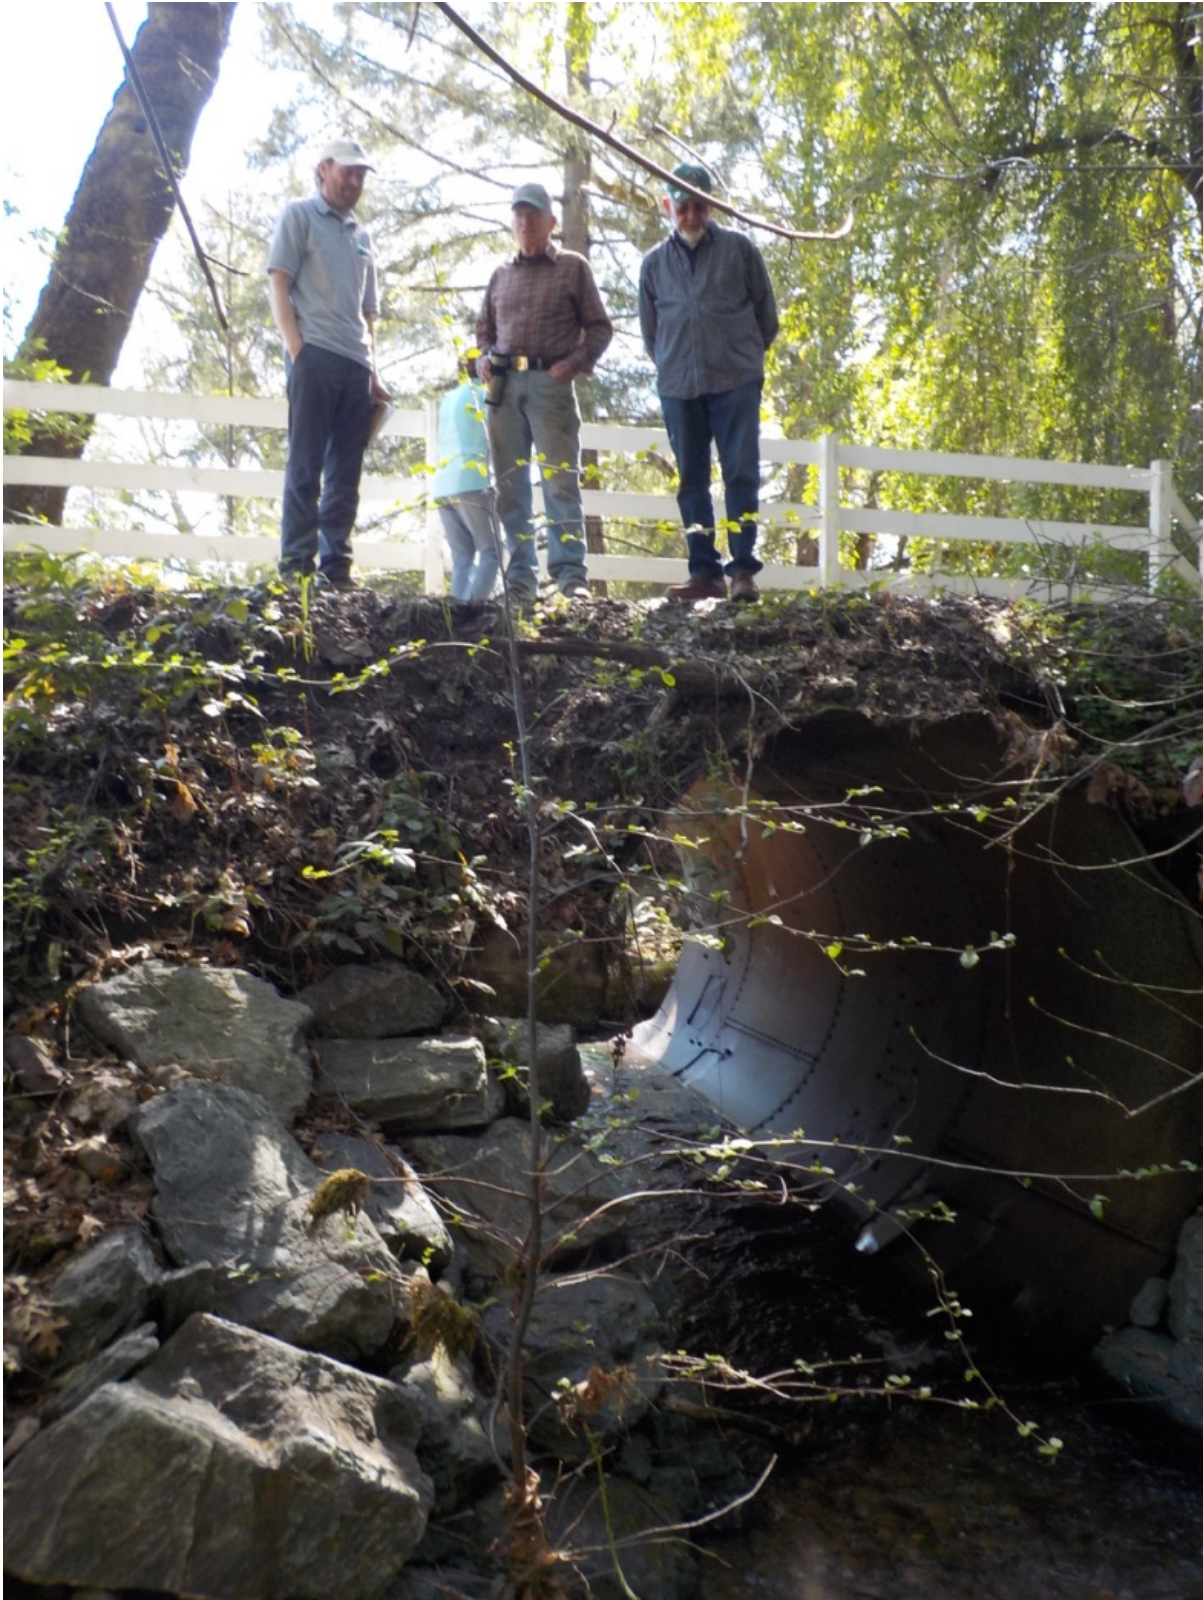
1 - Upper culvert (#2) inlet, looking downstream from LB

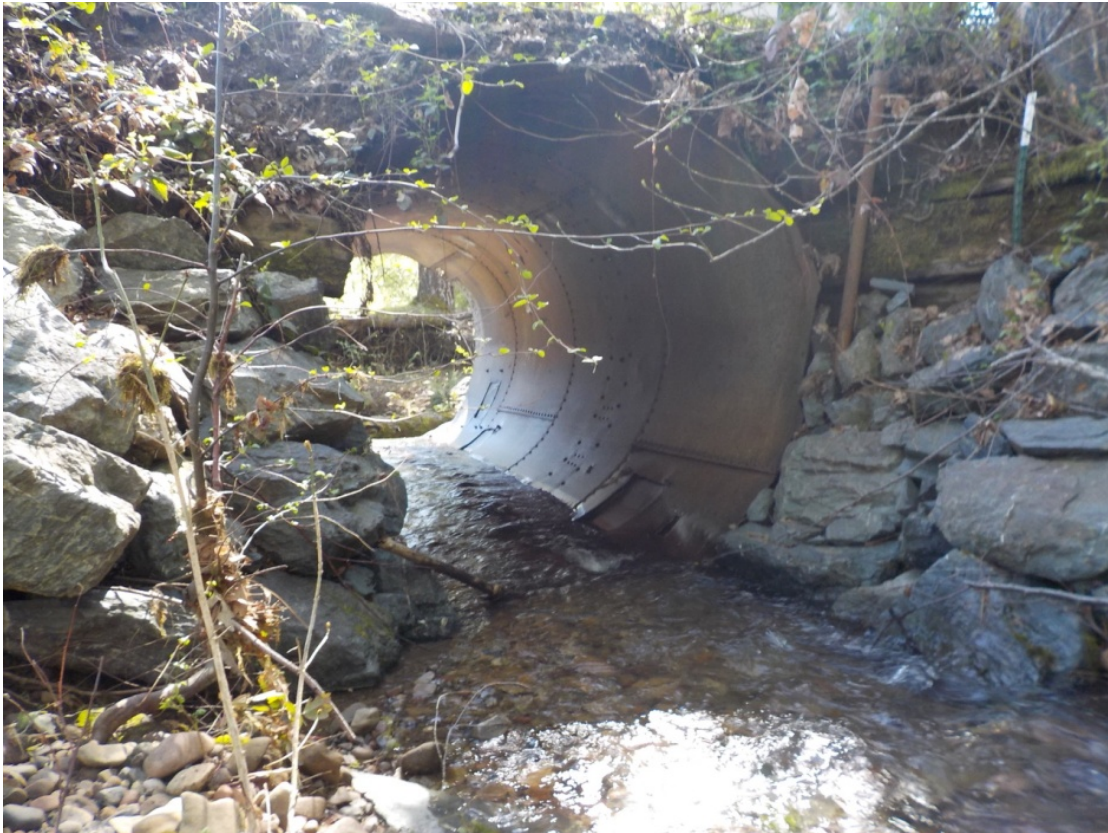
2 - Closer view of upper culvert (#2) inlet, looking downstream from LB

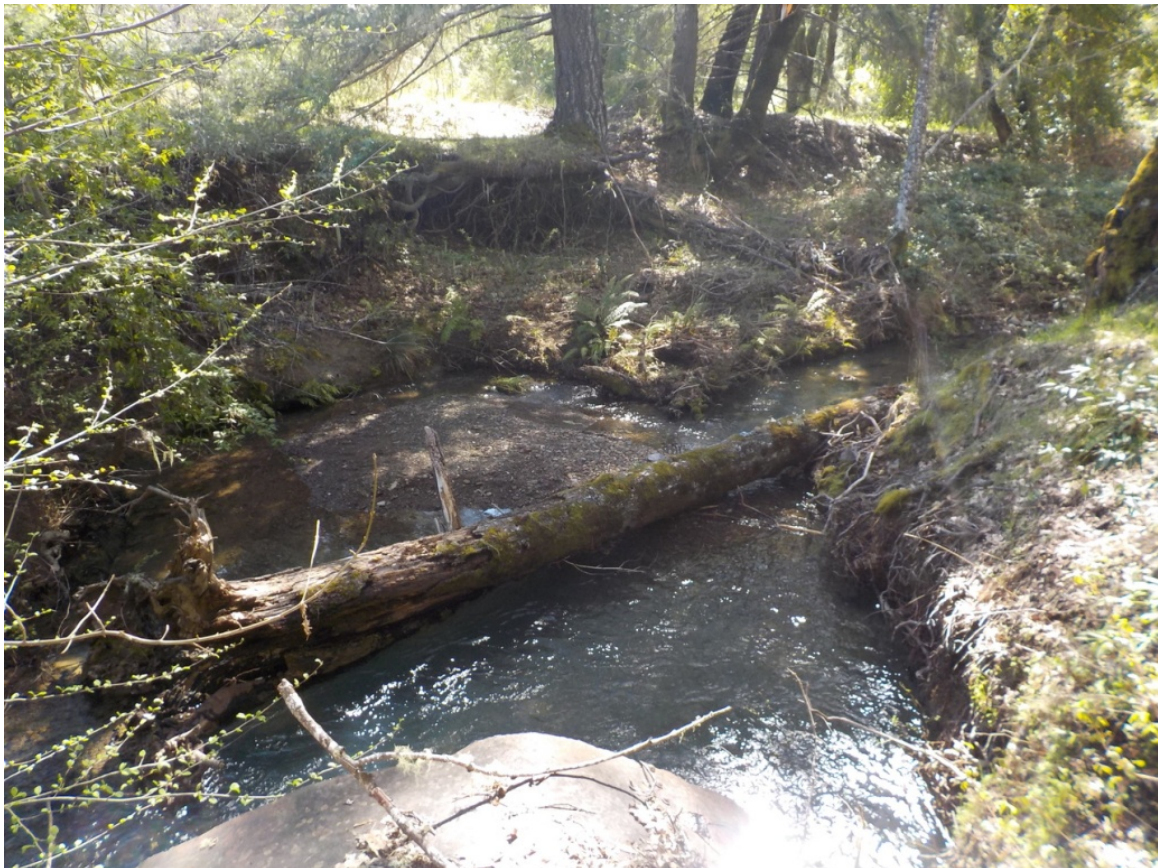
3 - Channel below upper culvert (#2), looking downstream

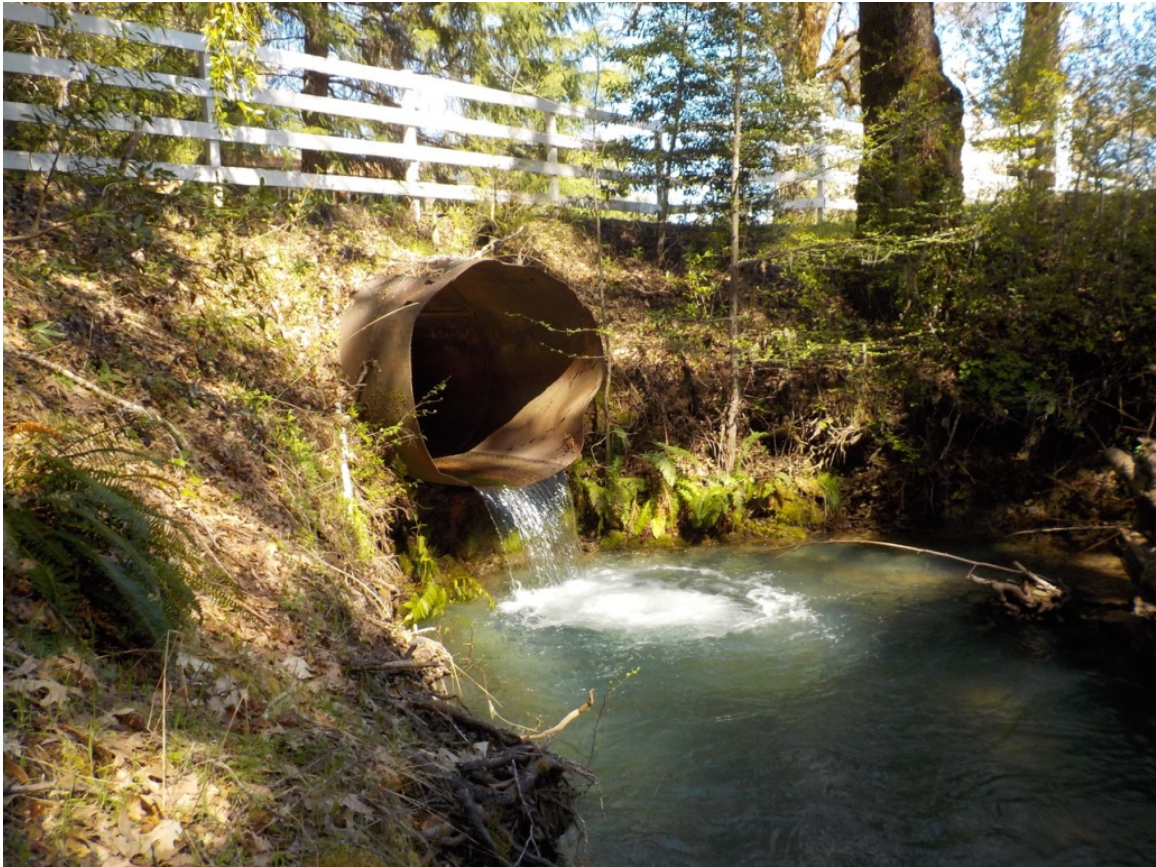
4 - Culvert (#2) outlet, looking upstream from RB

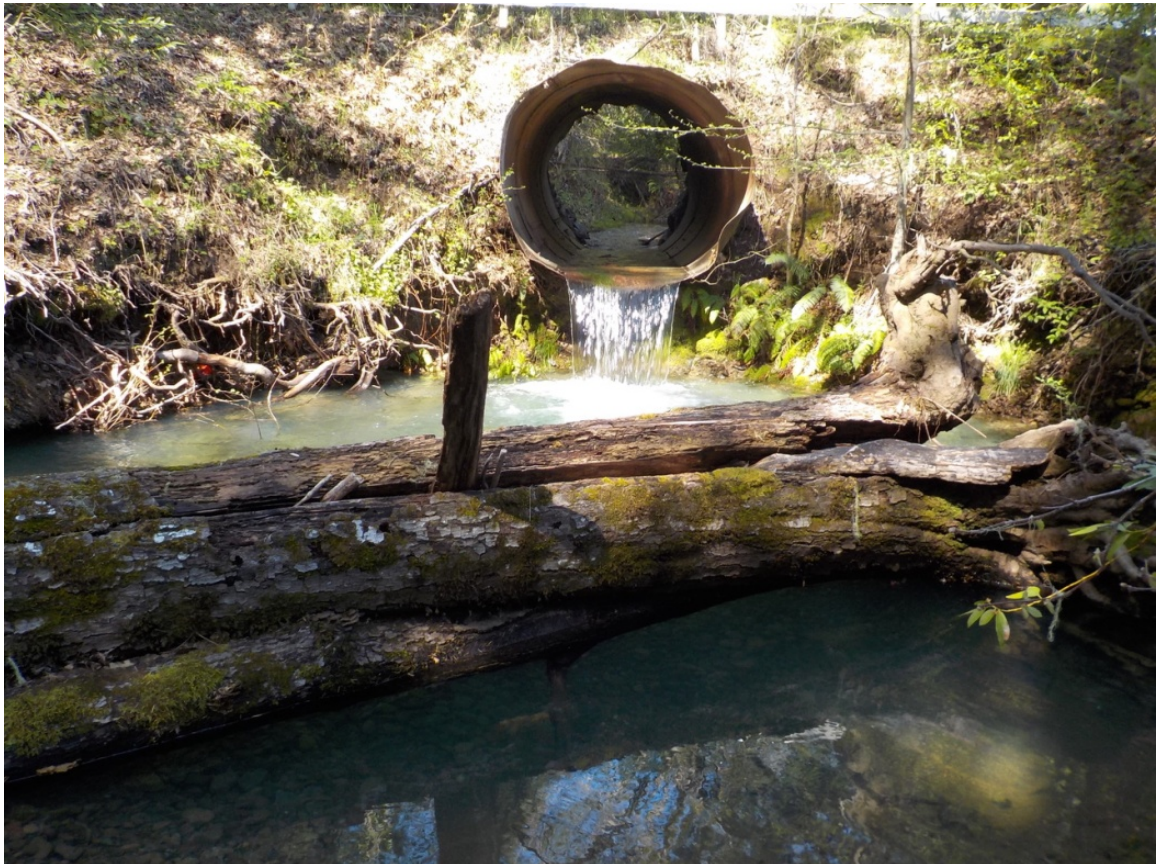
5 - Upper culvert (#2) outlet and pool, looking upstream from MC

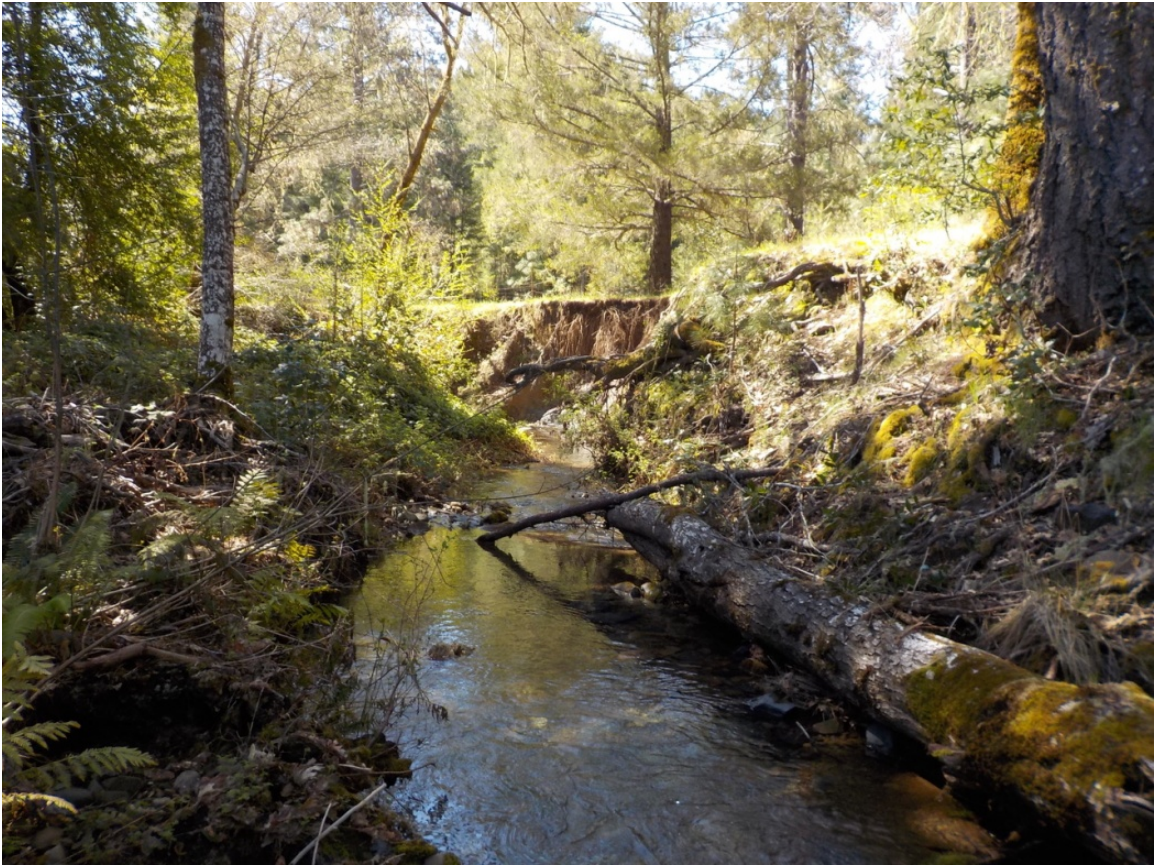
6 – Stream channel downstream of upper culvert (#2), looking downstream from LB

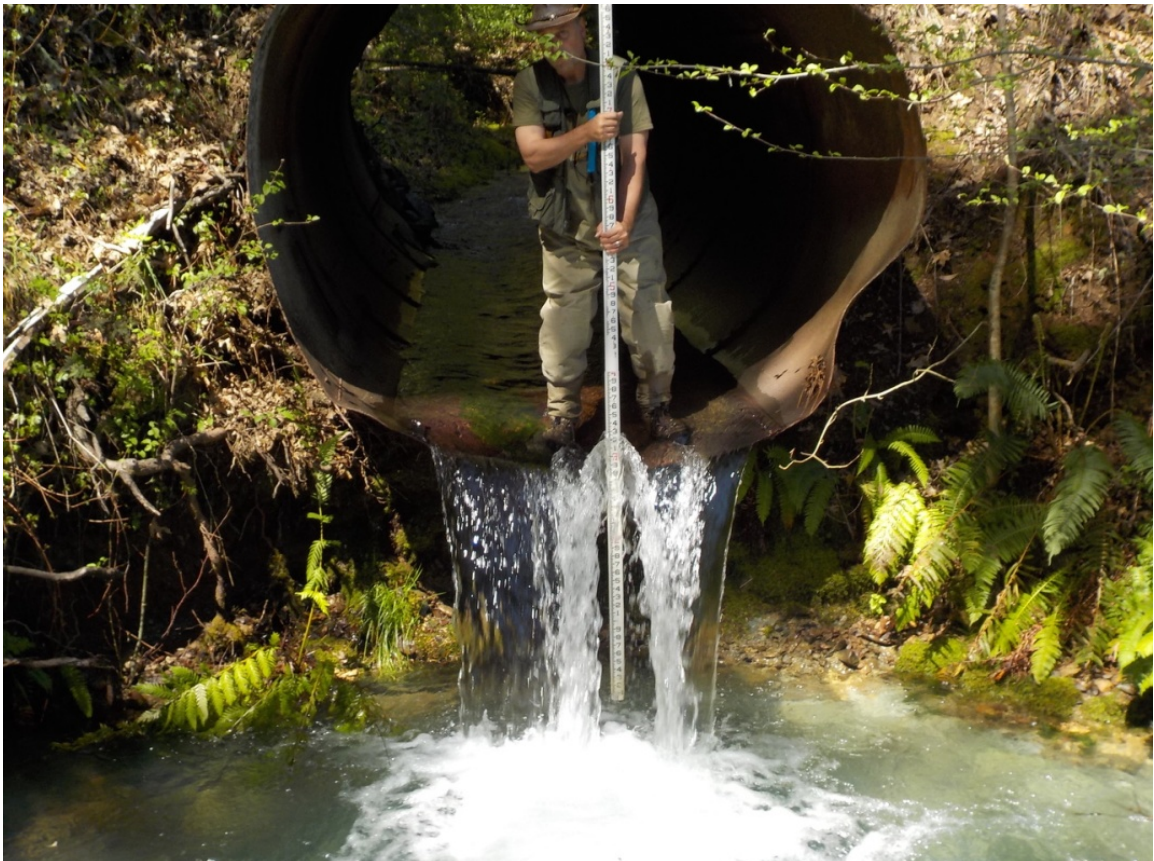
7 - Upper Culvert (#2), 3 foot drop to surface of pool, looking upstream from MC

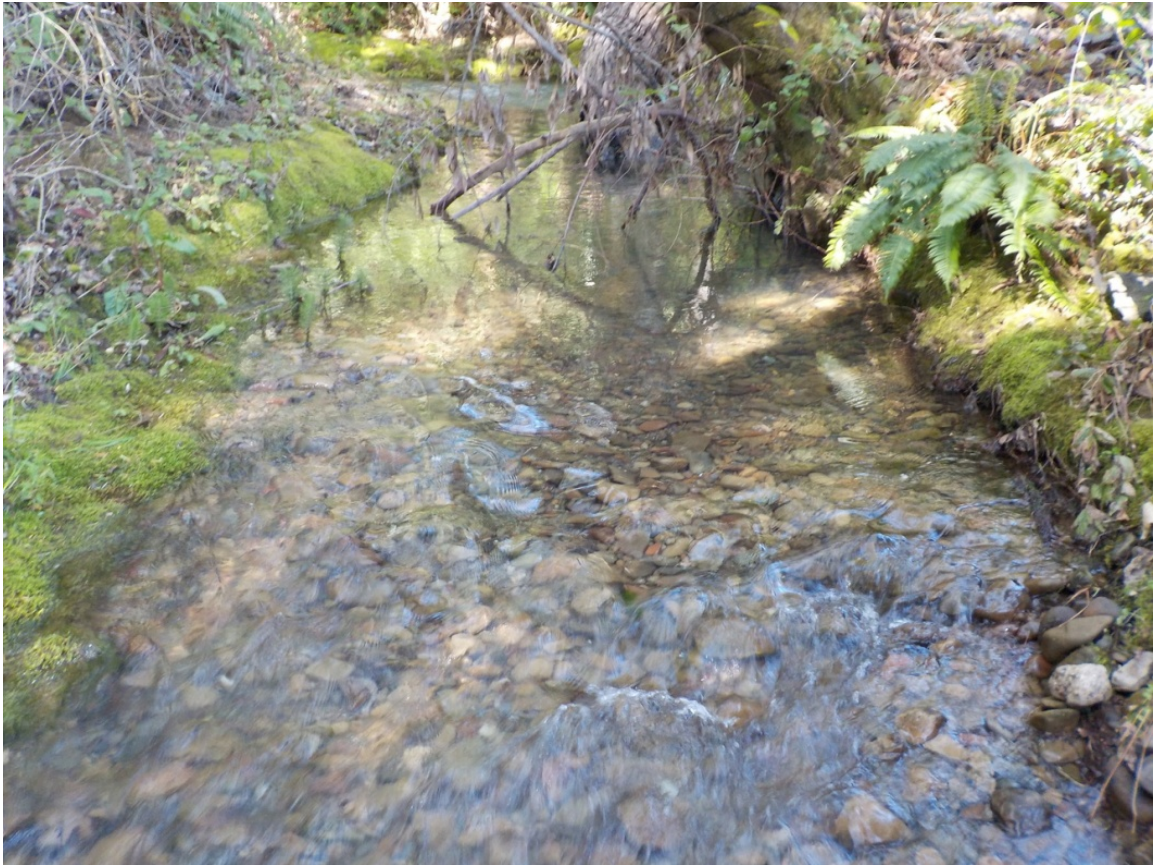
8 – Stream channel upstream of upper culvert (#2), looking upstream from MC

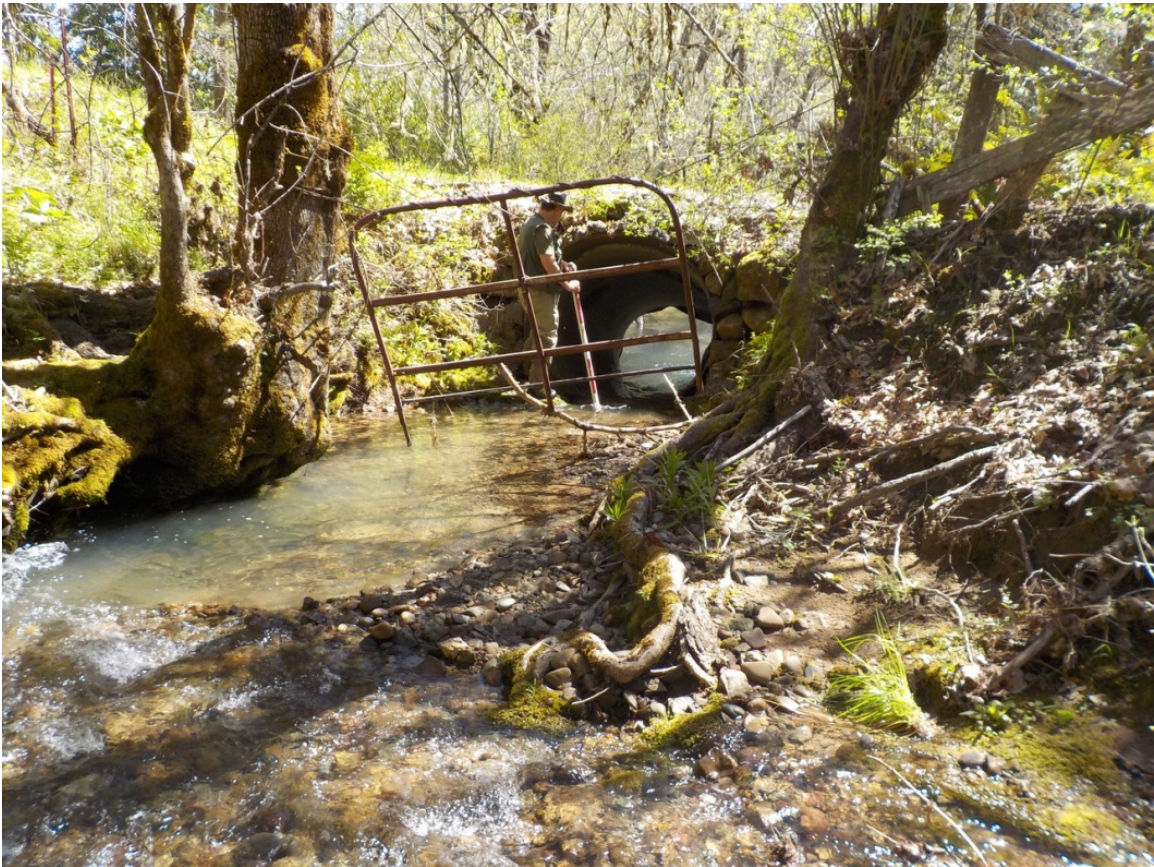
9 - Lower culvert (#1) inlet, looking downstream from RB

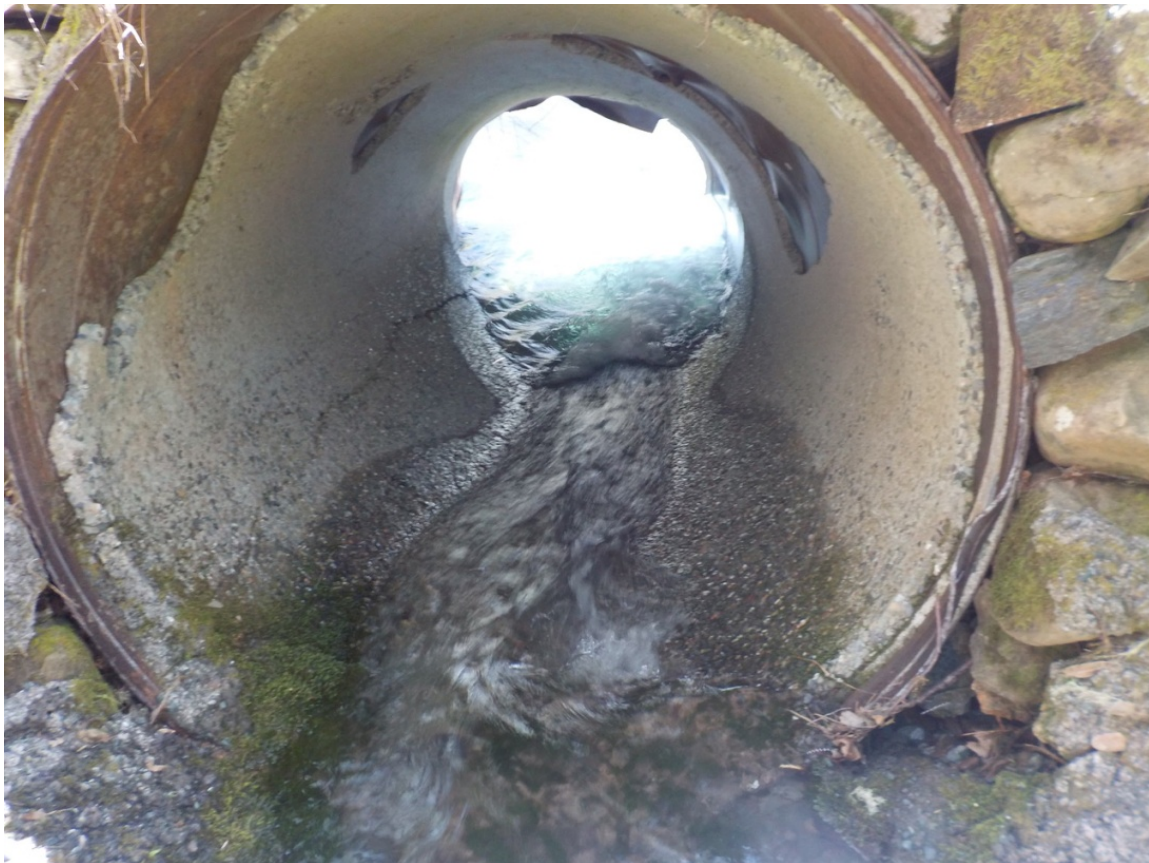
10 - Lower culvert (#1), interior, looking downstream from MC

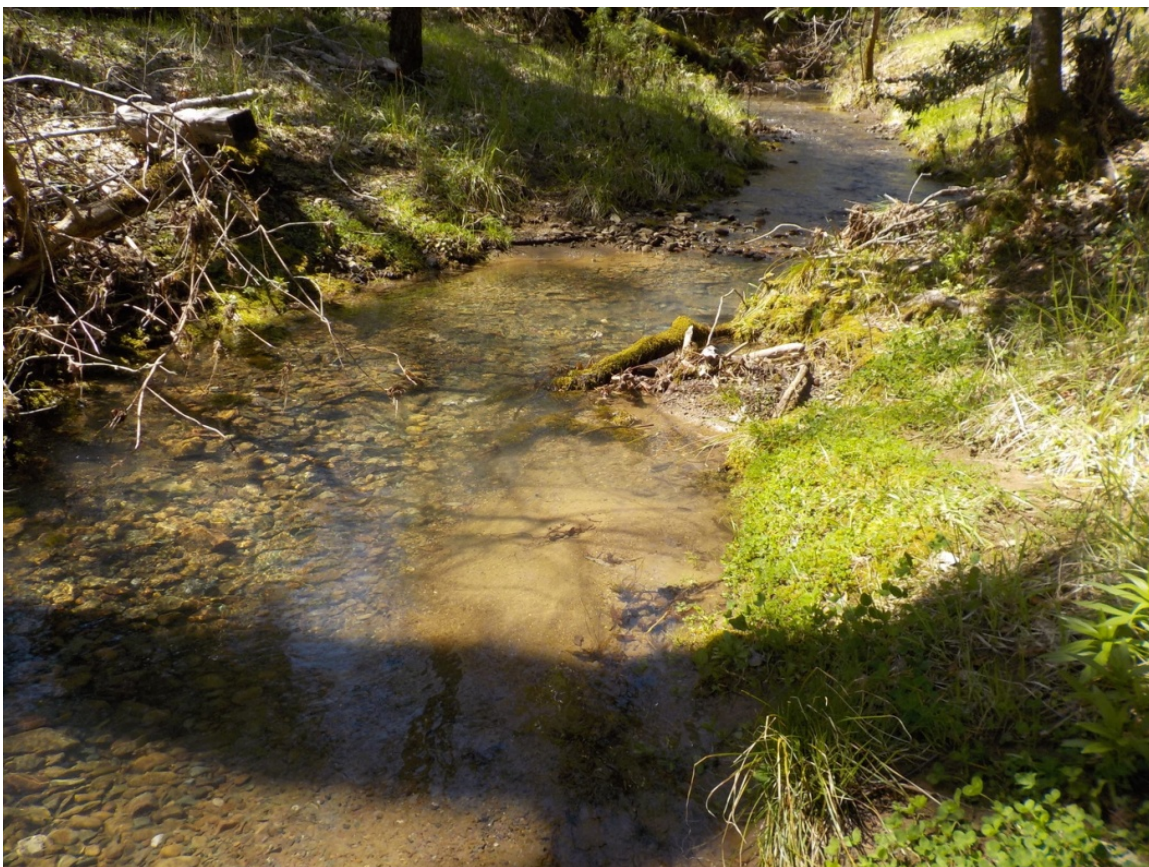
11 – Stream channel upstream of lower culvert (#1), looking upstream

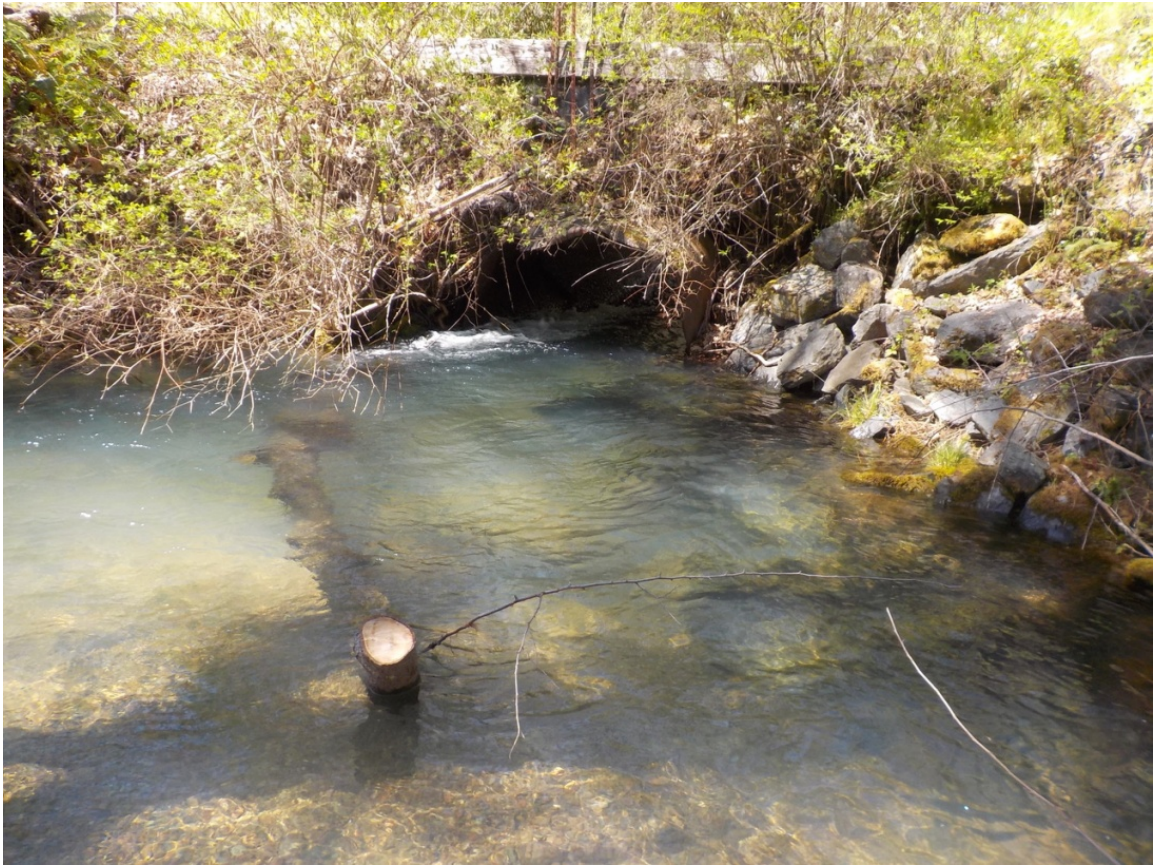
12 - Lower culvert (#1) and associated pool, looking upstream from MC

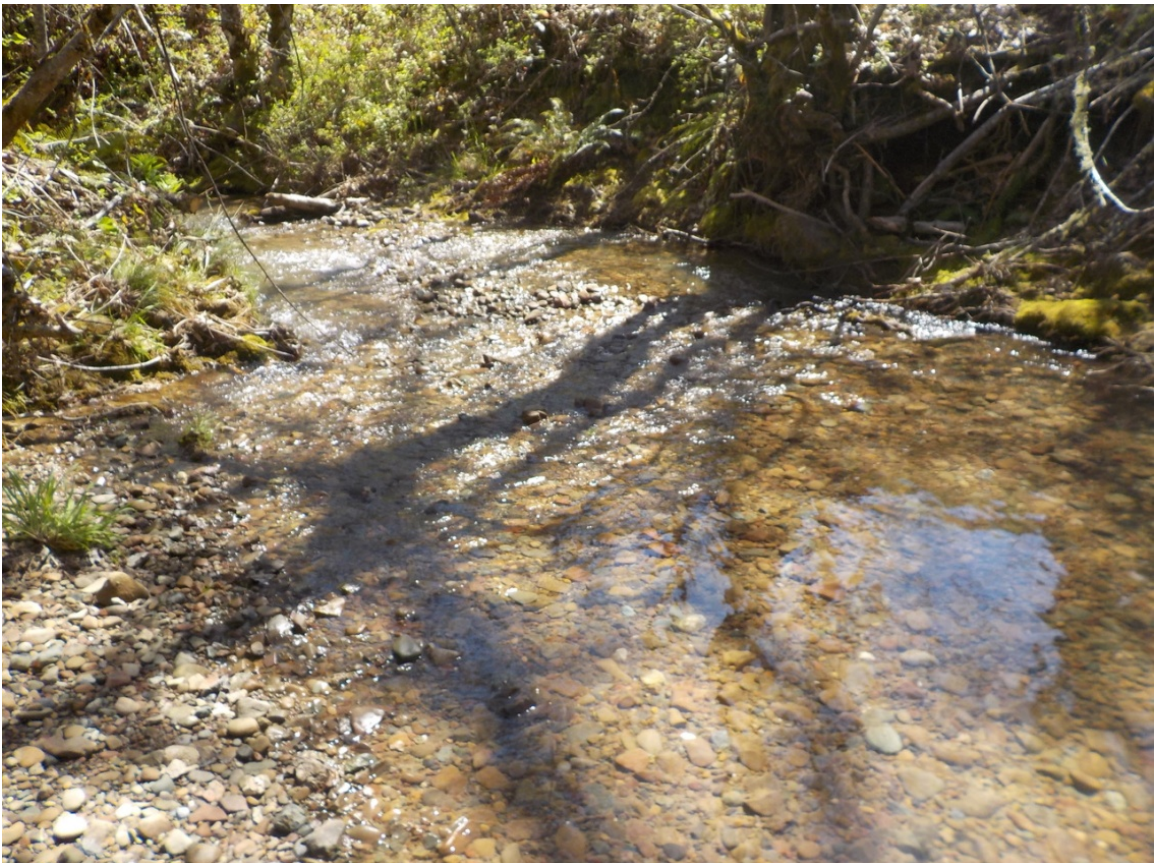
13 - Stream channel downstream of lower culvert (#1), looking downstream

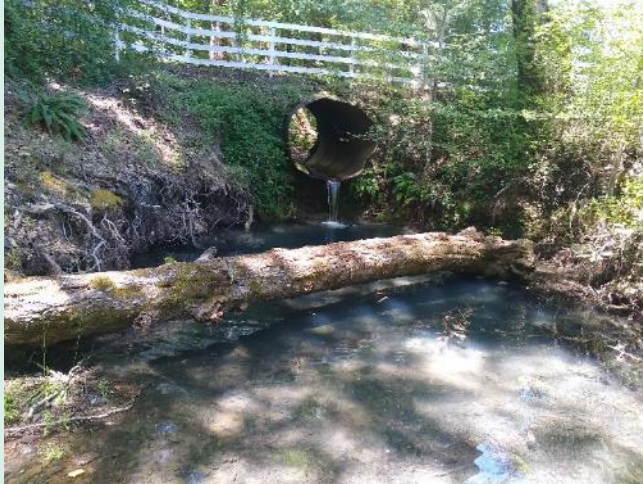
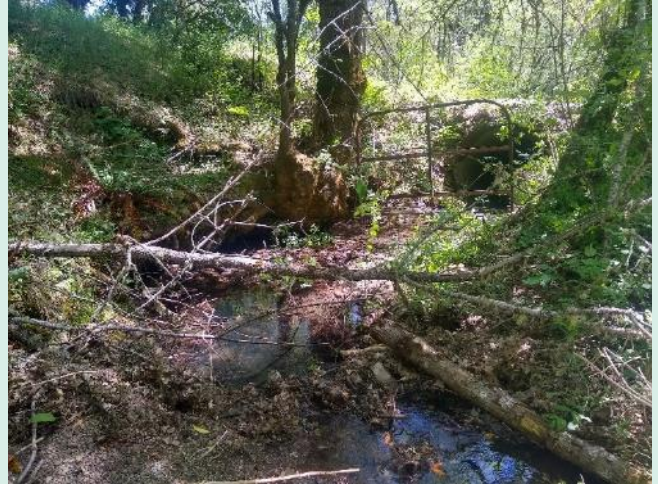
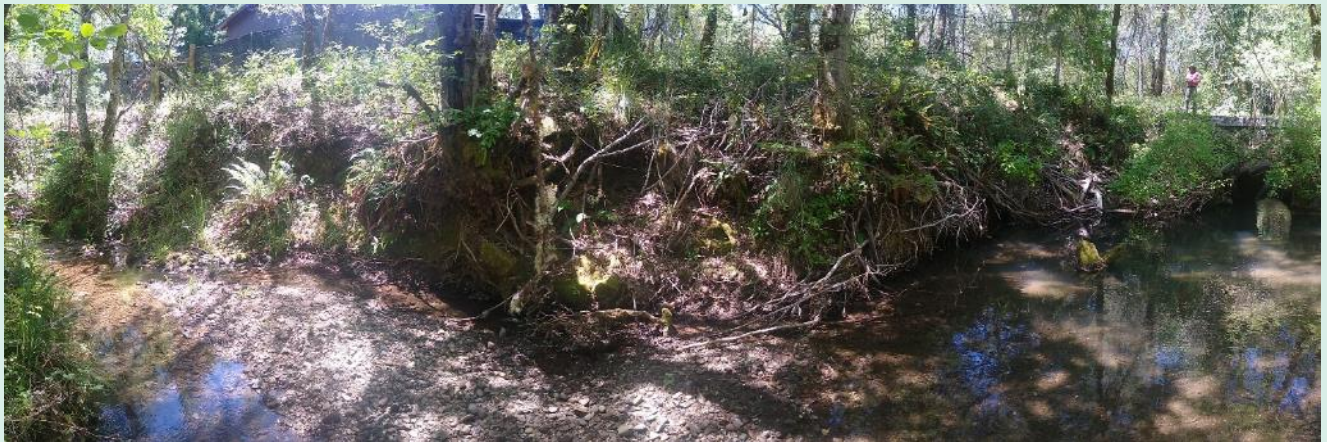
Cover photos: clockwise from top left –Outlet of Upper Culvert Crossing, Inlet of Lower Culvert Crossing, Channel conditions downstream of Lower Crossing.

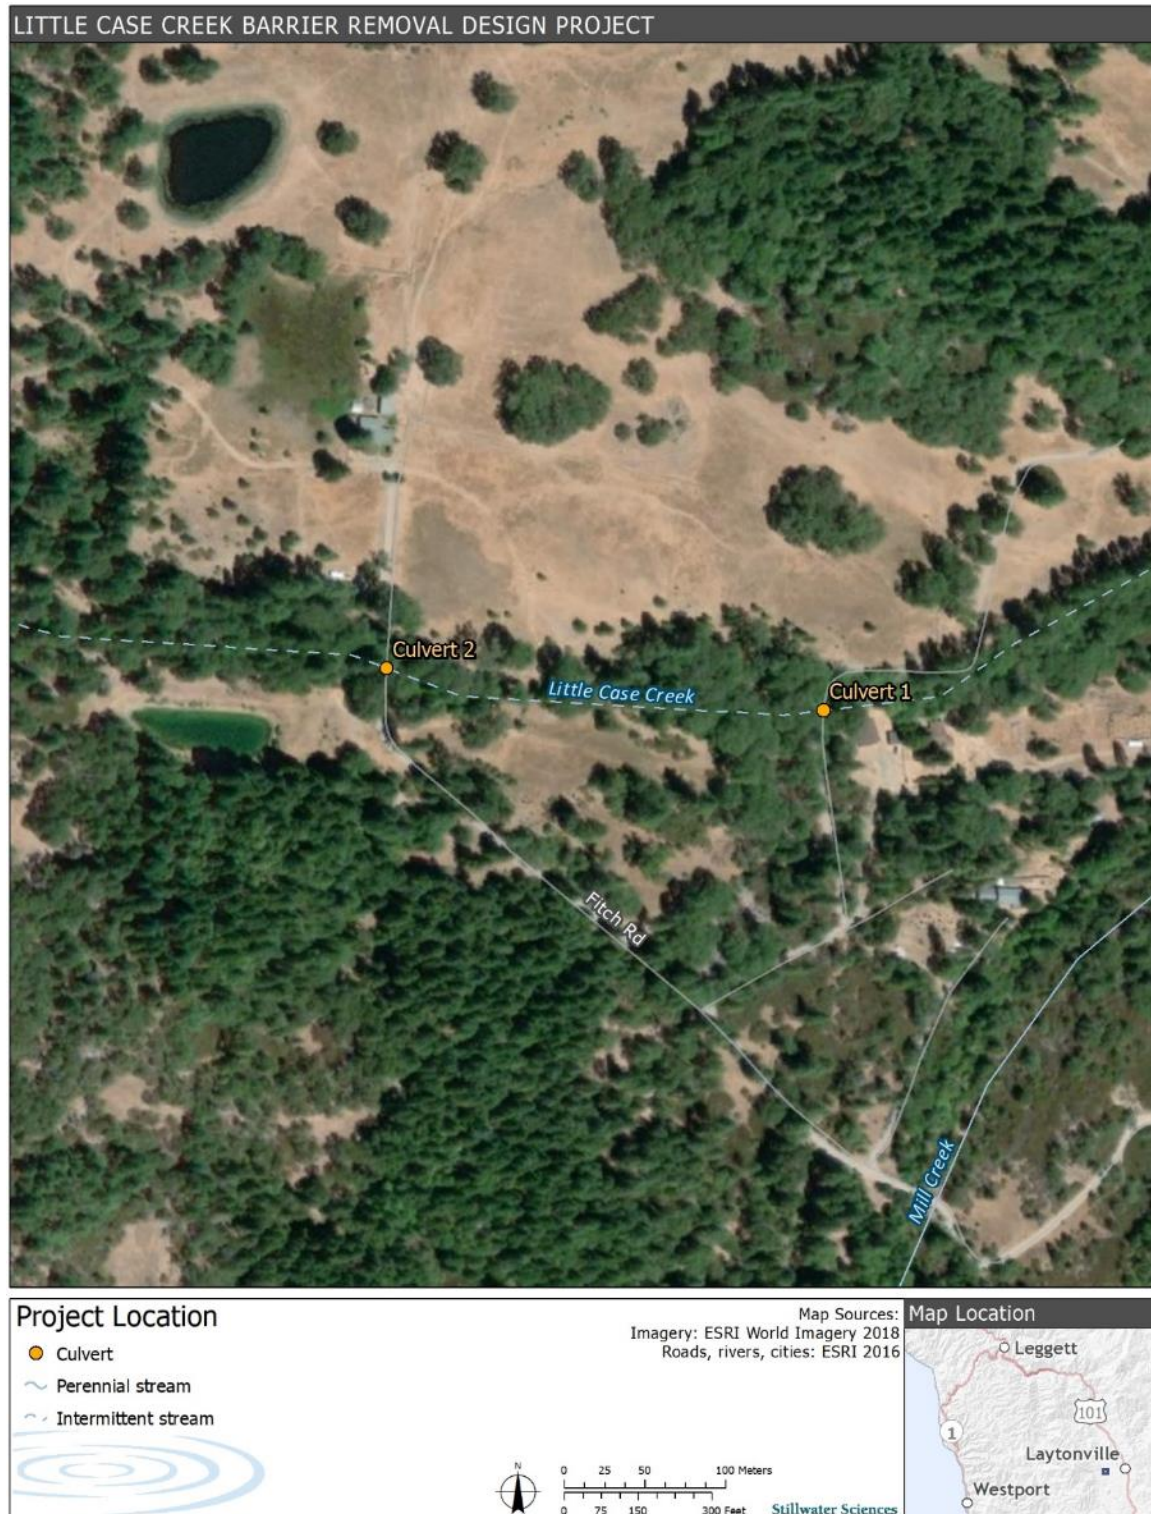
Figure 1-1. Location of the project sites near Laytonville, CA. Culvert 1 is the “Lower Crossing” and is downstream of the “Upper Crossing”, Culvert 2.

The project sites are located at private road-stream crossings on Little Case Creek approximately two miles west of Laytonville in Mendocino County, California (Figure 1-1). The two culvert crossings (Culvert 1 – Lower, Culvert 2 – Upper) are located on Little Case Creek. Little Case Creek receives Mill Creek and they both subsequently meet Tenmile Creek, which drain into the upper reaches of the South Fork Eel River. The Little Case Creek, Mill Creek, and the remaining western half of the Tenmile Creek watershed, originate on the eastern slope of the inner most Coast Range mountains. Downstream from the project, Tenmile Creek flows to the northwest and joins the South Fork Eel River at the base of Black and Brush Mountains and the Eastern side of Elk Horn Ridge.

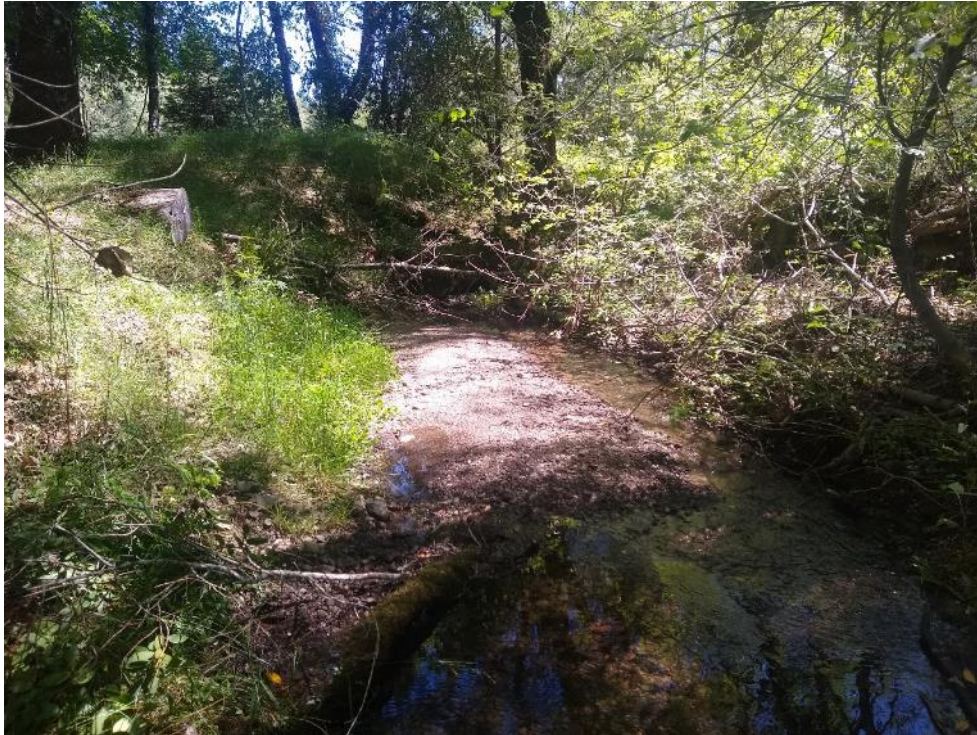
Figure 2-3. View looking downstream within 100 feet of Culvert 1 inlet. Culvert 1 is visible in underbrush to right; note ~70-degree right turn in thalweg.

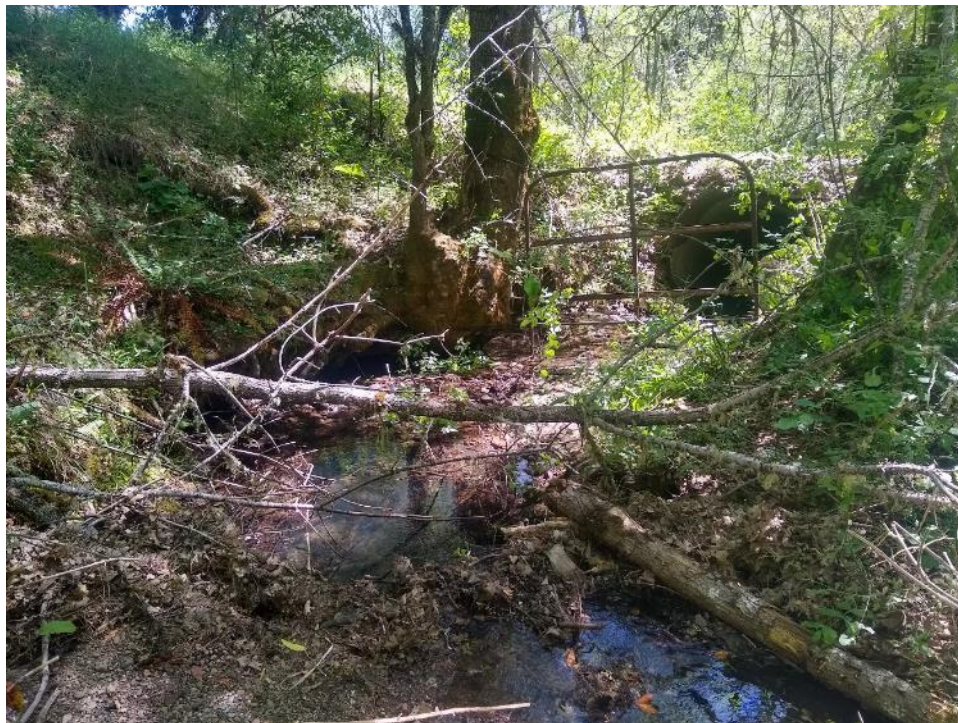
Figure 2-4. View looking downstream into the inlet of Culvert 1. Note strong bend in stream geometry immediately above inlet and large bay tree with under-cut roots.

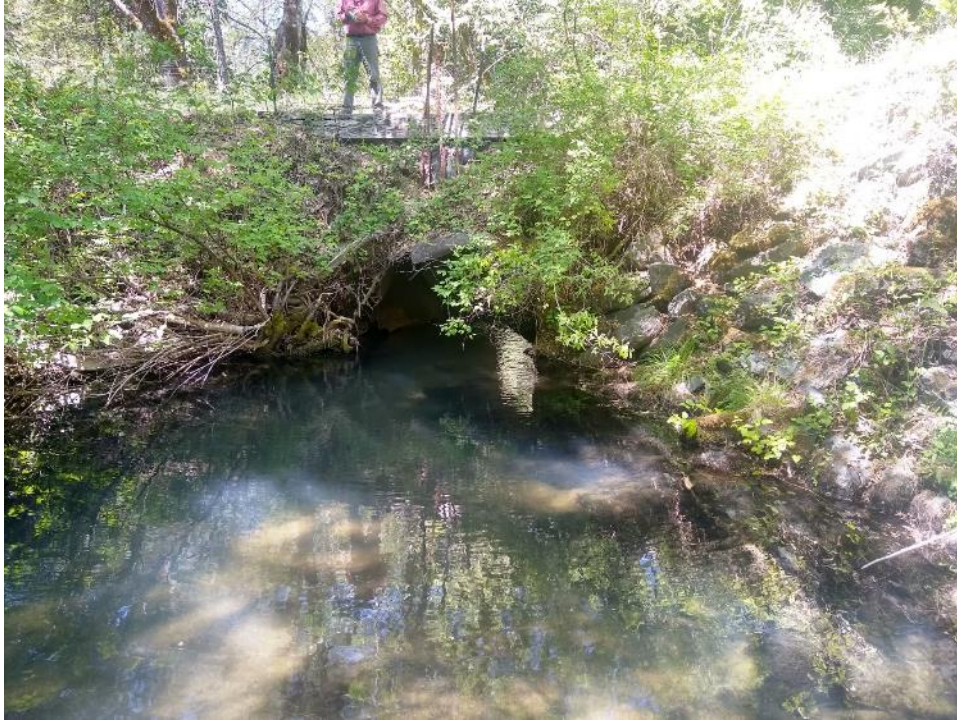
Figure 2-5. View looking over the scour pool, upstream into the outlet of Culvert 1. When the culvert crest elevation is compared to the previous figure, the steep slope is evident.

A large scour pool has developed at the outlet end that is several feet deeper than the surrounding channel. The downstream end of the scour pool contains a high percentage of finer sand and silts with a gravel bar forming the “crest” of the pool. Medium-dense underbrush, small-diameter trees, and exposed roots can be observed growing along the faces of the exposed banks, with limited vegetation in the active channel. A residence is located within approximately 100 feet, near the top of the bank on the outlet end, opposite the most-intense scour regions.

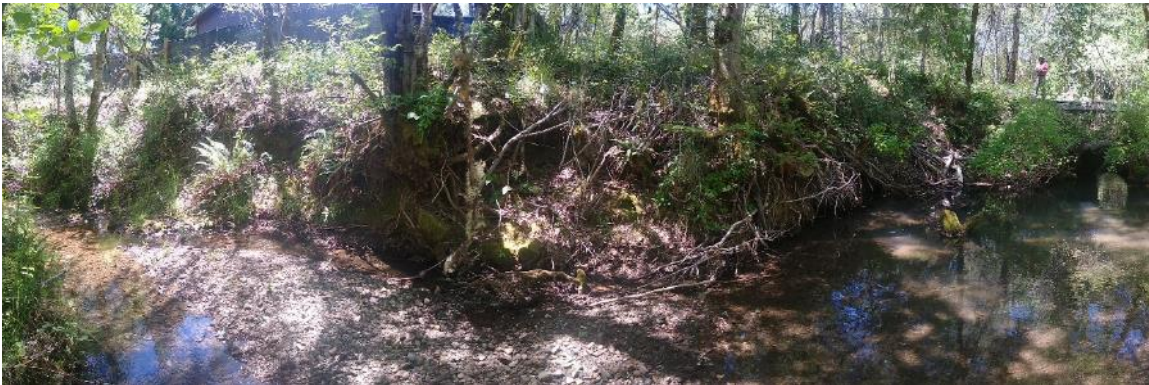
Figure 2-6. A roughly ~180-degree panoramic view of the downstream channel condition. Flow is from the outlet of Culvert 1, on the right, through the scour pool, and across the gravel bar to the left. Residence visible in background.
