California Fish Passage Forum

Project Name	Little Case Fish Passage Project
Lead Organization	Eel River Watershed Improvement Group
Name of Project Lead/Point of Contact	Isaac Mikus
Contact Email	isaac@erwig.org
Phone Number	(707) 845-8119
Location of Project	39.68385° N, -123.51815° W
Attach a map of your project	<div>  03070LittleCaseTopoMap.pdf</div>

Final Basis of Design Report – Little Case Creek Restoration Feasibility Study: Barrier Removal and Fish Passage Design Project

LITTLE CASE CREEK BARRIER REMOVAL AND FISH PASSAGE DESIGN PROJECT

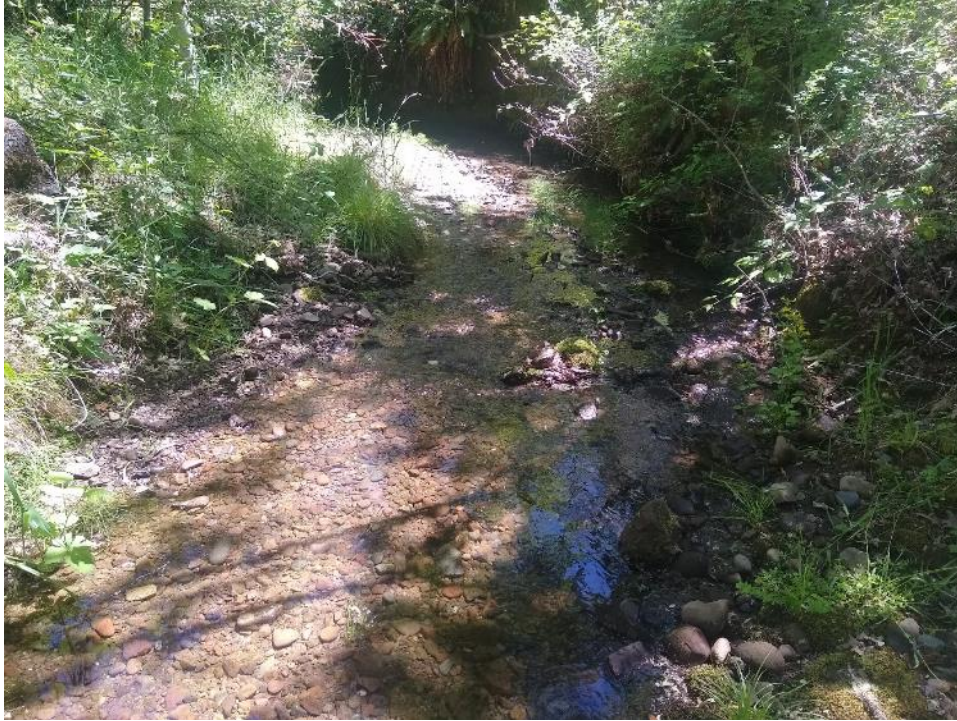
Figure 2-7. View looking downstream of the scour pool, exhibiting gravel and cobble substrate typical of the reach.

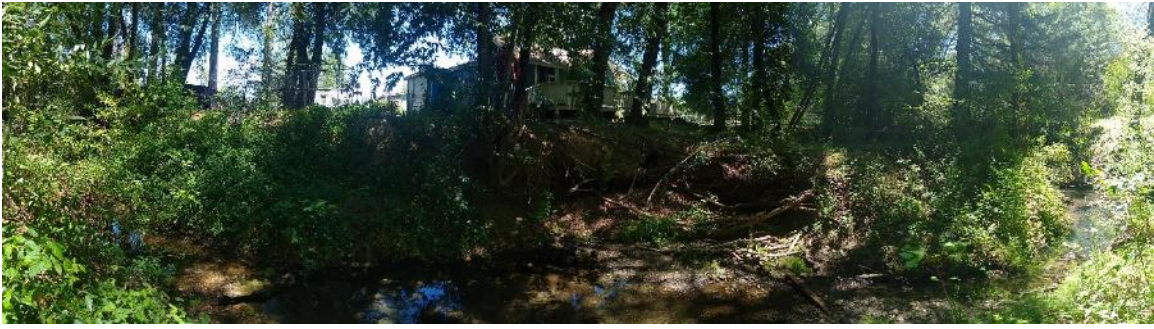
Figure 2-8. A roughly -180-degree panoramic view of the upstream channel condition. Flow is from left to right. The banks are visibly steep with exposed roots and underbrush. Vegetation extends into the active channel. A residence is visible within 20-feet of the top of bank.

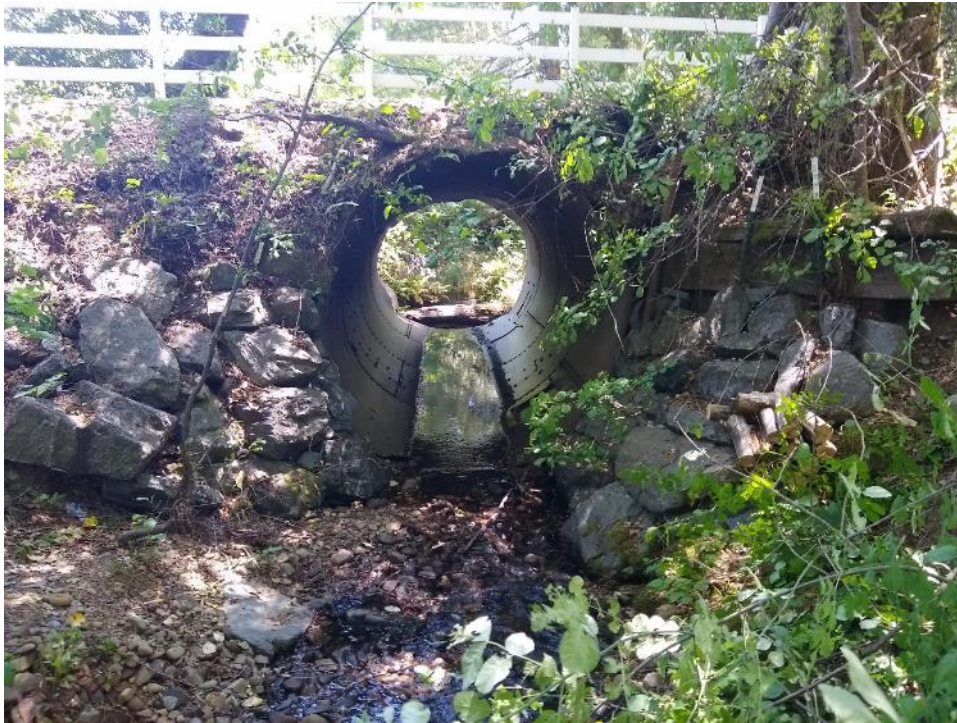
Figure 2-9. View looking downstream through Culvert 2. Note thin road base cover over culvert crest. Large diameter oak tree (right) is within the extent of disturbance for any alternative.

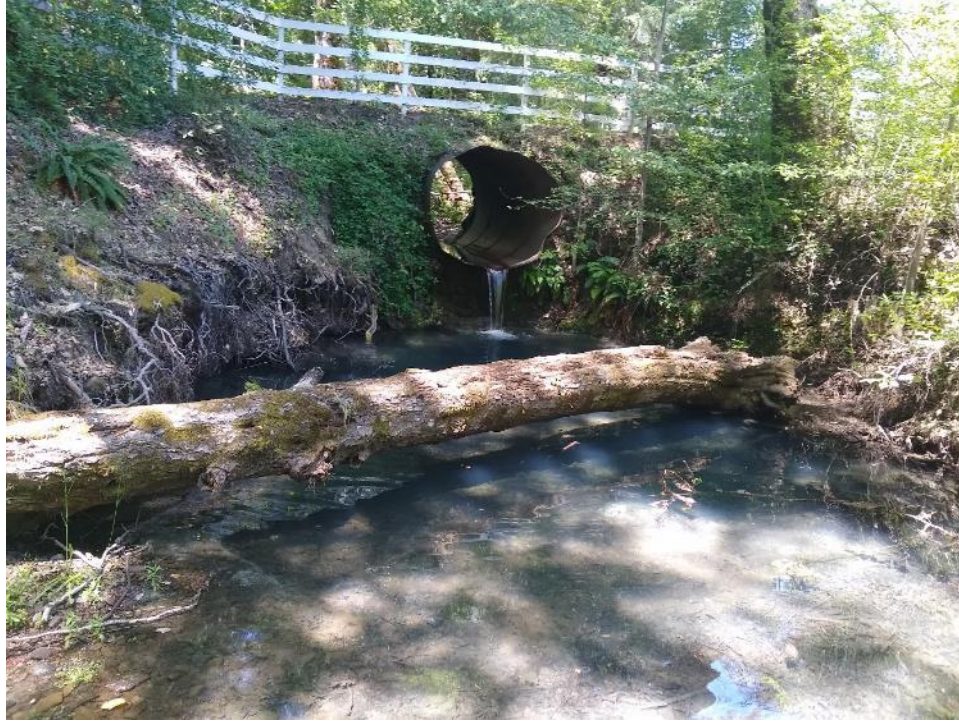
Figure 2-10. View looking upstream into the outlet of Culvert 2; impassable plunge visible (center). Evidence of scour and increased erosion rates are visible. Base of downed tree indicates historic location of bank.

A large scour pool has developed at the culvert outlet that is several feet deeper than the surrounding channel. The culvert outlet is being undercut by several feet. Other signs of continued and active erosion are visible and roots hang from the nearly vertical banks. There is no gravel readily observed in the scour pool, which instead contains fine sands and silts. The large tree visible in Figure 2-10 appears to have once grew along the bank, before being compromised by the expanding scour pool and falling into its current location.

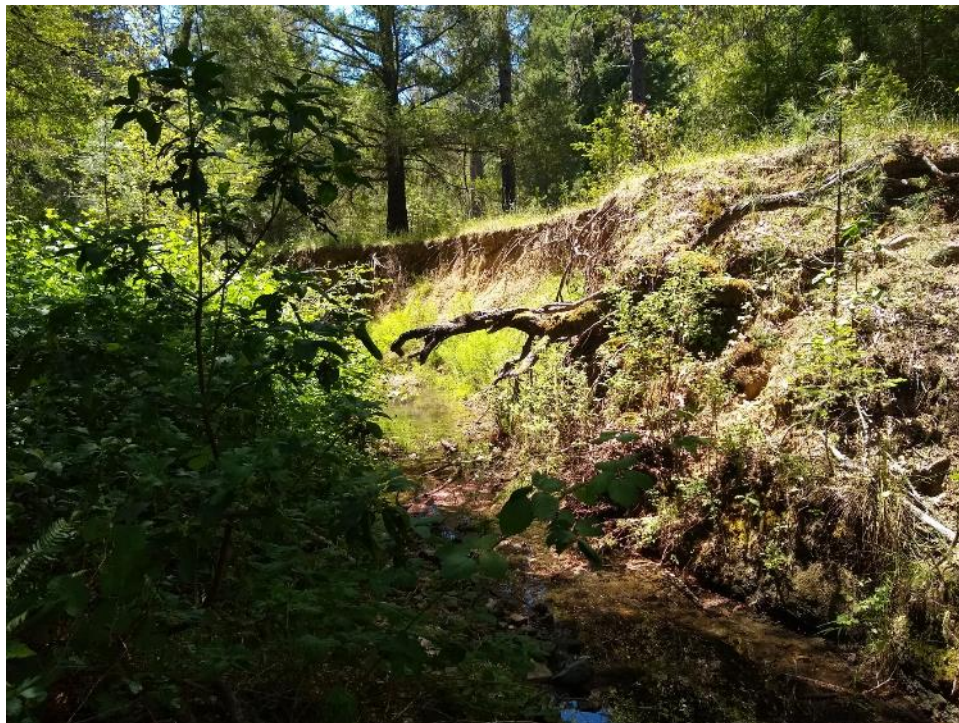
Figure 2-11. View looking downstream from below Culvert 2. Steep unstable bank and increased rates of erosion are evident.

Channel bed substrate in the downstream reach is dominated by gravel- and small cobble-dominant deposits. Similar to the Crossing 1 downstream reach, the gravel and cobble deposits are well sorted, freshly mobilized, not imbedded, and provide high-quality spawning habitat for salmonids (Figure 2-12). The gravel and cobble deposits form pool tailouts and riffles that establish hydraulic control in this reach. Significant right bank erosion is evident downstream from Crossing 2 as shown in Figure 2-11. Fine-grained sand and silt are evident in the upper portion of the cut bank with coarser gravel interspersed with fine-grained material in the lower portion of the cut bank. There is a large floodplain/bar in the middle of the channel which is occupied by native riparian vegetation and invasive Himalayan blackberries. Lateral migration of flow around this feature as well as ongoing channel incision appear to be driving the current geomorphic instability at this site.

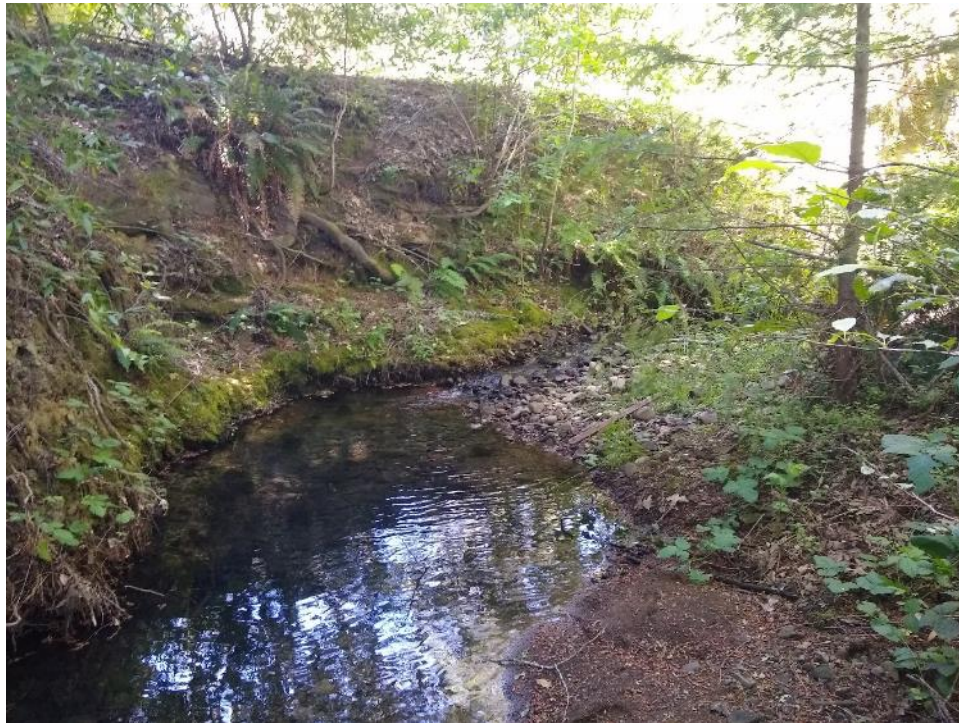
Figure 2-12. View looking upstream from below Culvert 2. Typical sand-gravel-cobble deposit with pool and small sand bar visible lower right.

The reach upstream of the crossing is relatively more stable with lower channel slope and banks stabilized by riparian vegetation and tree roots.

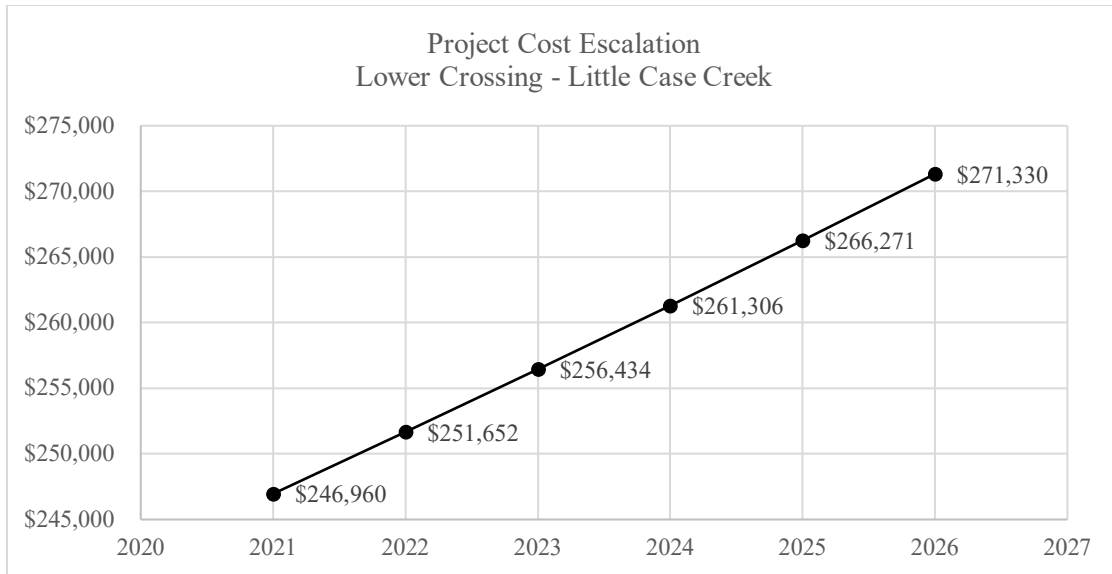
Figure 4-3. Anticipated escalation of project budget for the Lower Crossing for a five-year period assuming average inflation rate of ~1.9%.

Table 4-2 provides a Final 100% cost estimate for the Lower Crossing. Figure 4-3 provides the anticipated price escalation of that cost estimate for a five-year period given a ~1.9% average annual inflation rate. The assumed inflation rate is obtained from a Congressional Budget Office July 2020 release, *An Update to the Economic Outlook: 2020 to 2030*. This report presents the baseline economic forecast that the Congressional Budget Office is using as the basis for updating its budget projections for 2020 to 2030.

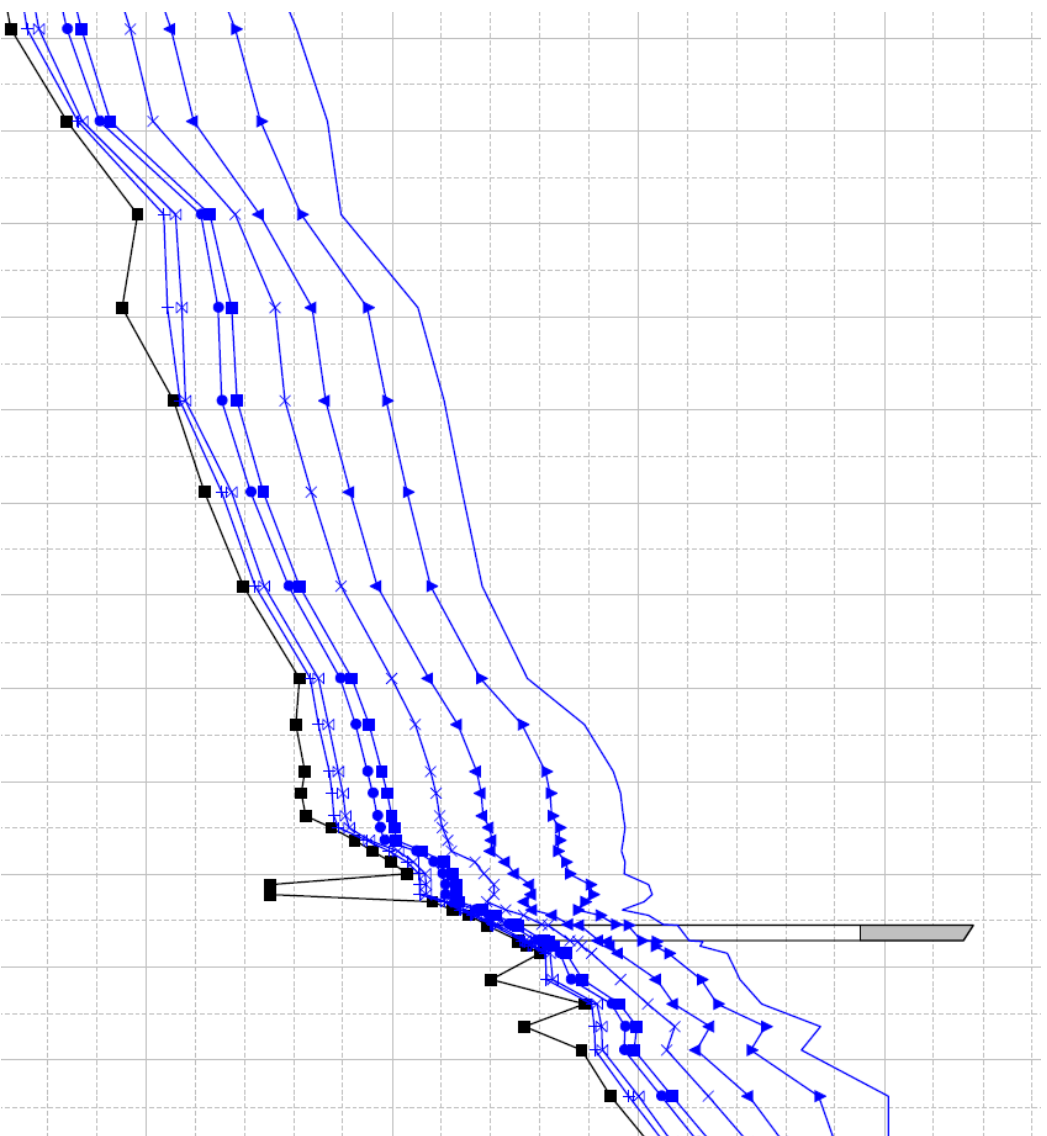
Figure 4-4. Modeled water surface elevations under proposed conditions at the Upper Crossing with a bridge (figure is cropped inset from above, see Figure 4-1 for legend).

Comparable to the Lower Crossing, the proposed-conditions hydraulic modeling of the design described above was conducted by grading the features in AutoCAD and re-cutting cross sections in HEC-RAS. Results from the proposed conditions modeling for the Upper Crossing have already been shown in Figure 4-1. Additionally, Figure 4-4 below provides a detailed view of the Upper Crossing and the predicted water surface elevations. The velocity present under proposed conditions, as well as the reductions in flow velocity through the Upper Crossing at fish passage flows are shown in Table 4-5. Cross sections and tabulated model results for existing and proposed conditions are provided in Appendix B. The proposed conditions modeling focused on evaluating a new crossing structure that could adequately convey flood flows, bedload, debris, and large wood, as described above in Section 4.1 General Design Objectives.

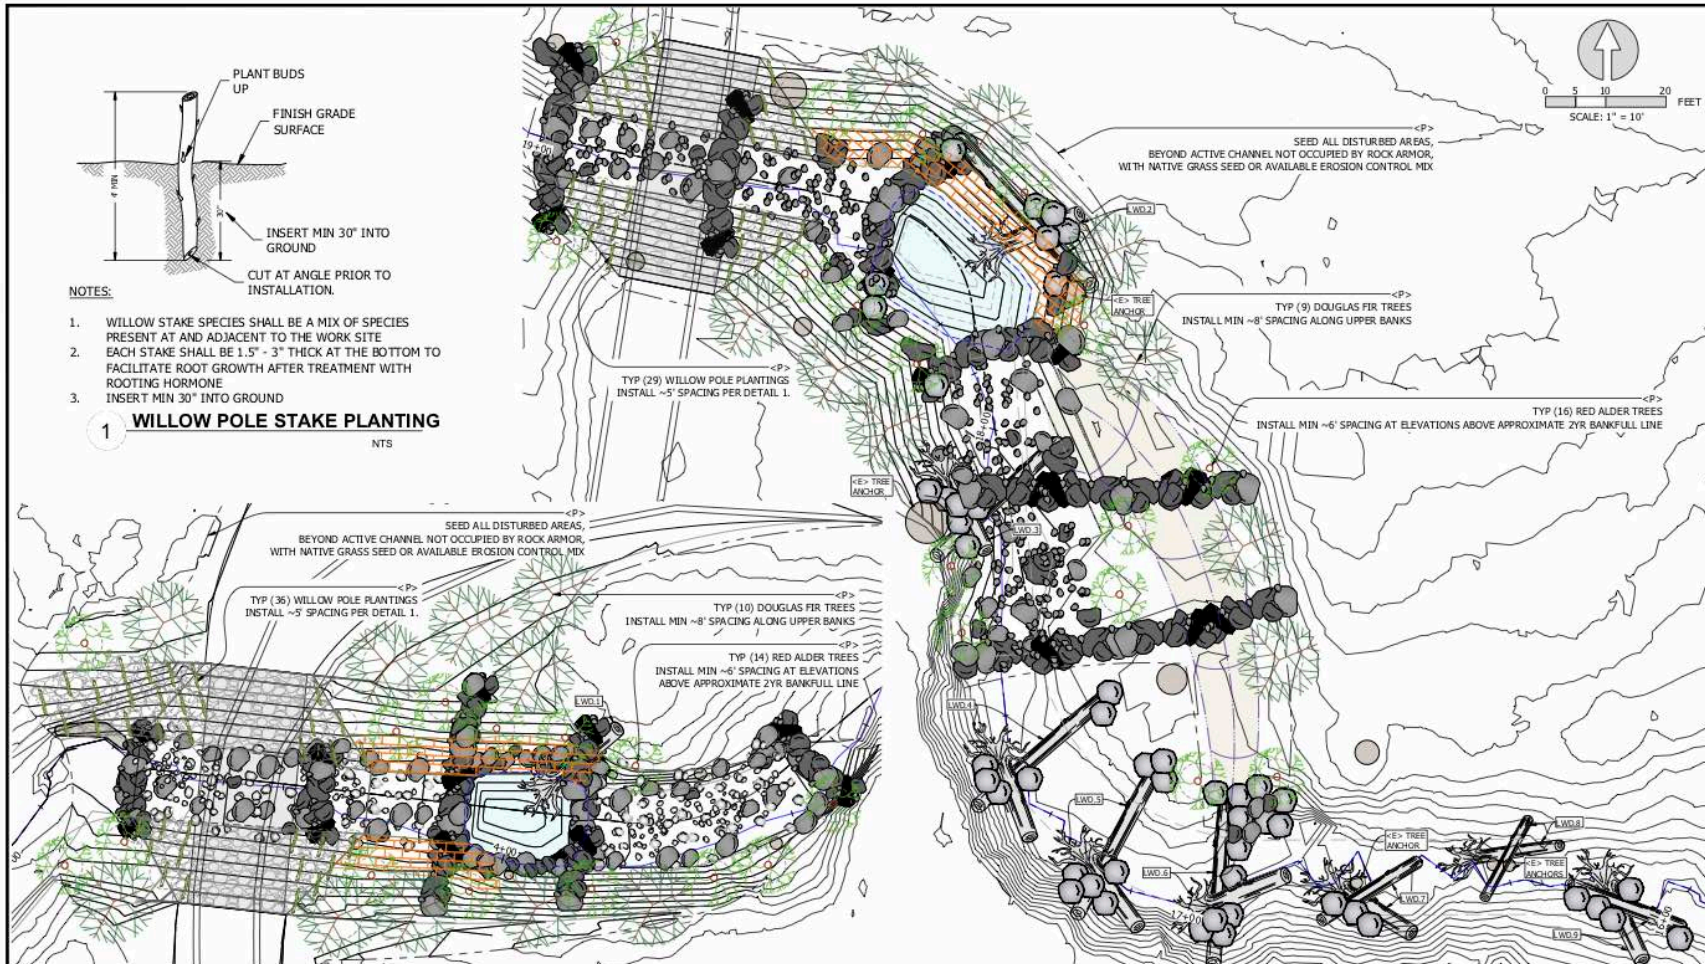
NTS

1 WILLOW POLE STAKE PLANTING
