Project Name	Ross Valley Sanitary District Shady Lane Abandoned Sewer and Barrier Removal Project
Contact Name	Steve Moore
Lead Organization	Ross Valley Sanitary District
Contact Email	smoore@rvsd.org
Phone Number	(415) 870-9764
Date	Thursday, October 15, 2020

Monitoring Plan Shady Lane Sewer Removal Project San Anselmo, California

SHADY LANE SEWER REMOVAL PROJECT

75% DESIGN PLANS SEPTEMBER 2, 2020

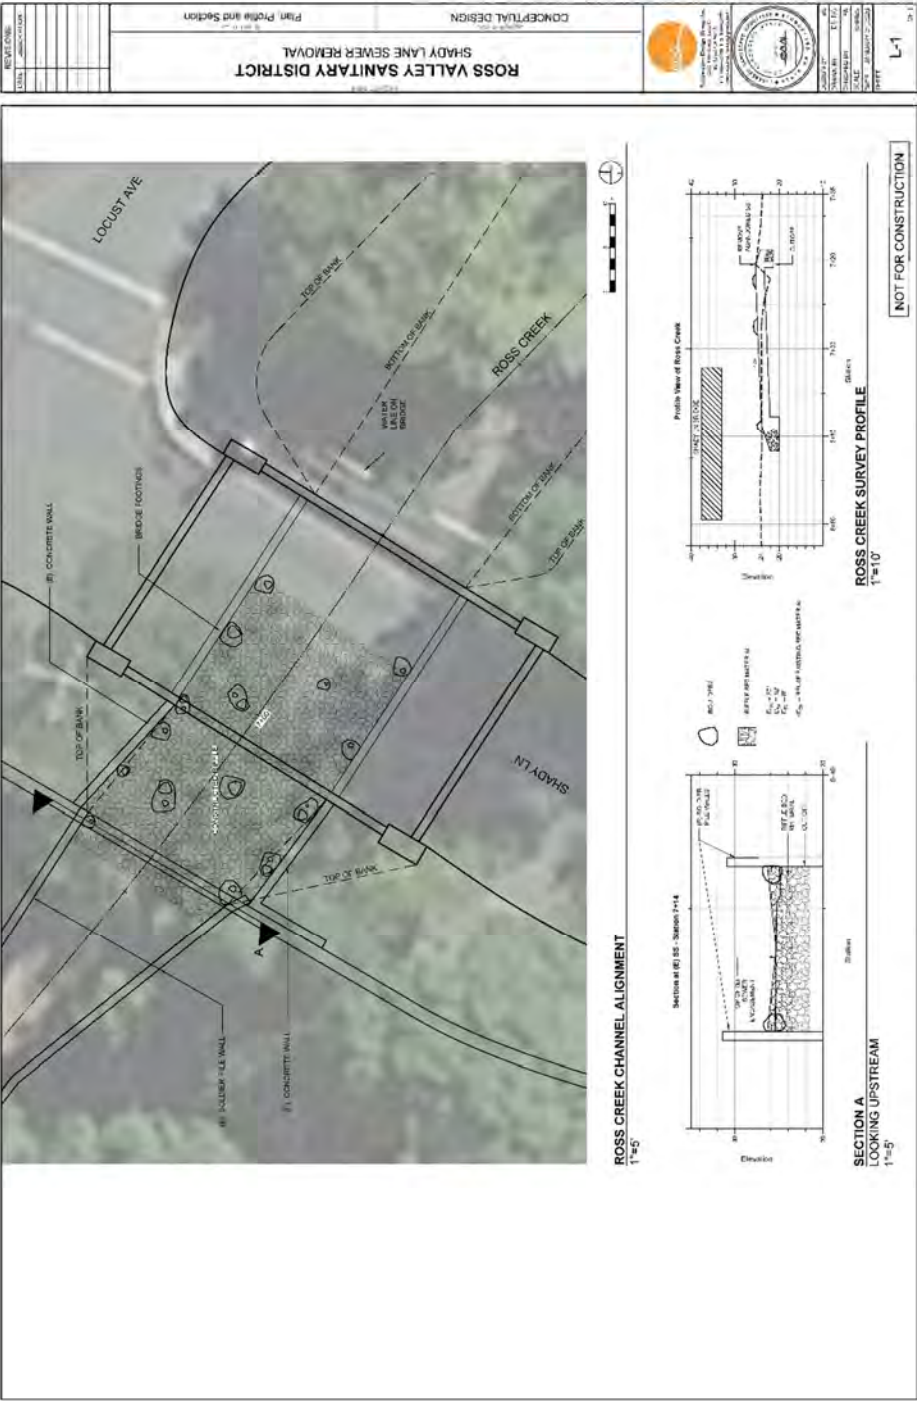
Attachment I. Concept Diagram

The RVSD will remove this barrier by replacing the abandoned sewer line with a natural channel bottom composed of the native channel bed material of coarse cobble and boulders. The concept design is included as Attachment 1 to this document.

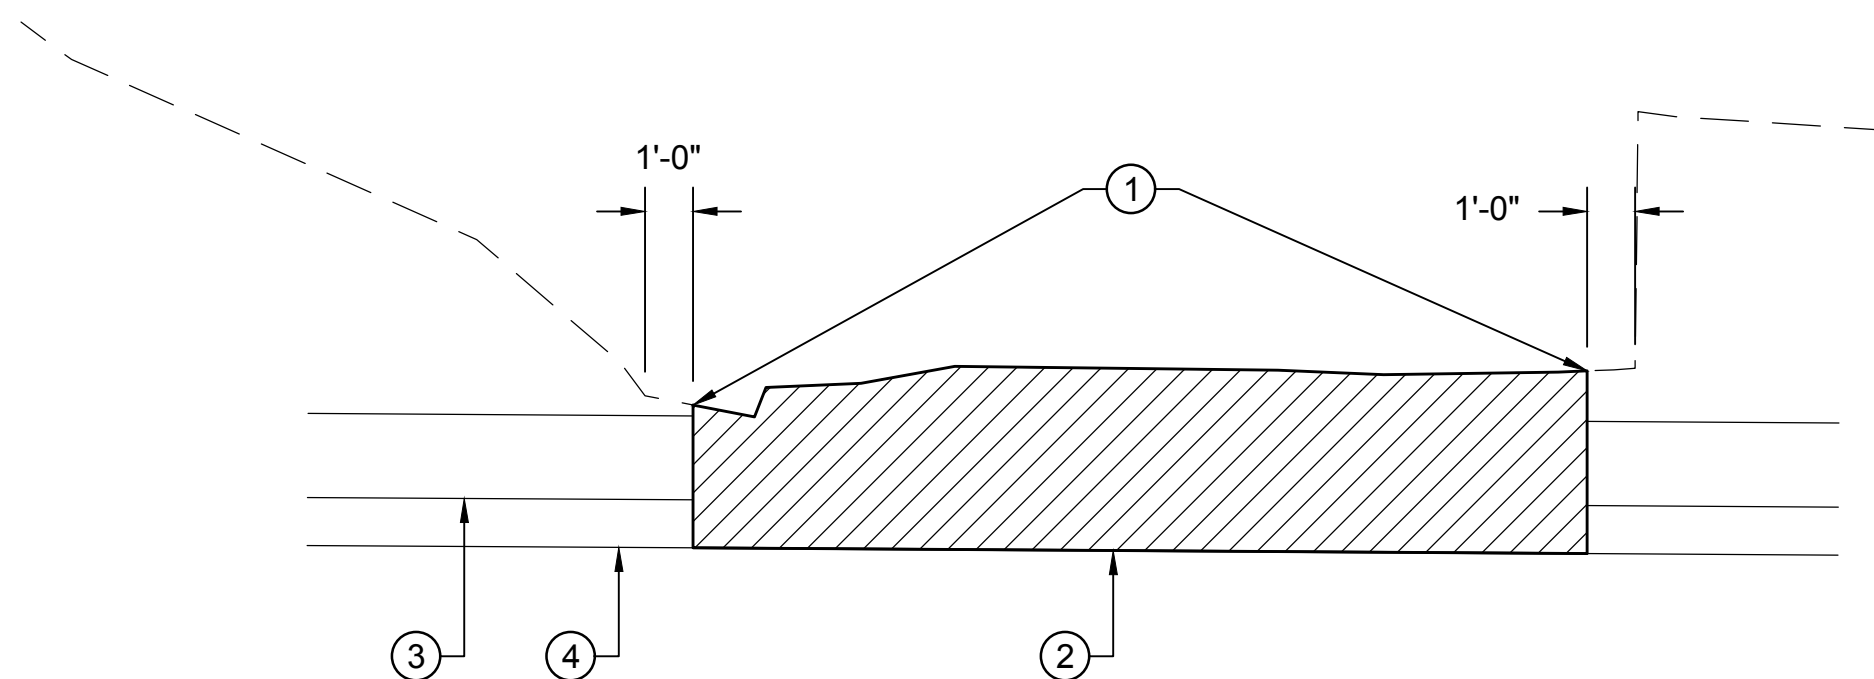
1 DEMO ABANDONED SANITARY SEWER PIPE SECTION
SCALE: 1/4" = 1'-0"

- 1 START CONC. DEMOLITION 1'-0" MIN FROM FACE OF EXISTING WALL OR TOE OF EXISTING SLOPE. PP EXISTING WALL AND SLOPE.
- 2 REMOVE ABANDONED SS SEWER PIPE AND CONC. CASING. BOTTOM OF CONC. ELEV IS UNKNOWN AND ESTIMATED AS 1'-0" BELOW ABANDONED SS PIPE.
- 3 ABANDONED 21" SS PIPE.
- 4 ESTIMATED BOTTOM OF CONC. CASING.

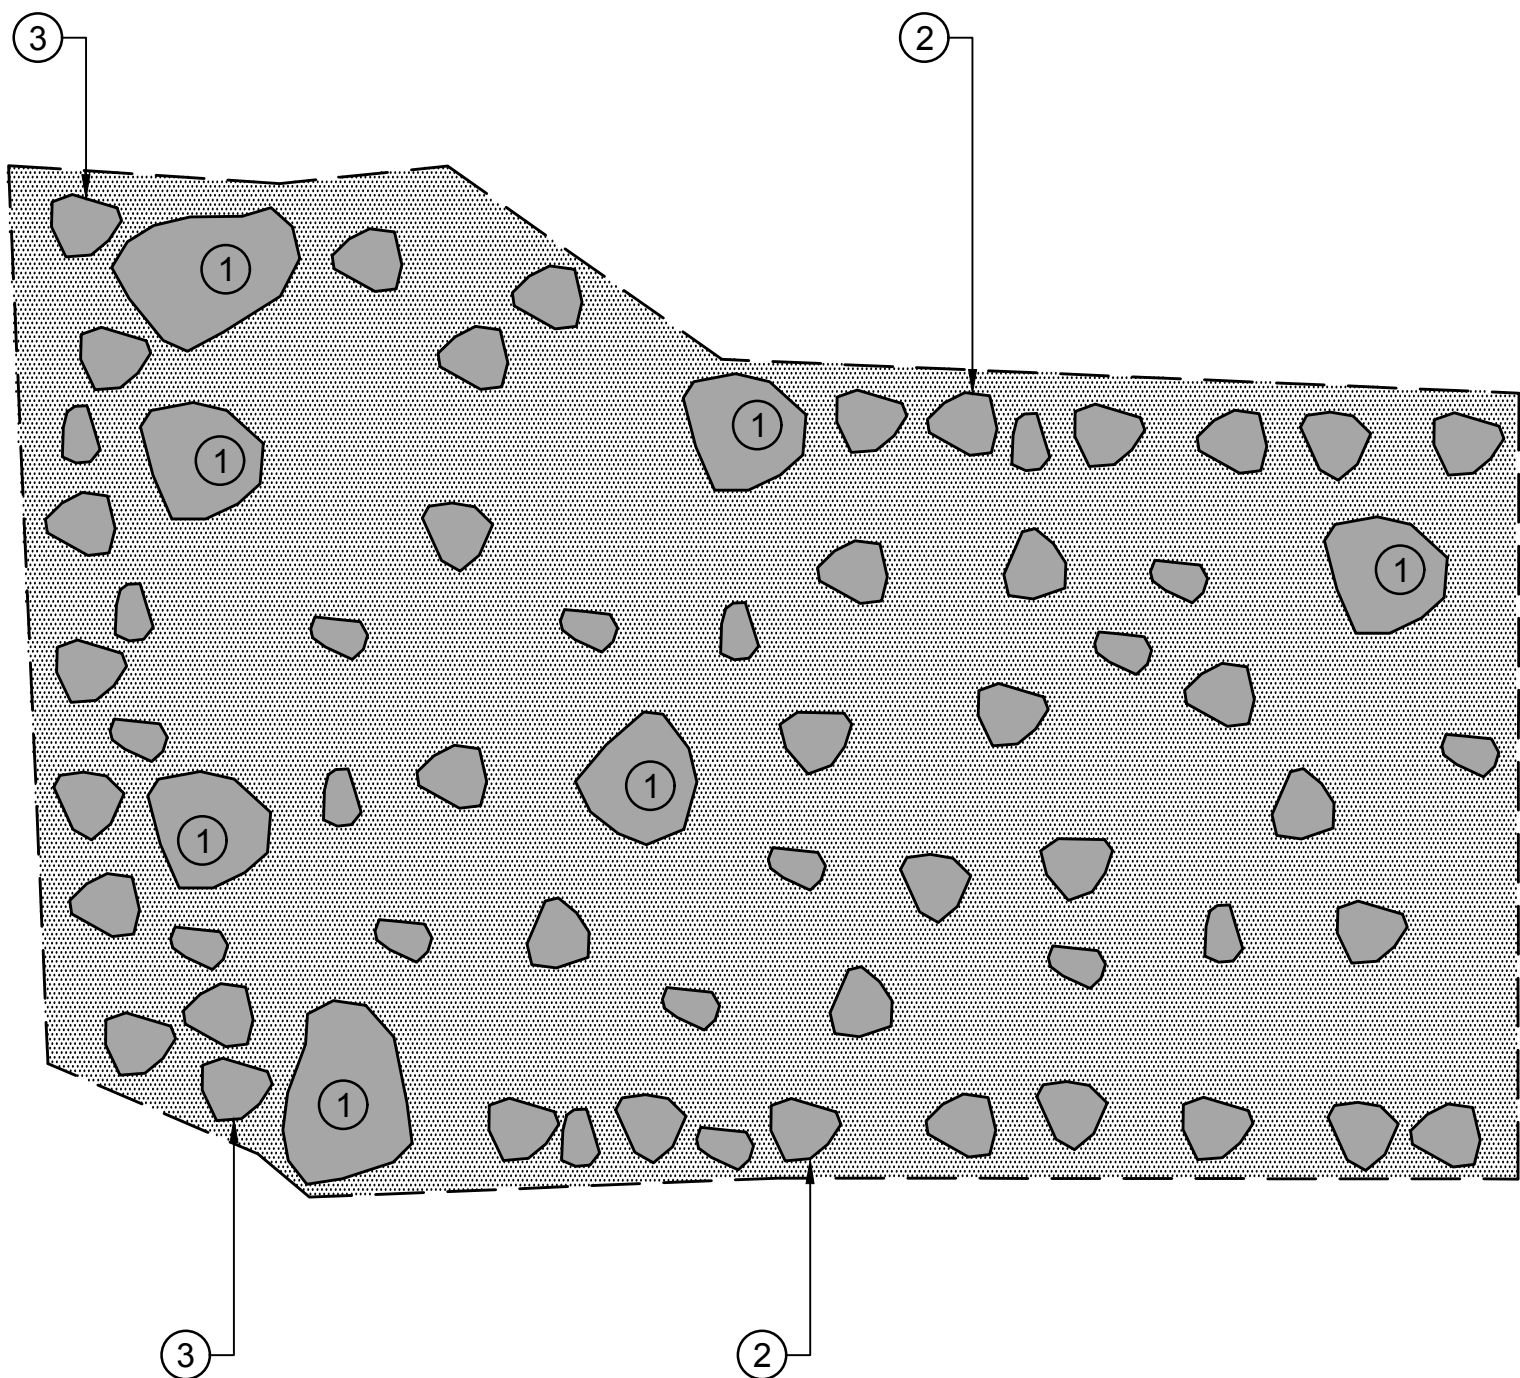
2 ROUGHENED CHANNEL DETAIL
SCALE: 1/4" = 1'-0"

ROUGHENED CHANNEL GRADATION:
INSTALL IN LIFTS AS REQUIRED TO
ENSURE VOIDLESS CONDITION

- D100 = 28-IN
- D84 = 12-IN
- D50 = 5-IN
- D16 = 1.39-IN
- D8 = 0.079-IN

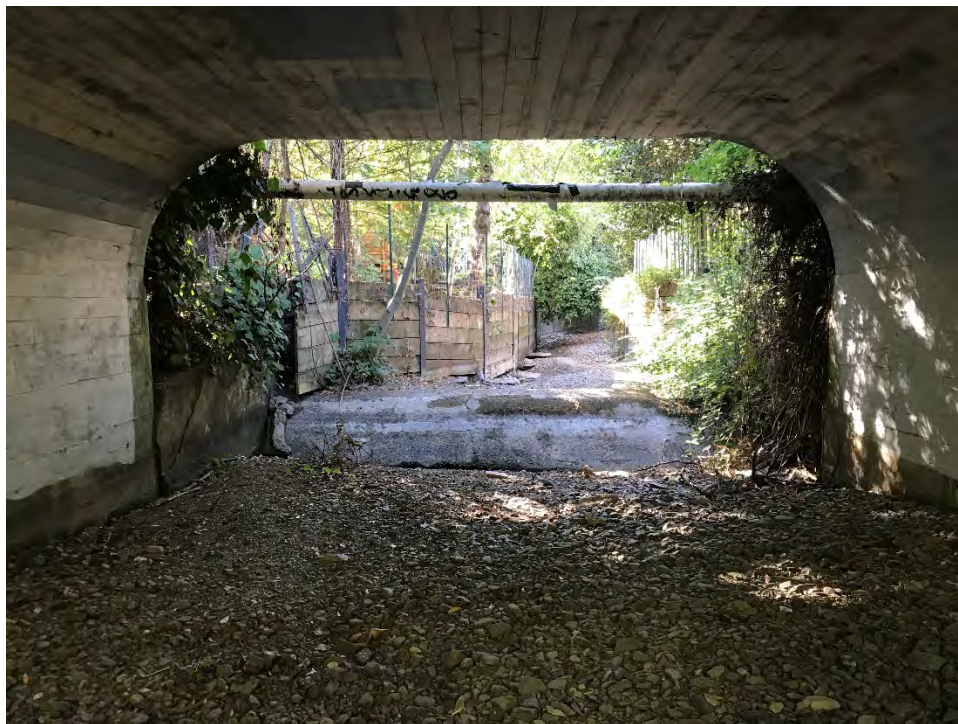
View of weir from downstream end of bridge. (Sep. 2019)

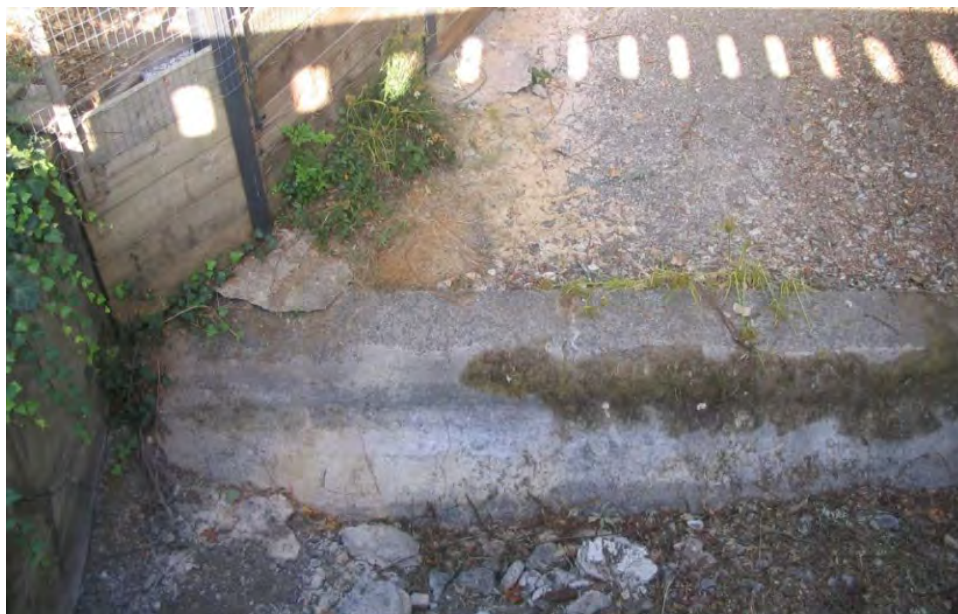
Looking down at the abandoned sewer line from Shady Lane bridge. (Sep. 2009)

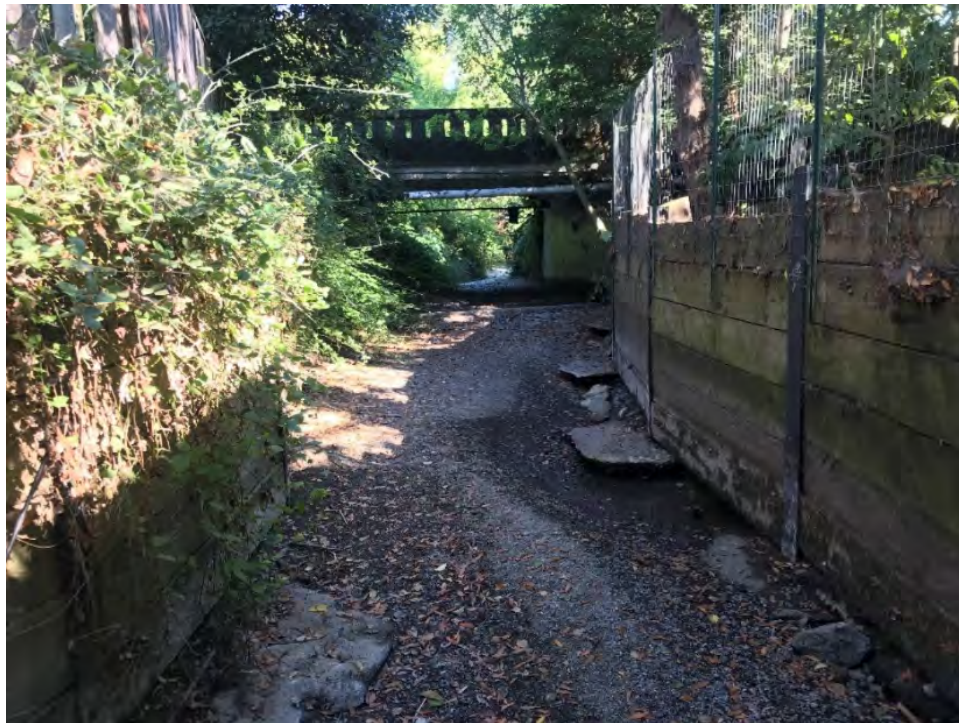
Looking downstream towards the bridge crossing, adjacent wall footings are noticeably eroded. (Sep. 2019)

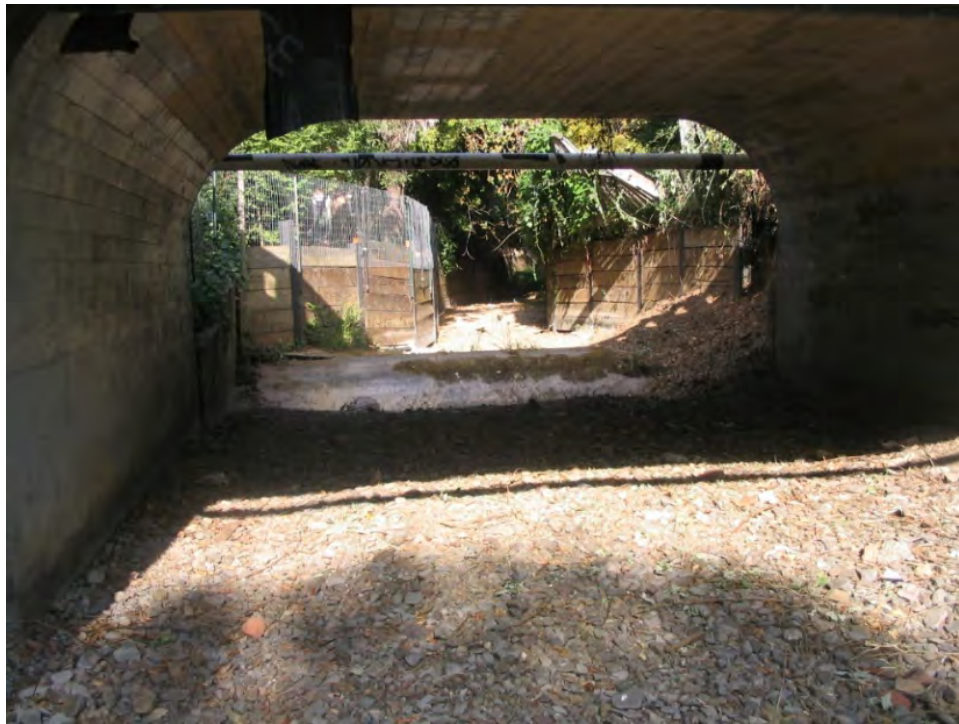
Looking upstream to constricted channel through bridge crossing. (Sep. 2009)

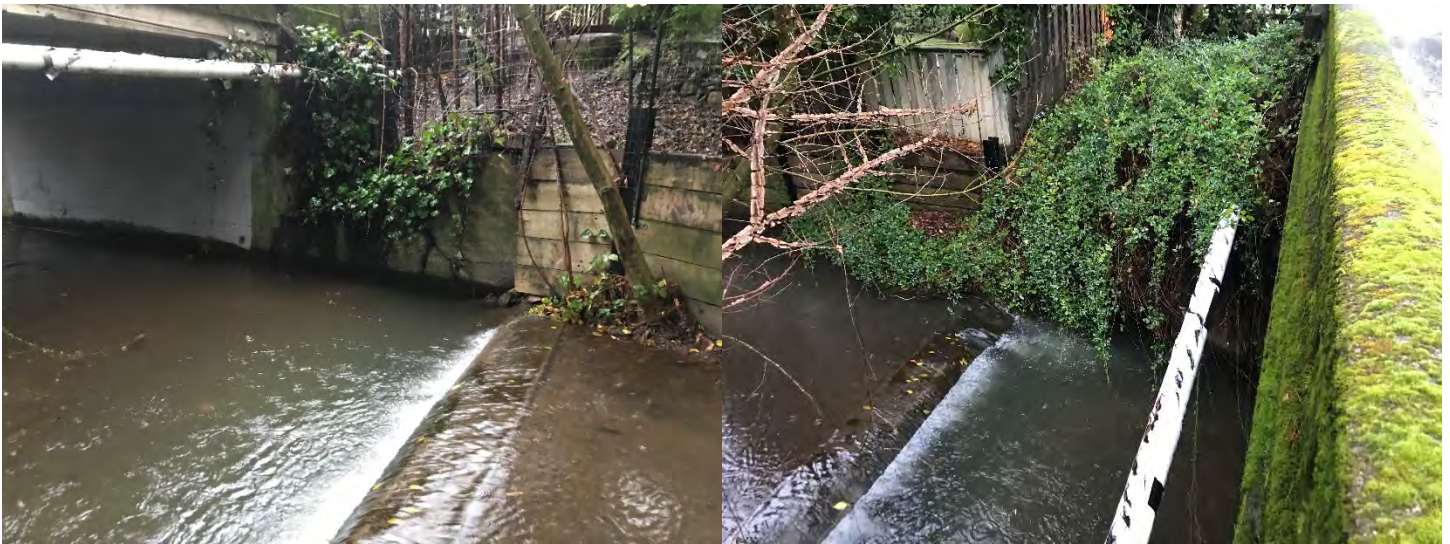
Weir flow over abandoned sewer line during winter base flow (Jan. 2020)

A 21-inch sewer, encased in concrete, rests on the bed of Ross Creek. The concrete casing forms a 3.5-ft dam in the bed of the creek, sufficient to be a barrier to most YOY steelhead seeking summer rearing habitat or to smolts attempting to leave the creek. This project completely removes this barrier.

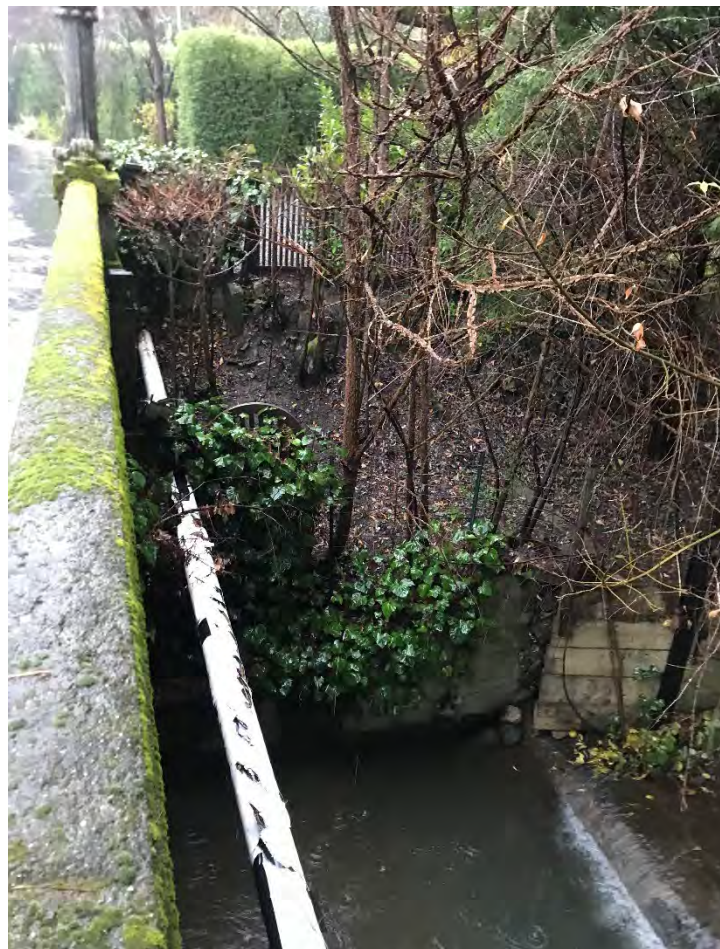
The abandoned sewer line is easily visible from the Shady Lane Bridge. (Jan. 2020)
