SMALL DAM REMOVAL EFFECTIVENESS MONITORING FOR STEELHEAD TROUT IN SOUTHERN CALIFORNIA UNDER EXTENDED DROUGHT CONDITIONS

Final Report: March, 2019

Prepared by:
Stacie Fejtek Smith, D.Env.
Marine Habitat Resource Specialist
Earth Resources Technology/NOAA Restoration Center
Jonathan Trilli
Fisheries Technician
Pacific States Marine Fisheries Commission

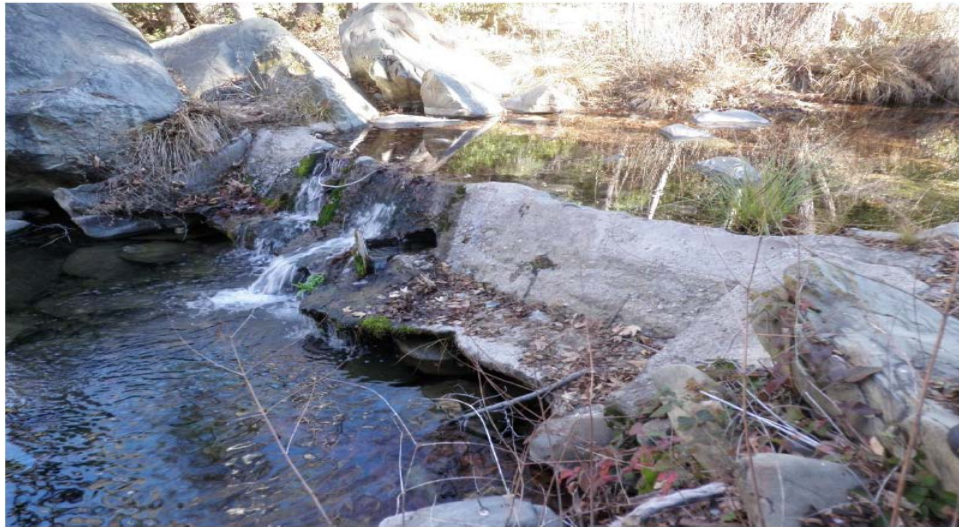
Figure III-1. Lion Creek check dam before removal, looking upstream from left bank at small (3.1 feet high). Lion Creek check dam was removed in October of 2014. Photo courtesy of CCC Camarillo.

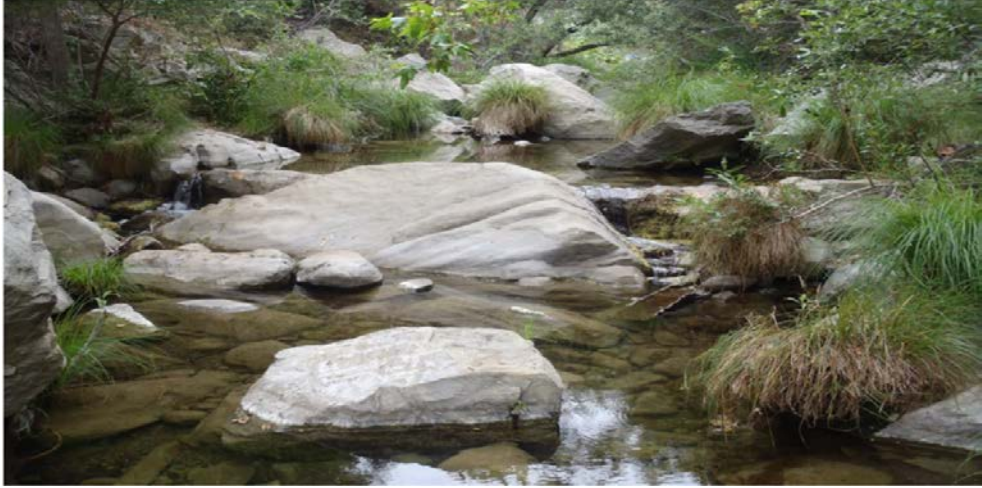
Figure III-2. Arroyo Sequit check dam before removal. Upstream view of small (5 feet high) check dam that was demolished in August-September 2014. Photo courtesy of CCC Camarillo.

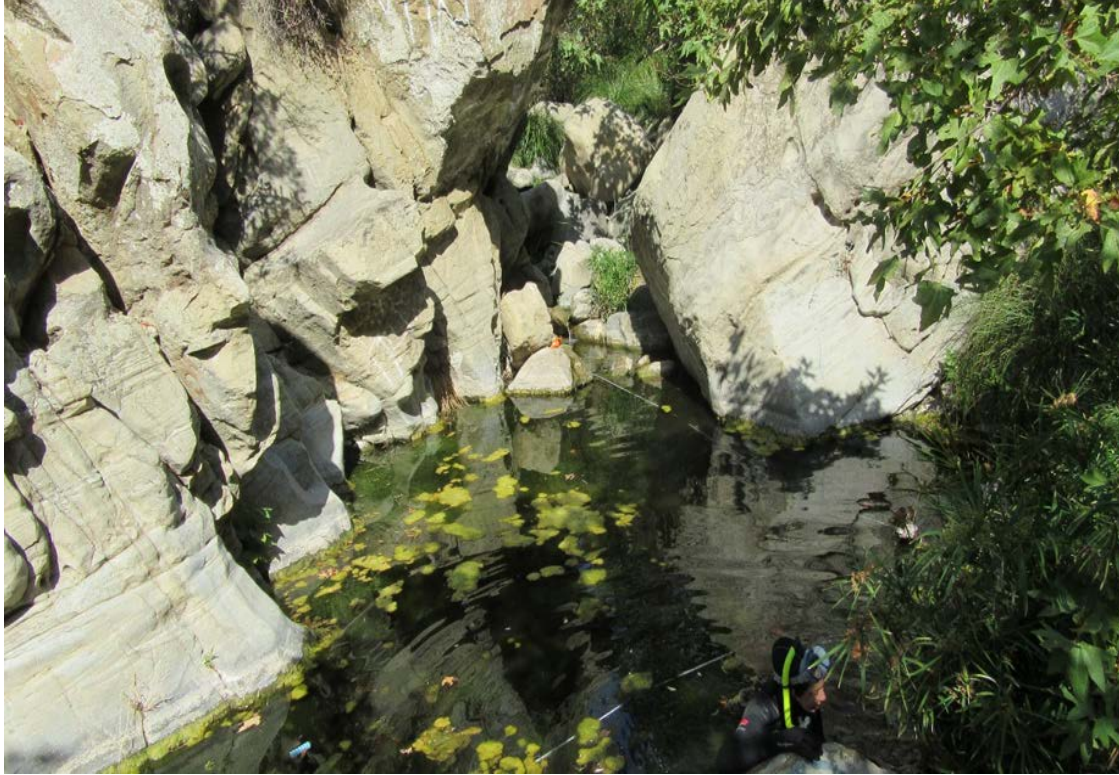
Figure IV-4. 2017 “upstream pool” above Arroyo Sequit dam removal site. Looking upstream at the “upstream pool” from the dam removal showing pool with Santa Monica Mountain Resource Conservation District conducting snorkel surveys. This perennial pool exhibits good overhead coverage/shading provided by terrestrial vegetation, trees, and bedrock cliff.

There was a 1.48ft difference in the deepest thalweg measurement within the pool from 2016 to 2017. In 2017, the pool had a max depth of 4.88ft and had good overhead coverage/shading provided by terrestrial vegetation, trees, and bedrock cliff (Figure IV-4). This pool remained wetted throughout the duration of the survey period despite drought conditions. The sediment frequency distribution within the upstream pool (Figure IV-5) exhibited a significant increase in silt (grain size $<.062$) from 2015 to 2016 which then significantly decreased in 2017 surveys. Silt comprised 28% of the stream channel particles sampled in 2016 and only 4% in 2017 and was not reported in 2015. There was more coarse sand (1-2mm) and very fine gravel (2-4mm) encountered in 2017 than in 2015 or 2016. Fine sediment had a frequency of 48% in 2017, 28%

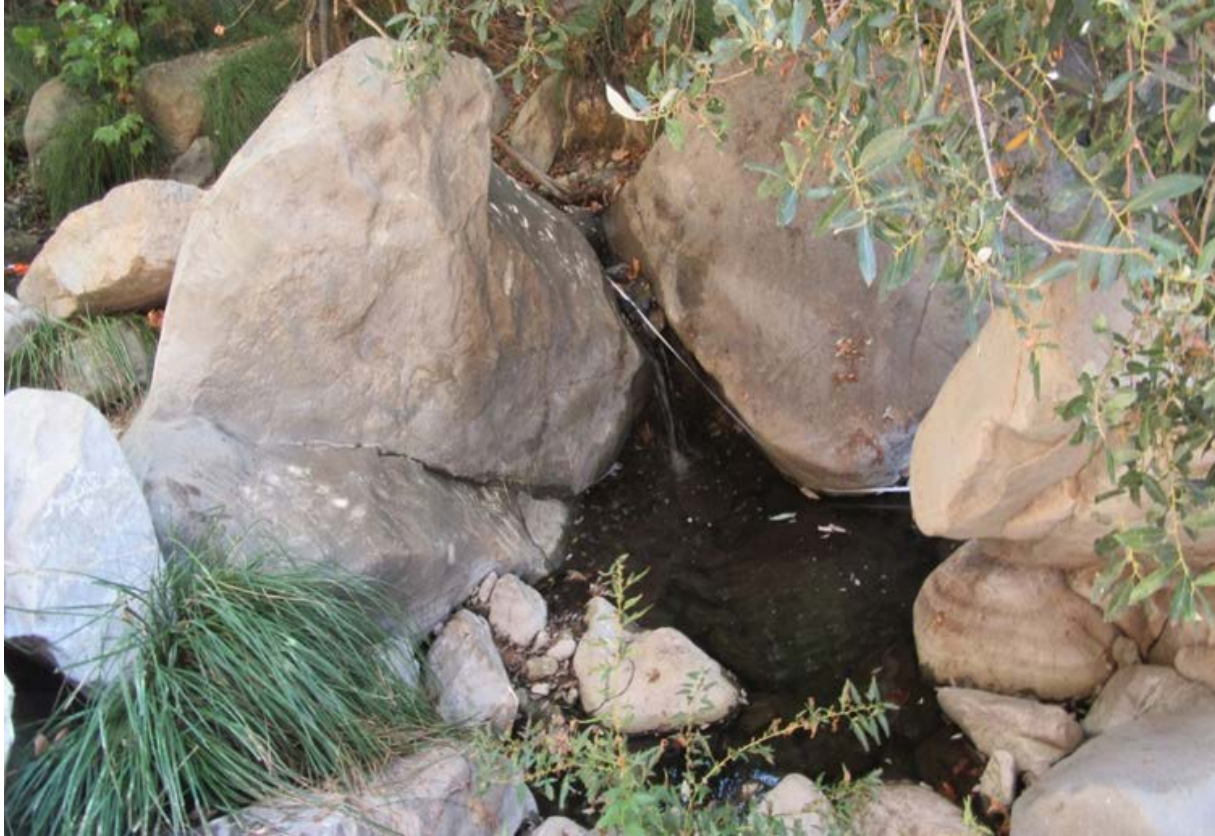
Figure IV-7. 2017 Arroyo Sequit, small boulder forced plunge pool above dam removal site. In 2017, there was a 2.66ft difference between the top of the small fall and the water surface of the corresponding pool.

Step-pool formations encountered in 2015 and 2016 located above dam removal area transitioned into one pool in 2017 (~146.88-165.16ft in Figure IV-2 US of Dam). A small boulder forced plunge feeding into a pool reached its highest plunge height in 2017 where there was a 2.66ft difference between the top of the small fall and the water surface of the corresponding pool (Figure IV-7). The max depth of the corresponding pool in 2017 was 2ft. This plunge doesn't appear to be large enough to impede steelhead movement under high flows but may potentially be a barrier during periods of low flow. The twelve feet stretch of shallow

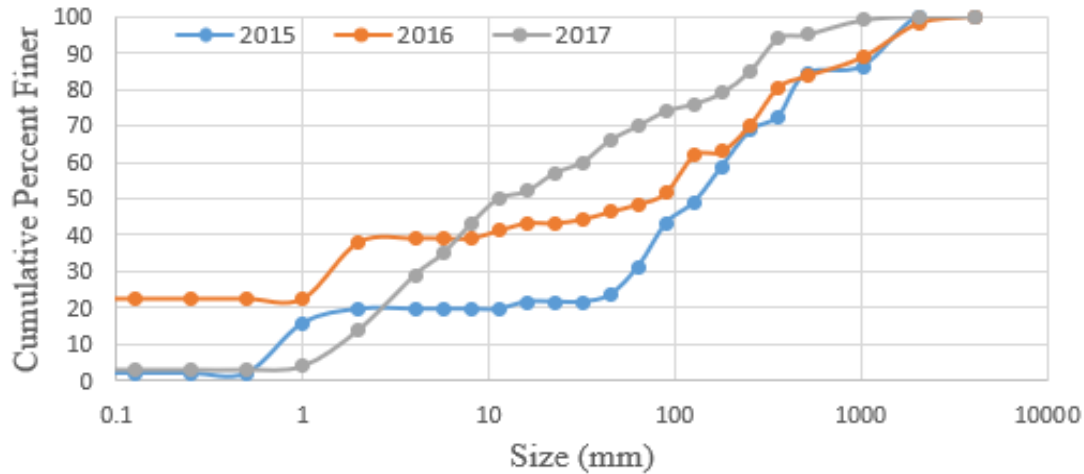
Figure IV-11. Cumulative particle size distribution curve for the area located directly downstream of dam removal. D50 value was highest in 2015 at 134mm while the highest D84 value was in 2016 at 563mm.

storm system when assessed in 2017. The streambed material was coarser in 2015 and 2016 where there was a higher frequency of cobble and boulder (Figure IV-10 and IV-11). D50 value was highest in 2015 at 134mm (large cobble) while the highest D84 value was in 2016 at 563mm (medium boulder) (Figure IV-11). The percentage of preferred particle size for spawning within pebble counts was lowest (23%) in 2016 (two years post dam removal) and highest (33%) in 2017 (three years post dam removal). Intermediate levels of all metrics were observed immediately after dam removal in 2015.

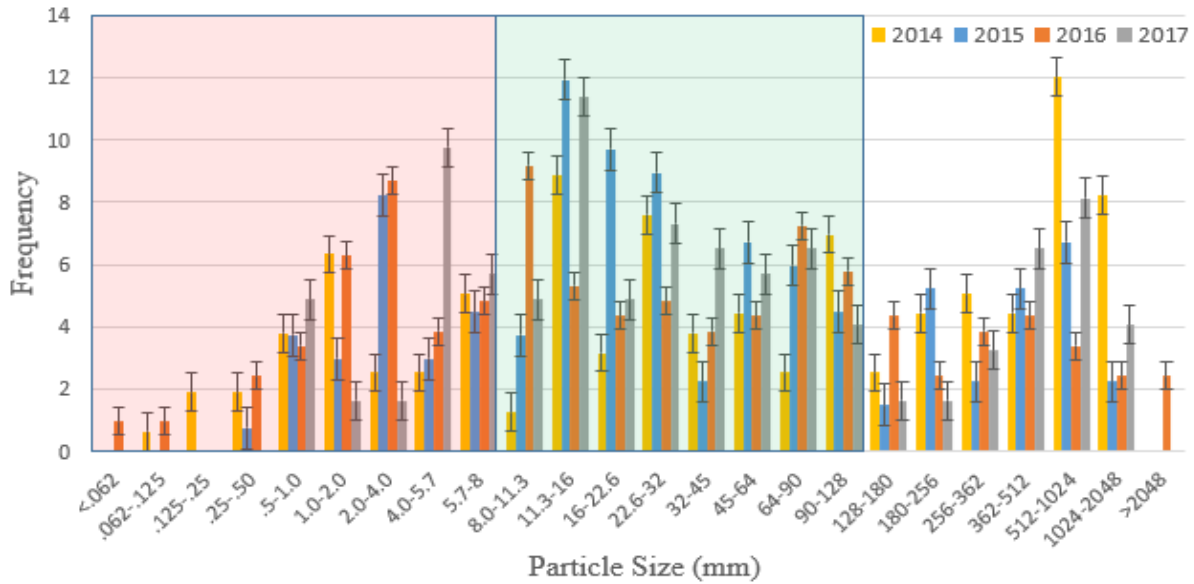
Figure IV-16. Particle size frequency distribution with standard error for area upstream of dam removal. All three years surveyed post dam removal had a higher percentage of preferred particles for spawning (green shaded area) sampled than in 2014 (54%, 45%, 51% versus 39%).

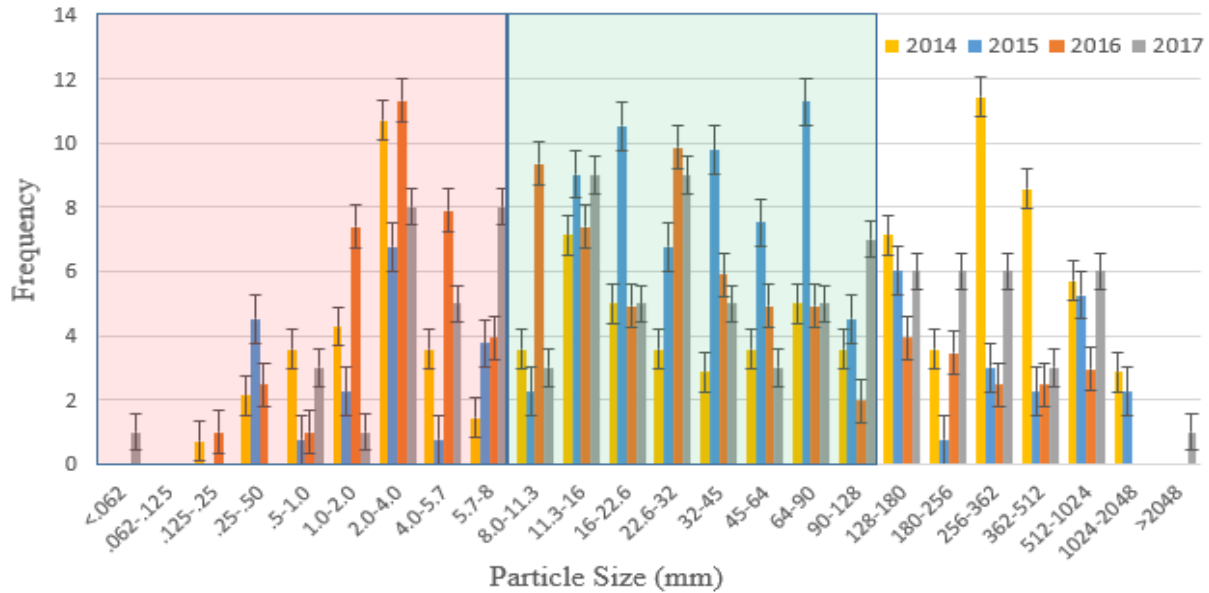
Figure IV-18. Particle size frequency distribution with standard error for the area within the area downstream of dam removal. The percentage of preferred particles for spawning (green shaded area) were higher in post-dam removal years than in 2014 (46-62% versus 34%).

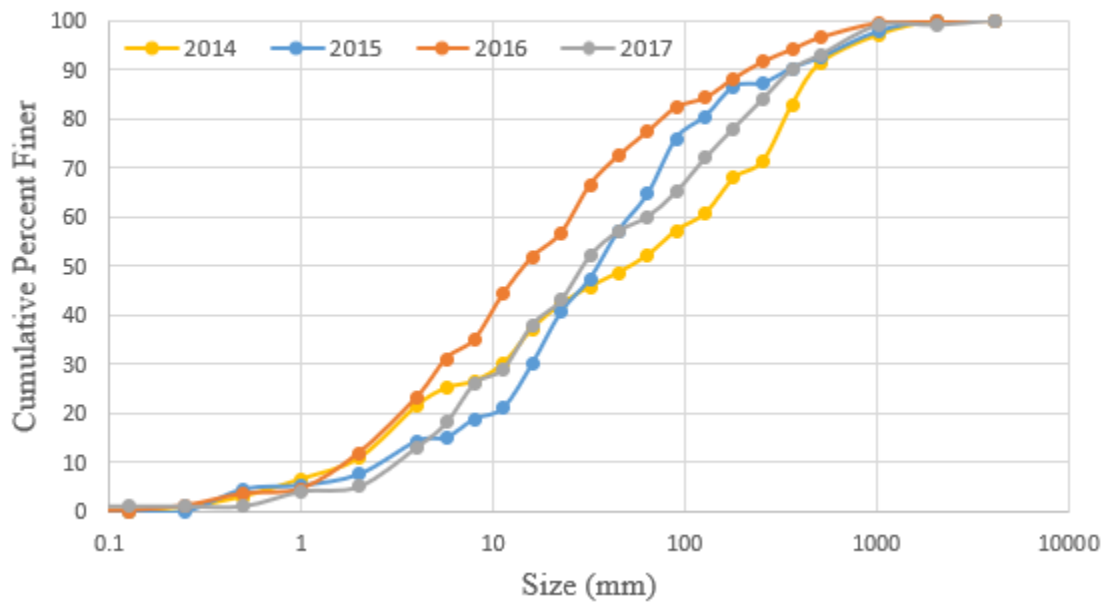
Figure IV-19. Cumulative particle size distribution curve for area downstream of dam removal. D50 and D84 values were highest in 2014 (pre-dam removal) at 53mm and 383mm respectively.

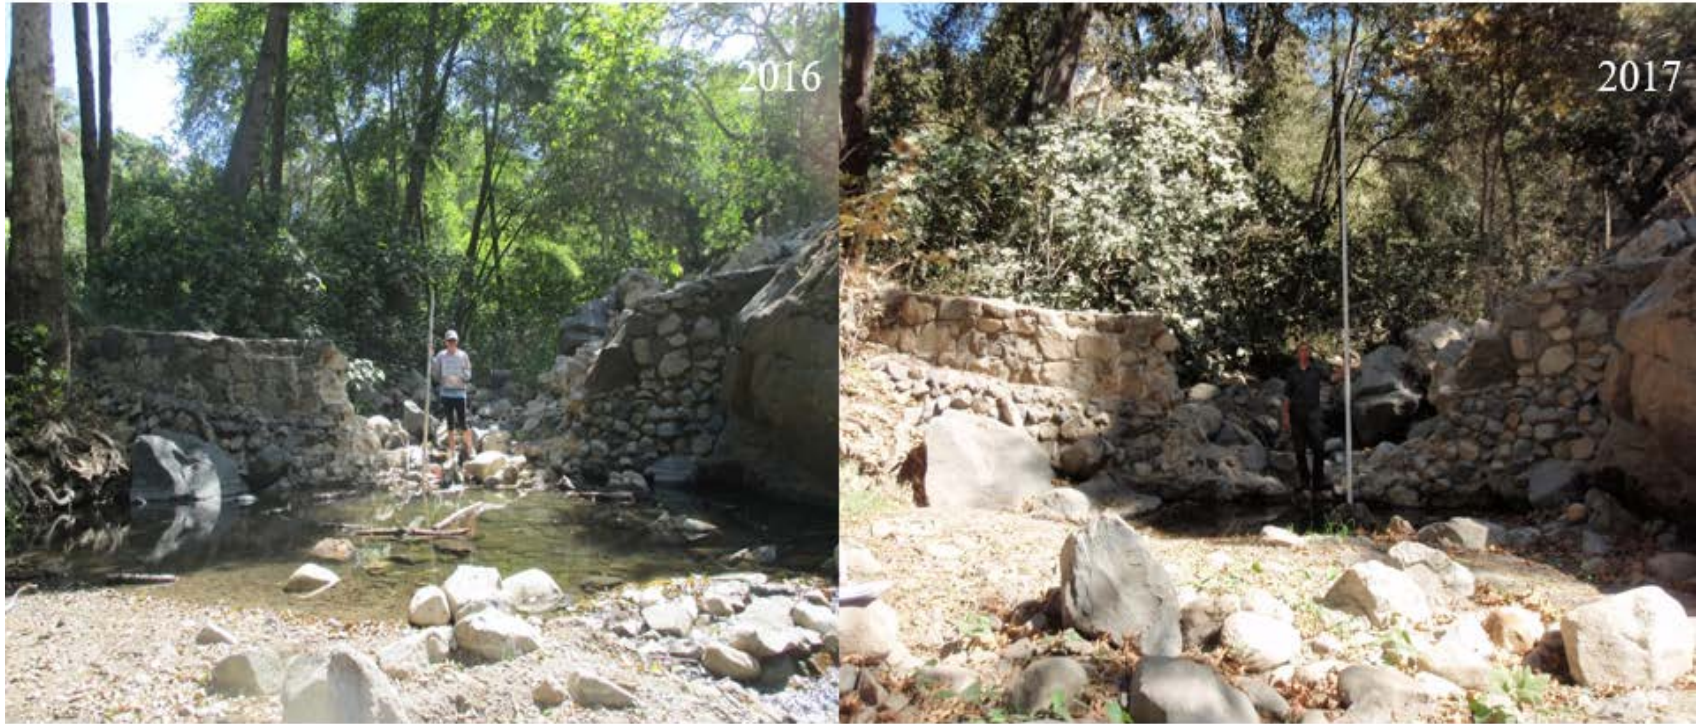
Figure IV-22. Comparison of 2016 vs. 2017 TCFD11 dam removal site . High levels of scour and large boulder movement was observed when conducting monitoring activities in 2017.

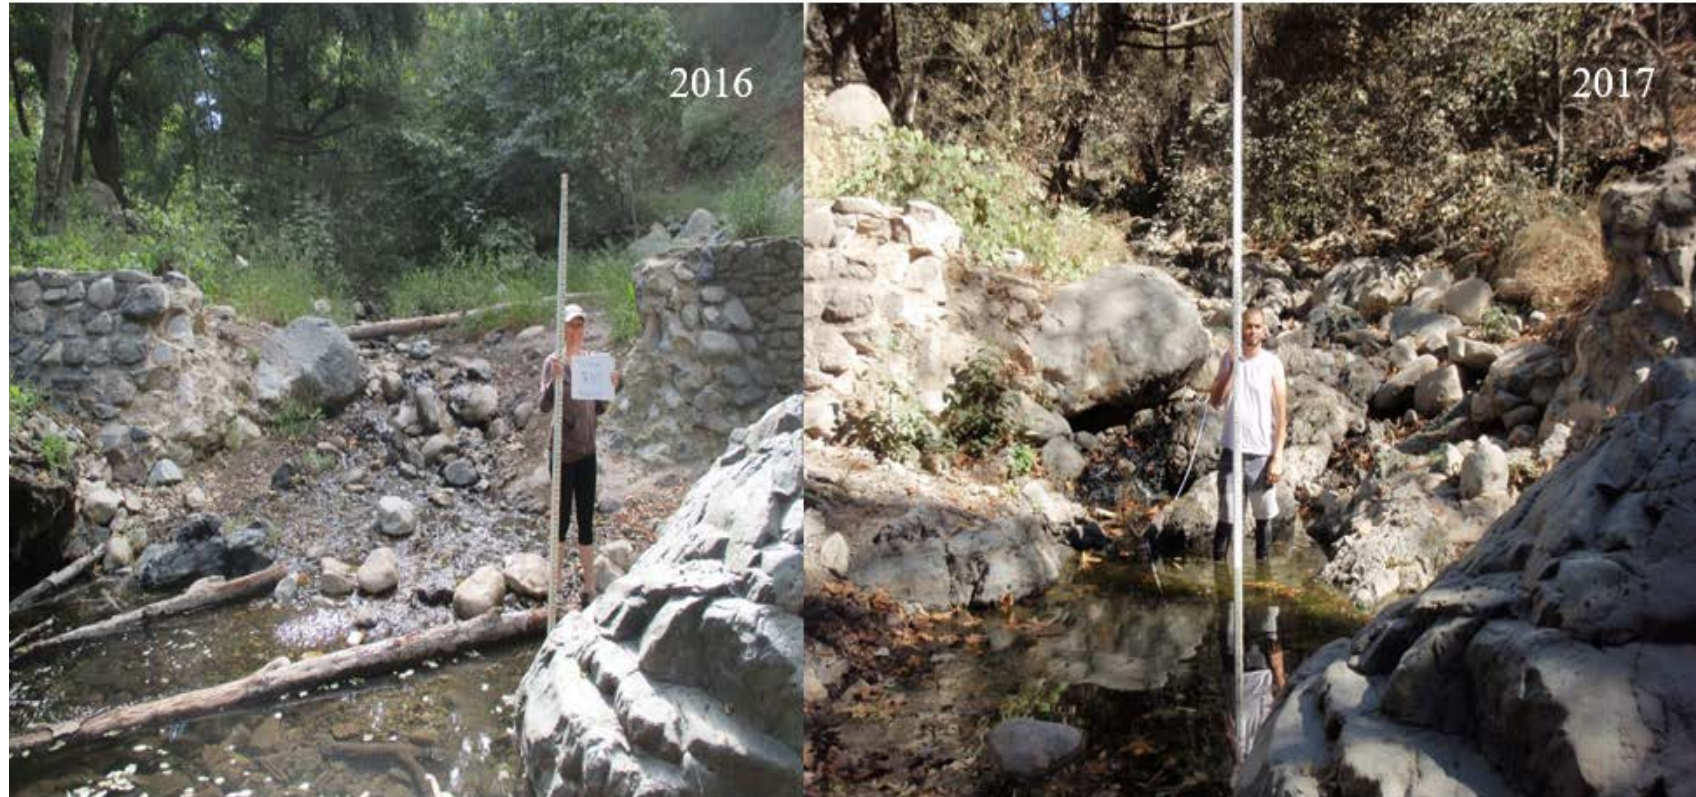
Figure IV-23. Comparison of 2016 vs. 2017 TCFD7 dam removal site in which nearly 2ft of scour was observed in 2017 when compared to 2016.

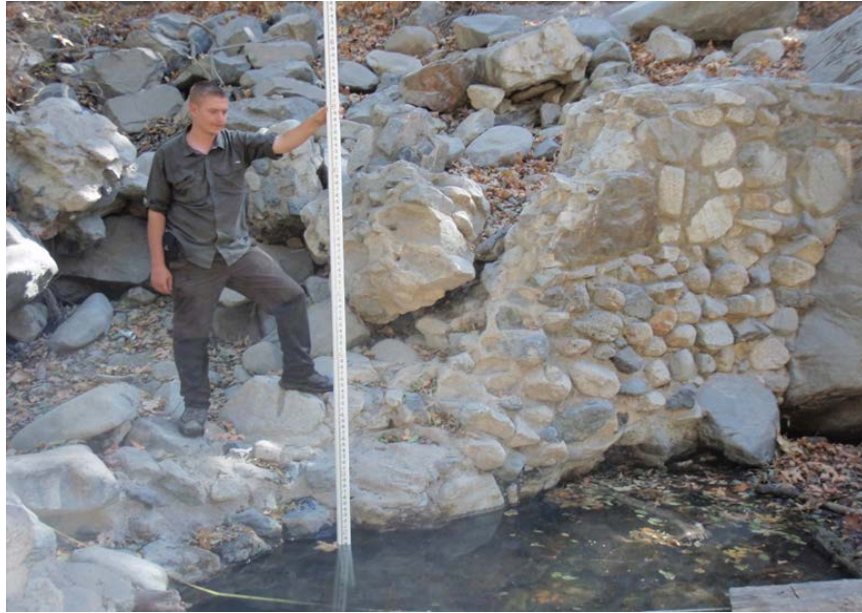
Figure IV-24. TCFD11 in 2017. Significant scour observed in 2017 exposing lower remnant section of TCFD11 creating a small plunge to lower pool with additional scour.

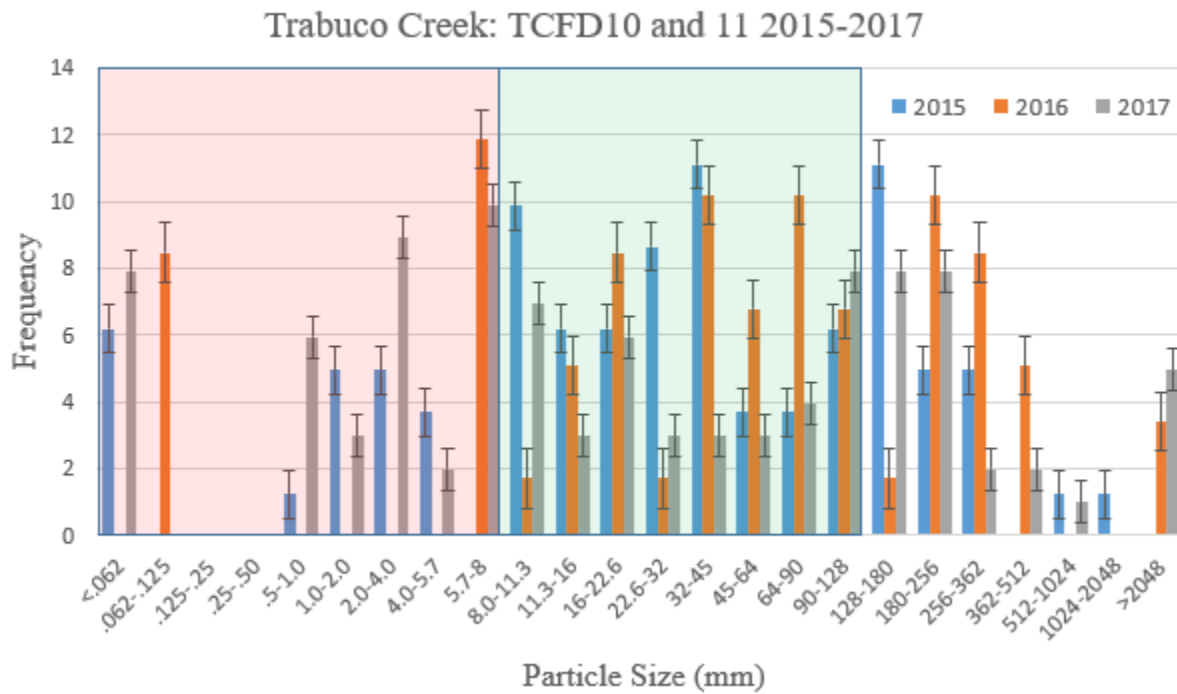
Figure IV-25. Particle size frequency distribution with standard error for the reach that encompasses the area where both TCFD10 and 11 once existed. The percentage of particles of ideal spawning size sampled (green shaded area) was highest in 2015 at 56% and lowest in 2017 at 37%.

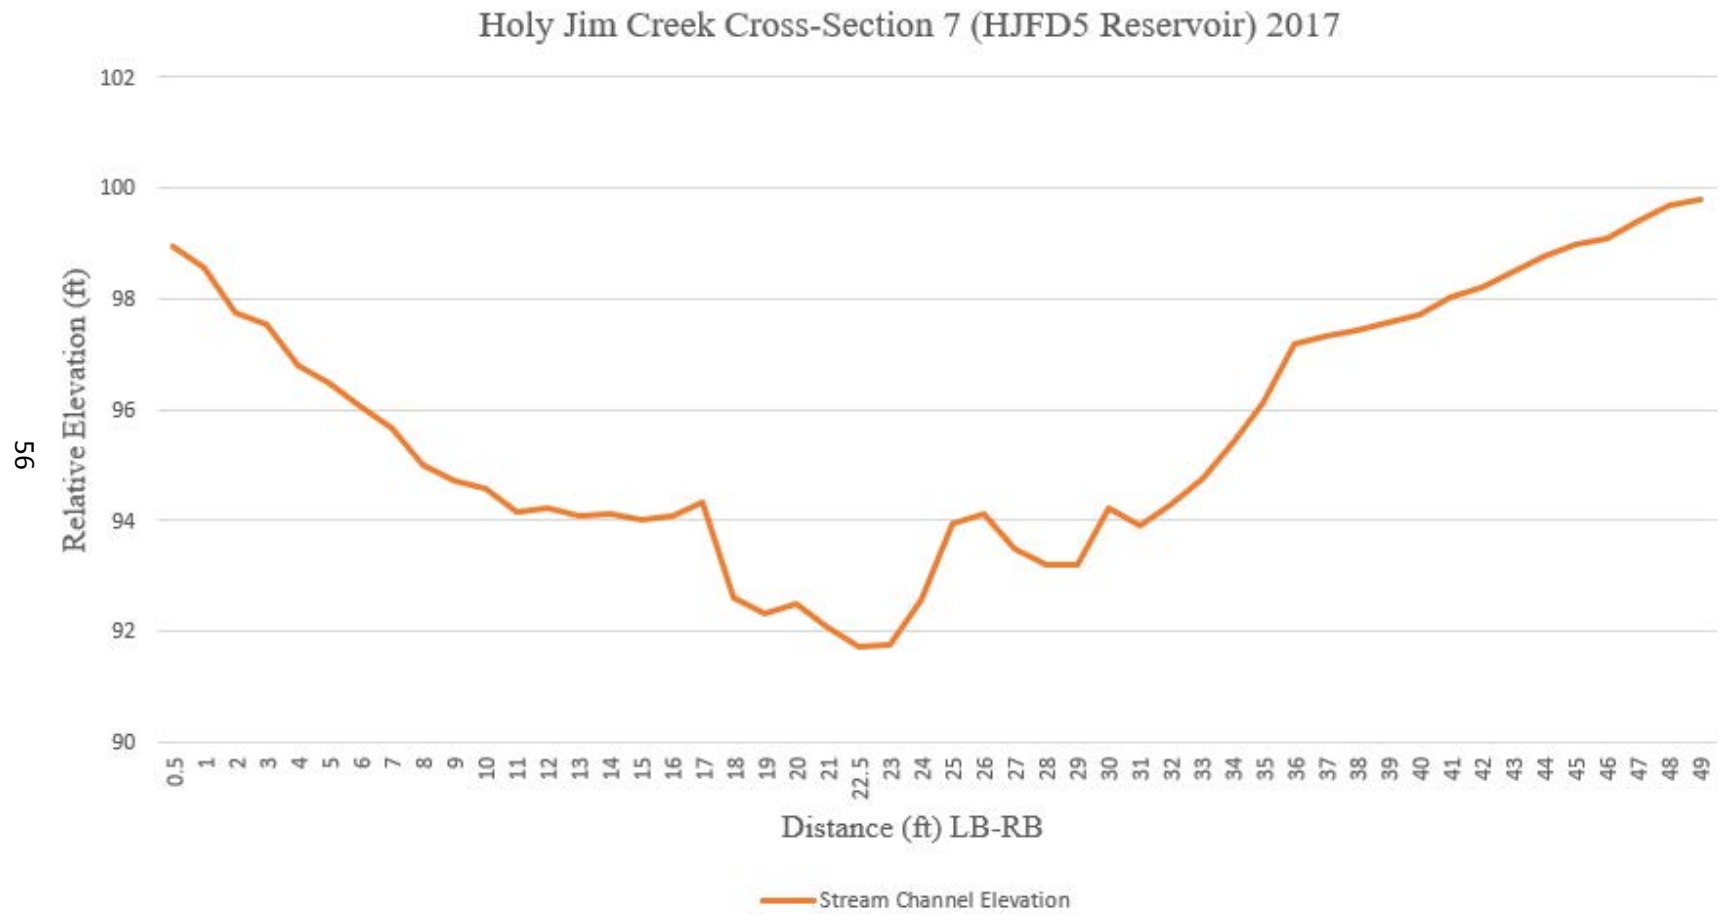
Figure IV-30. Cross-section of stream channel conducted at HJFD5 reservoir.

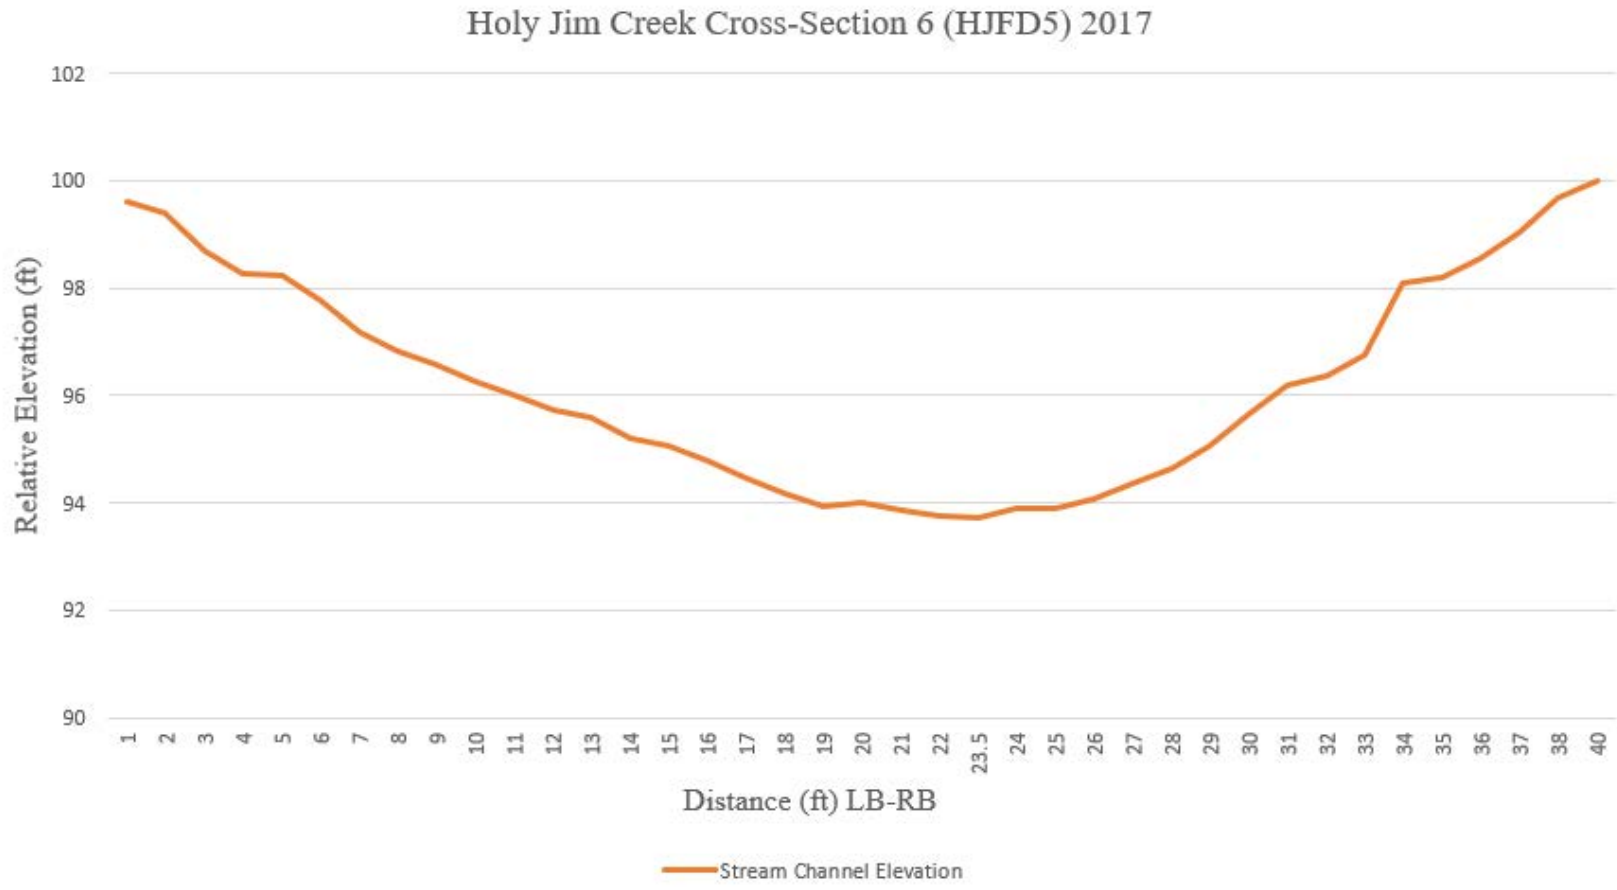
Figure IV-31. Cross-section of stream channel conducted slightly upstream of the base of HJFD5.

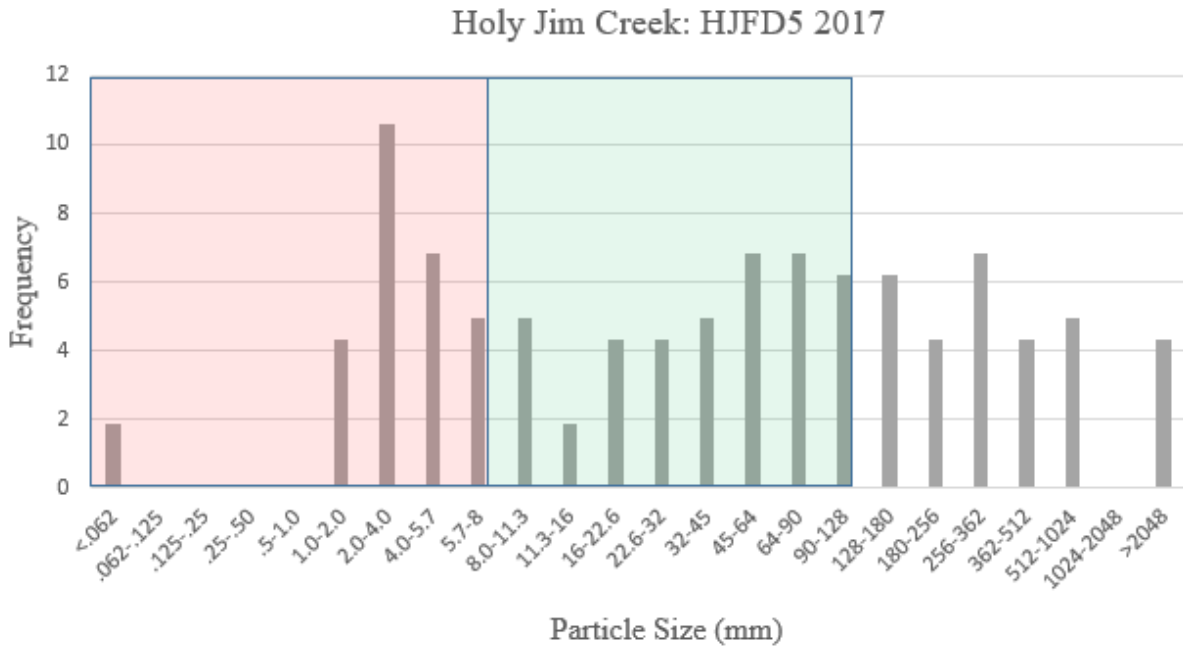
Figure IV-32. Particle size frequency distribution for the area from HJFD5 to where HJFD6 once existed. The percentage of preferred particles for spawning (green shaded area) sampled within the pebble count for this reach was 40%.

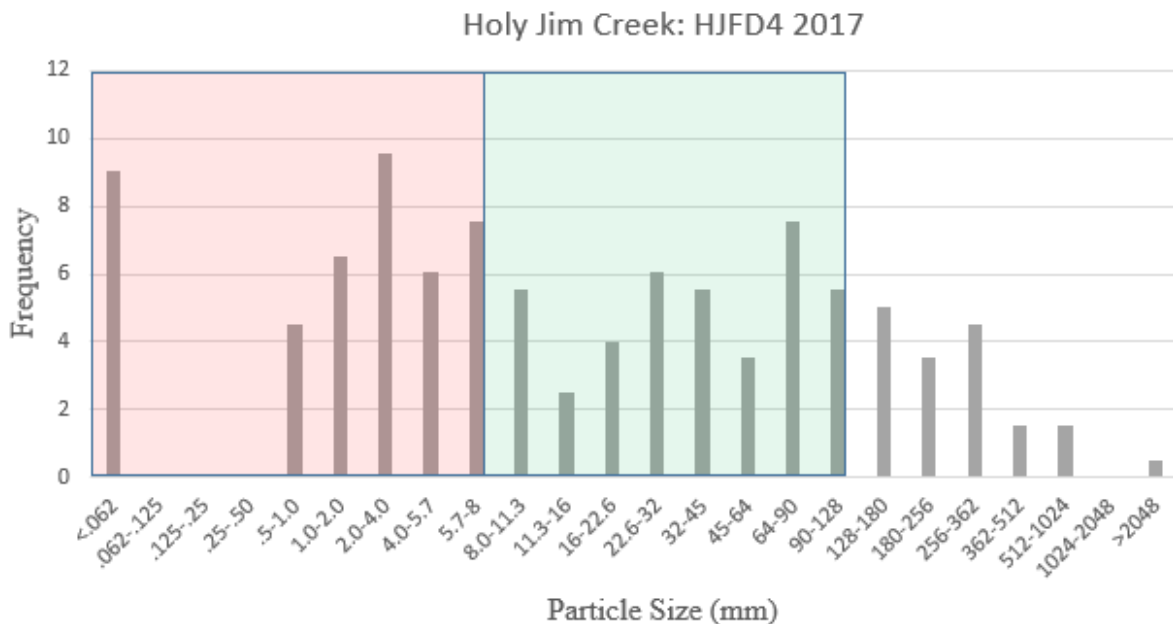
Figure IV-34. Particle size frequency distribution for the area beginning at HJFD4 up to the wetted pool directly below HJFD5. The percentage of preferred particles for spawning (green shaded area) sampled for this reach in the pebble count was 40%.

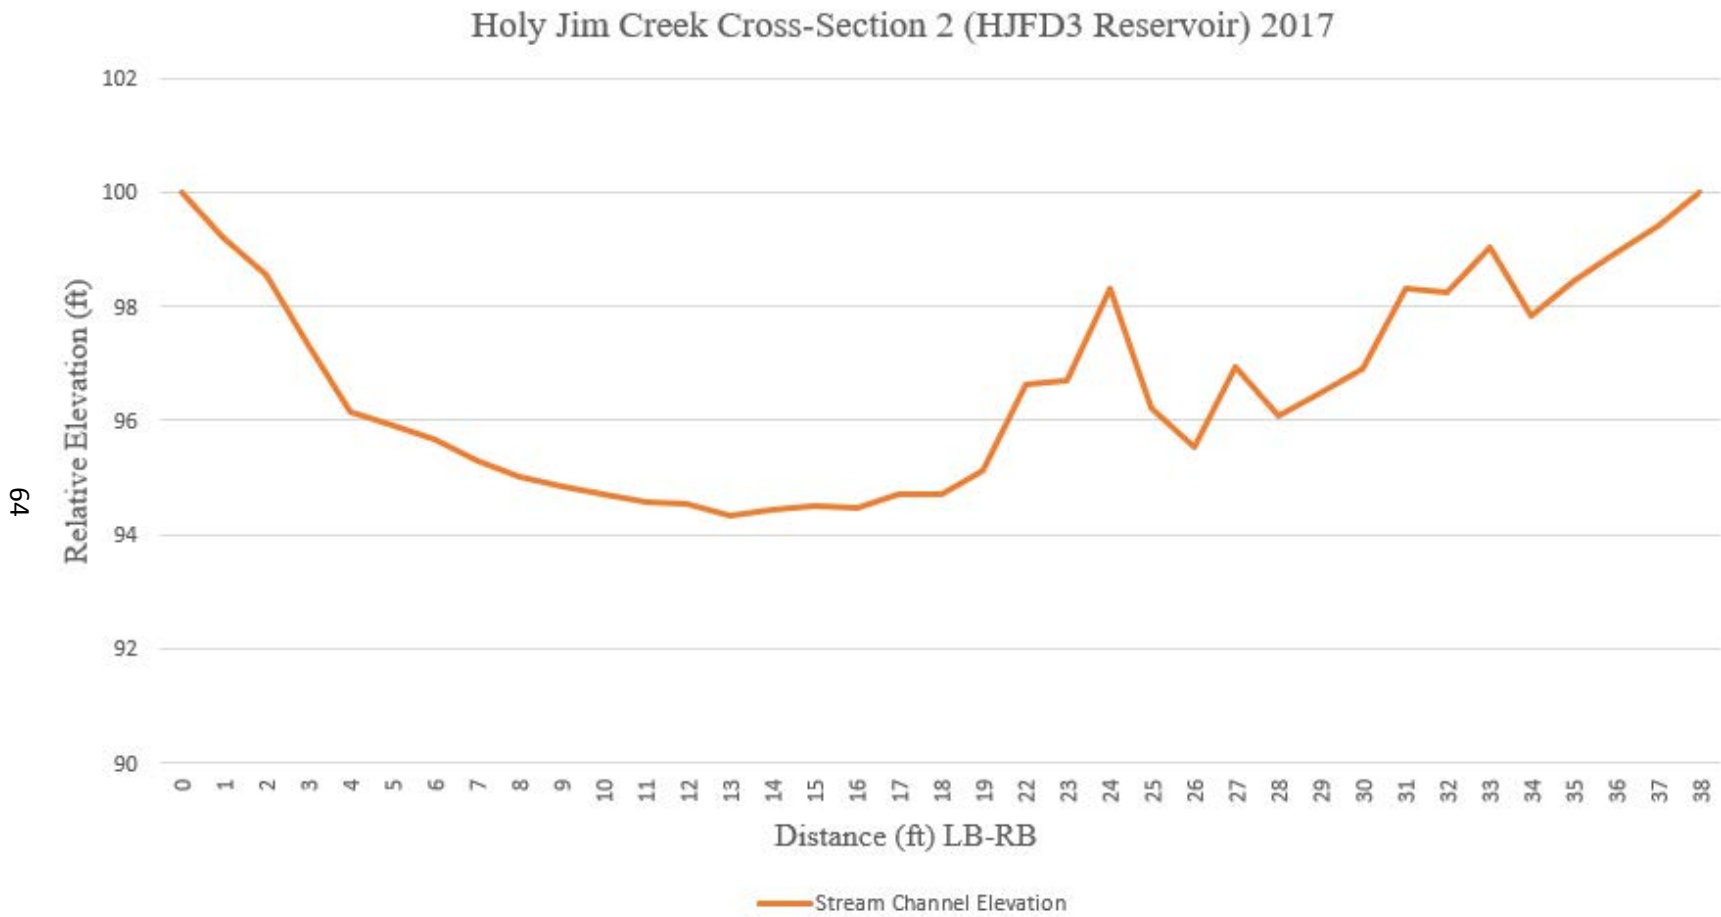
Figure IV-39. Cross-section of stream channel conducted in the reservoir of HJFD3.

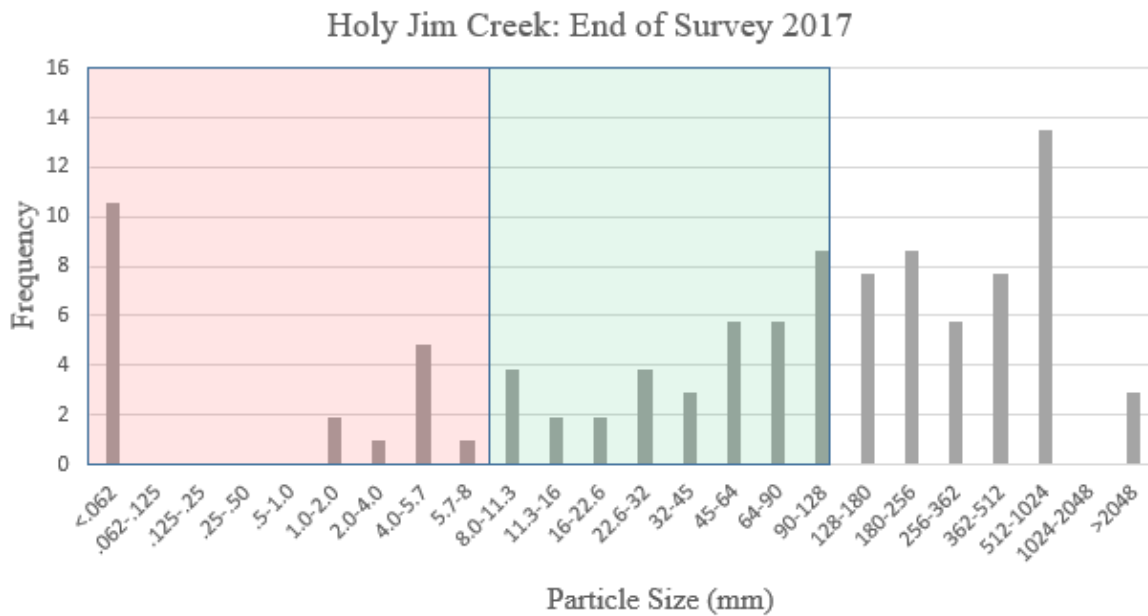
Figure IV-42. Particle size frequency distribution for stream channel from bottom of HJFD3 to the end of the survey. Percentage of preferred particles for spawning (green shaded area) sampled for this reach was 35%.

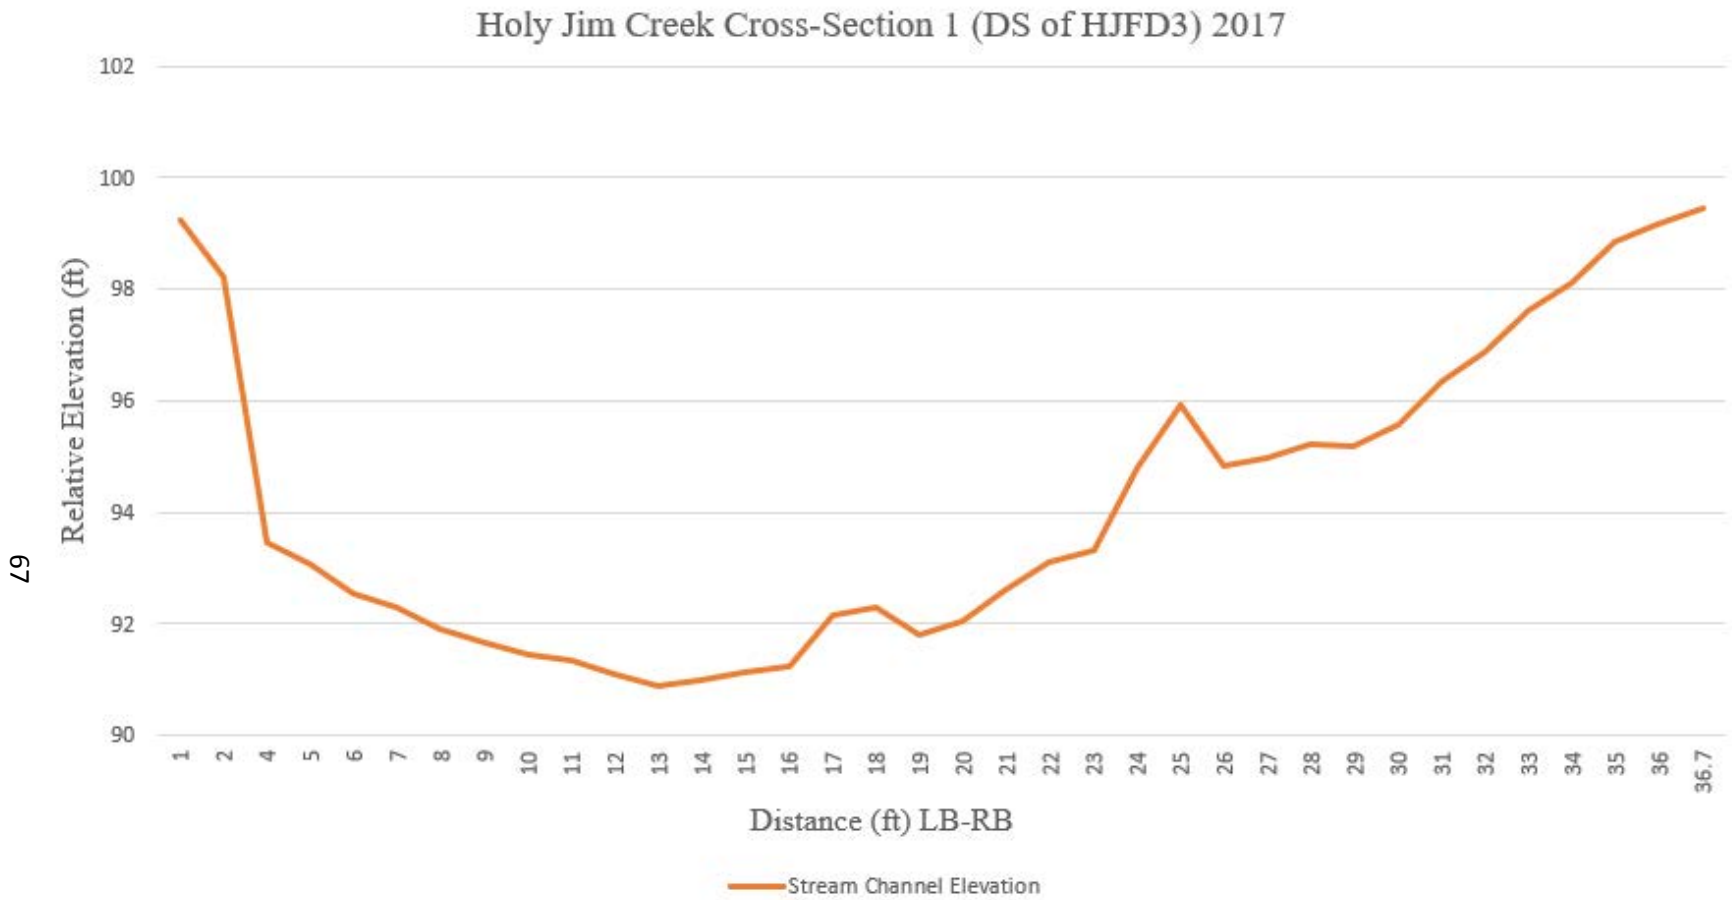
Figure IV-43. Cross-section of stream channel conducted slightly downstream of the base of HJFD3.

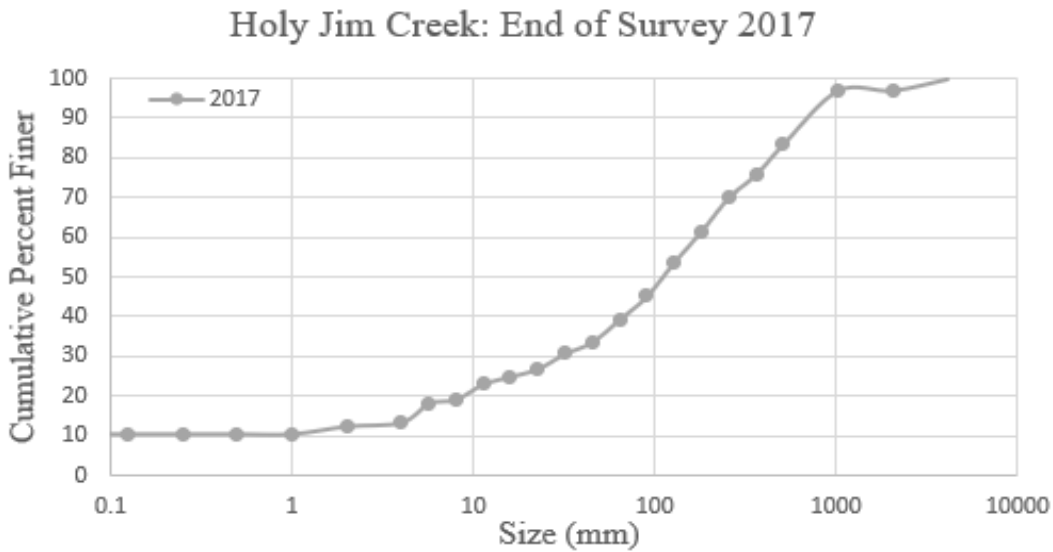
Figure IV-44. Cumulative particle size distribution curve for the stream channel from below HJFD3 to the end of survey. This reach had the coarsest streambed substrate according to pebble counts with D50 value of 112mm and D84 value of 527mm.
