Sulphur Creek Fish Passage Restoration Project

Napa River Watershed, CA

California Fish Passage Forum
November 7, 2023

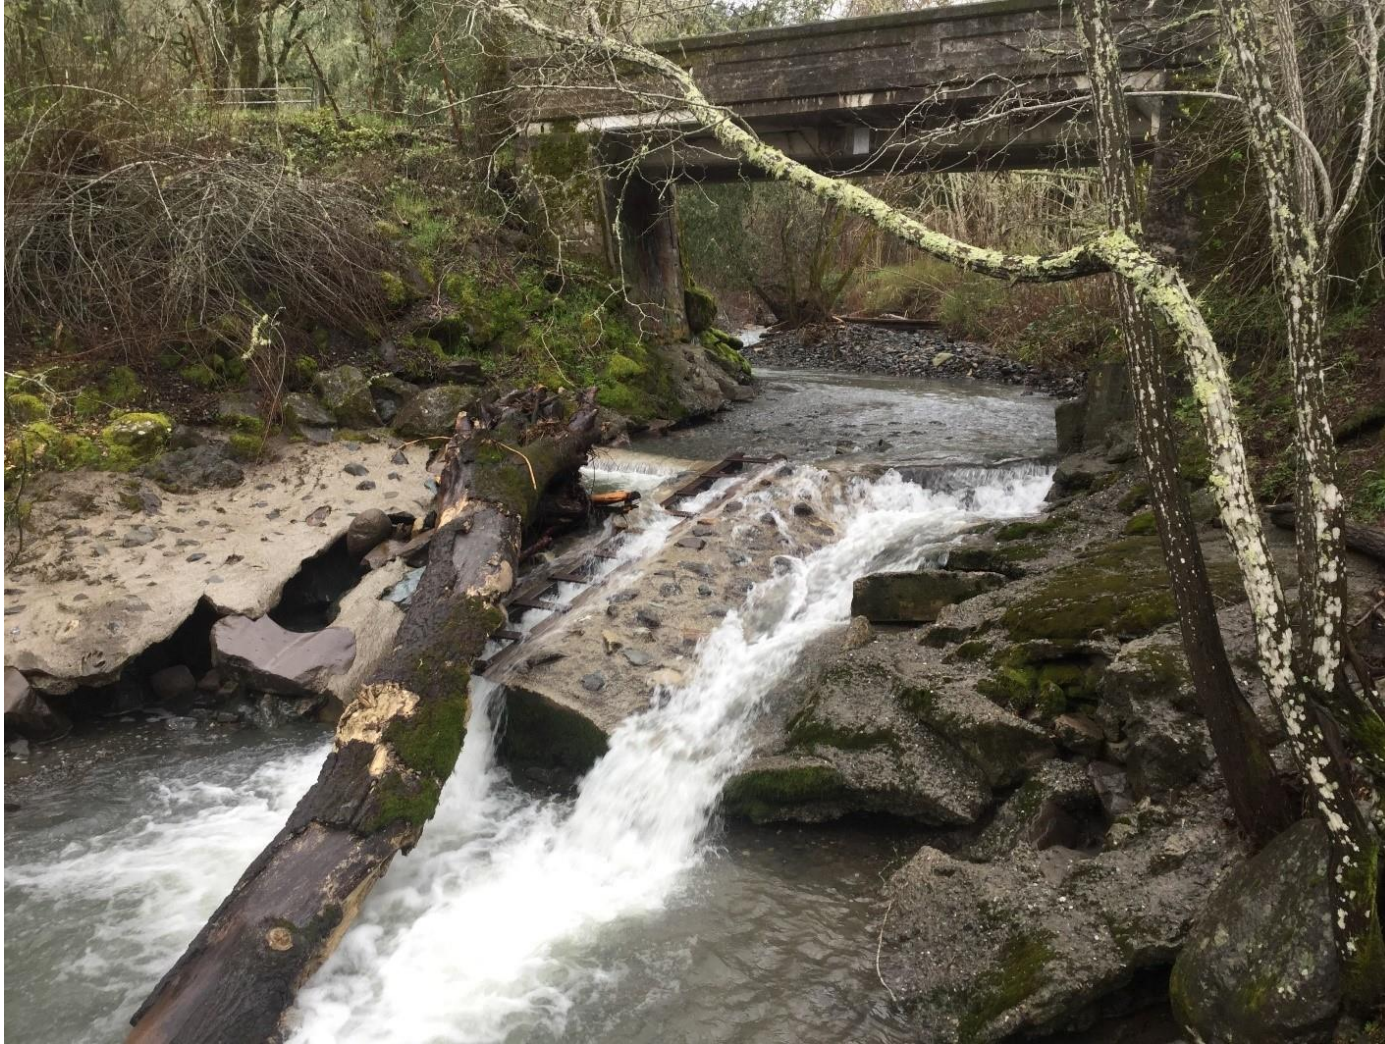
- Bridge apron inhibits passage to ~4.2 mi. of perennial spawning, rearing habitat
- Sulphur Creek supports threatened CCC steelhead, Chinook salmon, lamprey
- Bridge built 1916
- 1916-1950s: Restricted high flows, channel and footing scour

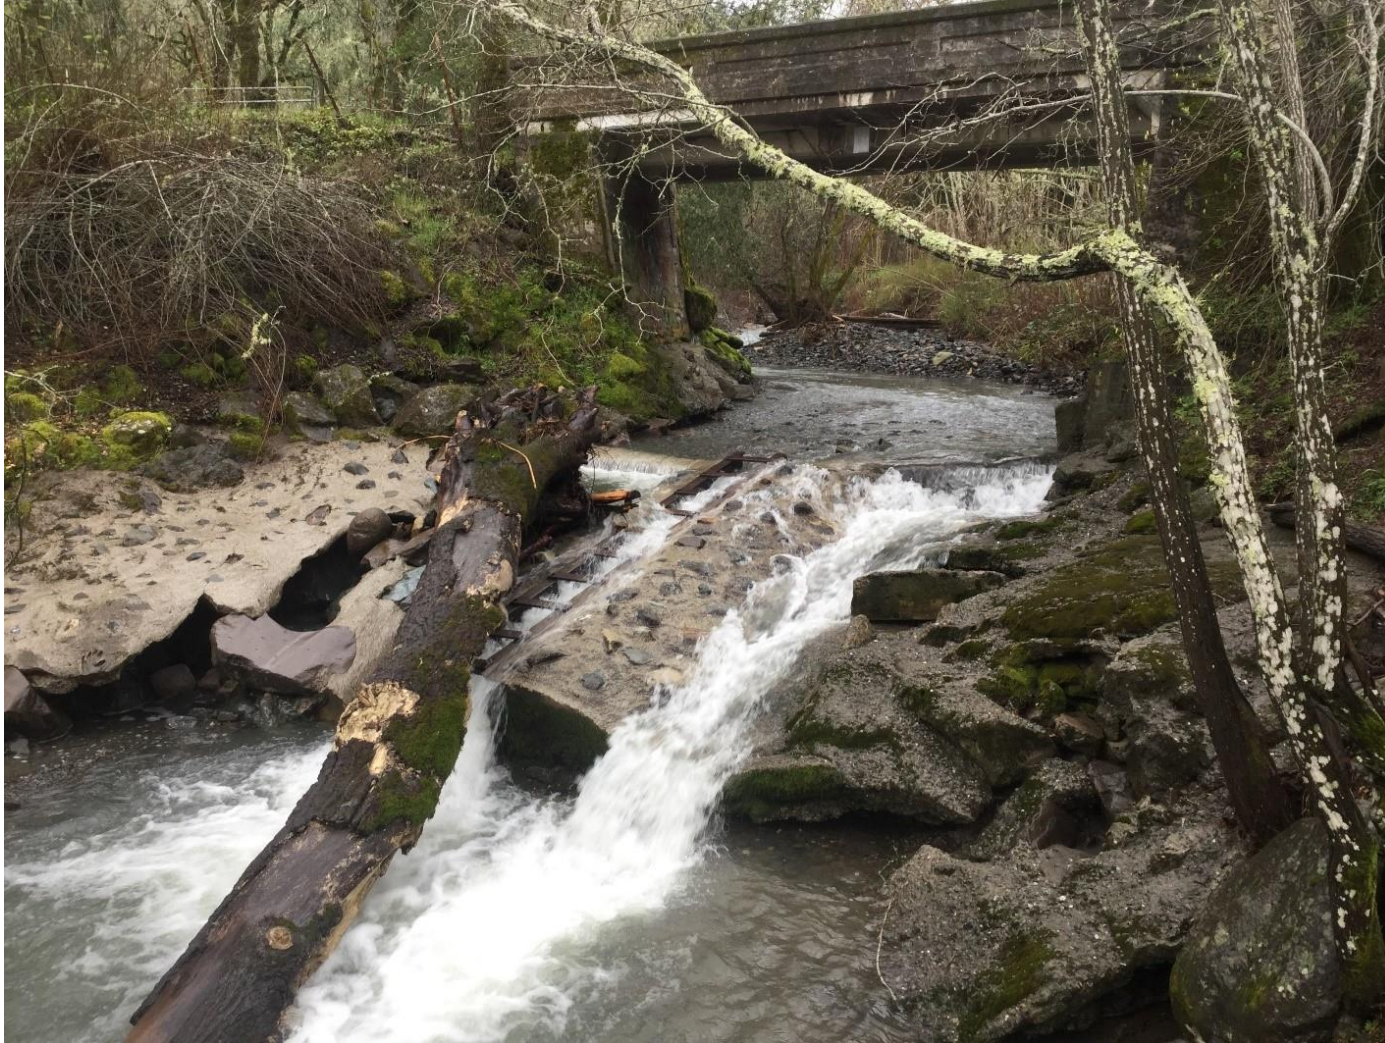
- 1950s-2000s: Further scour → armoring of bank & footing, rock revetment, wingwalls
- 2003: Downtcutting → CDFW funded Alaska steeppass fishway using best information available
- 2005: Deemed inoperable during most passage flows by CDFW

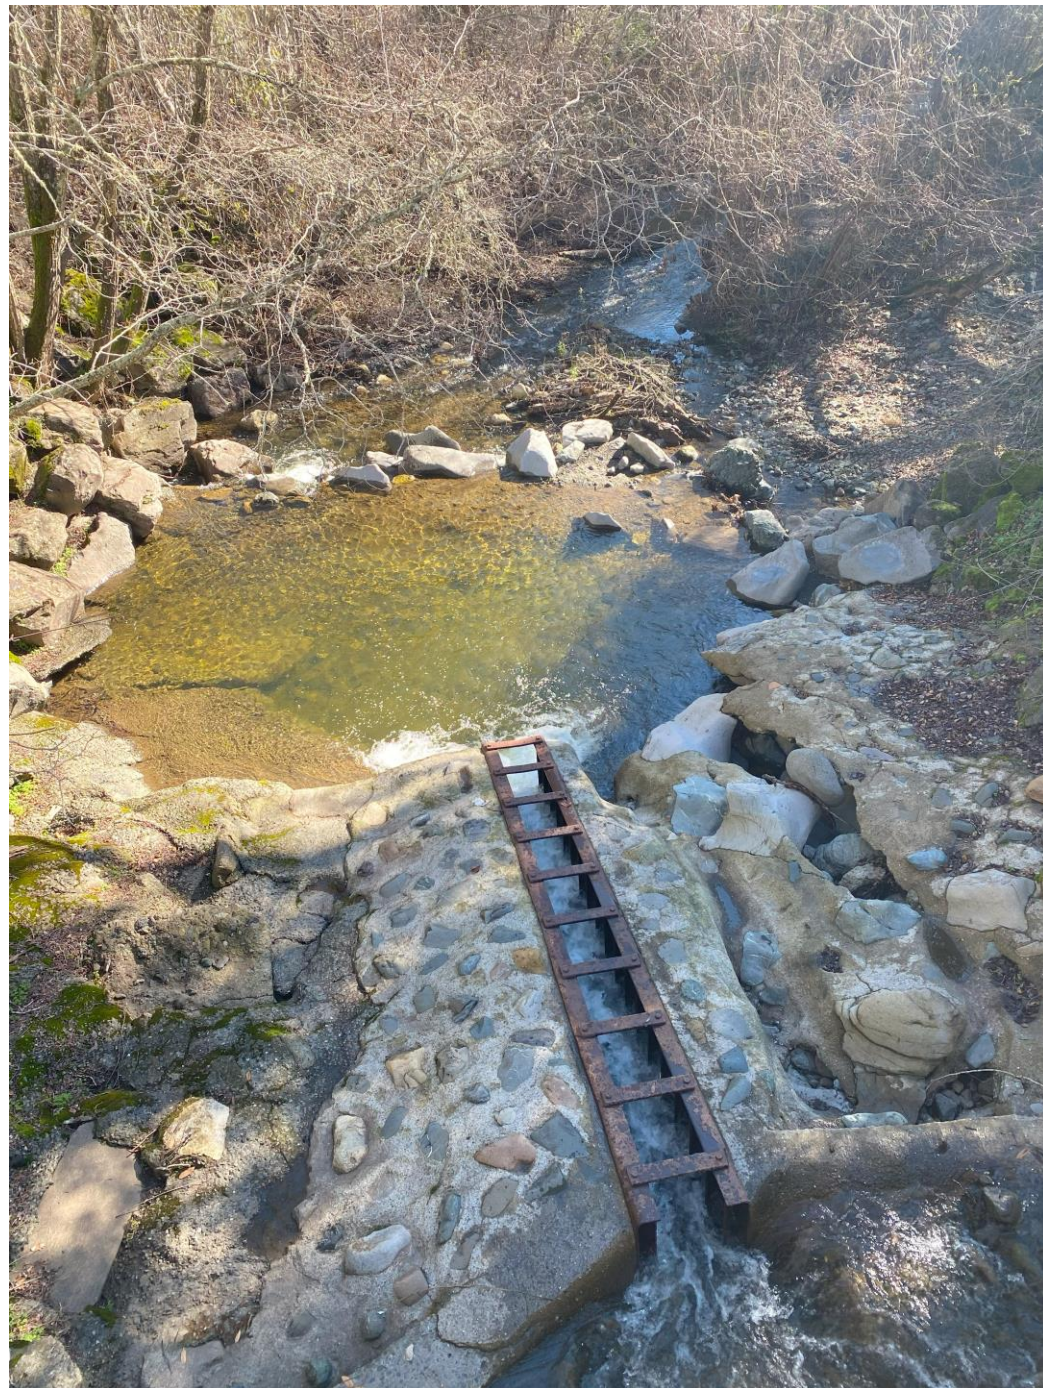
- Private bridge for residents constraining flow
- Fish ladder and eroding concrete casing disjointed
- Cabled rock weir for pool formation
- Nearby home on left bank
- Project site in intermittent transitional reach of Sulphur Creek (between high energy headwaters and low energy valley)

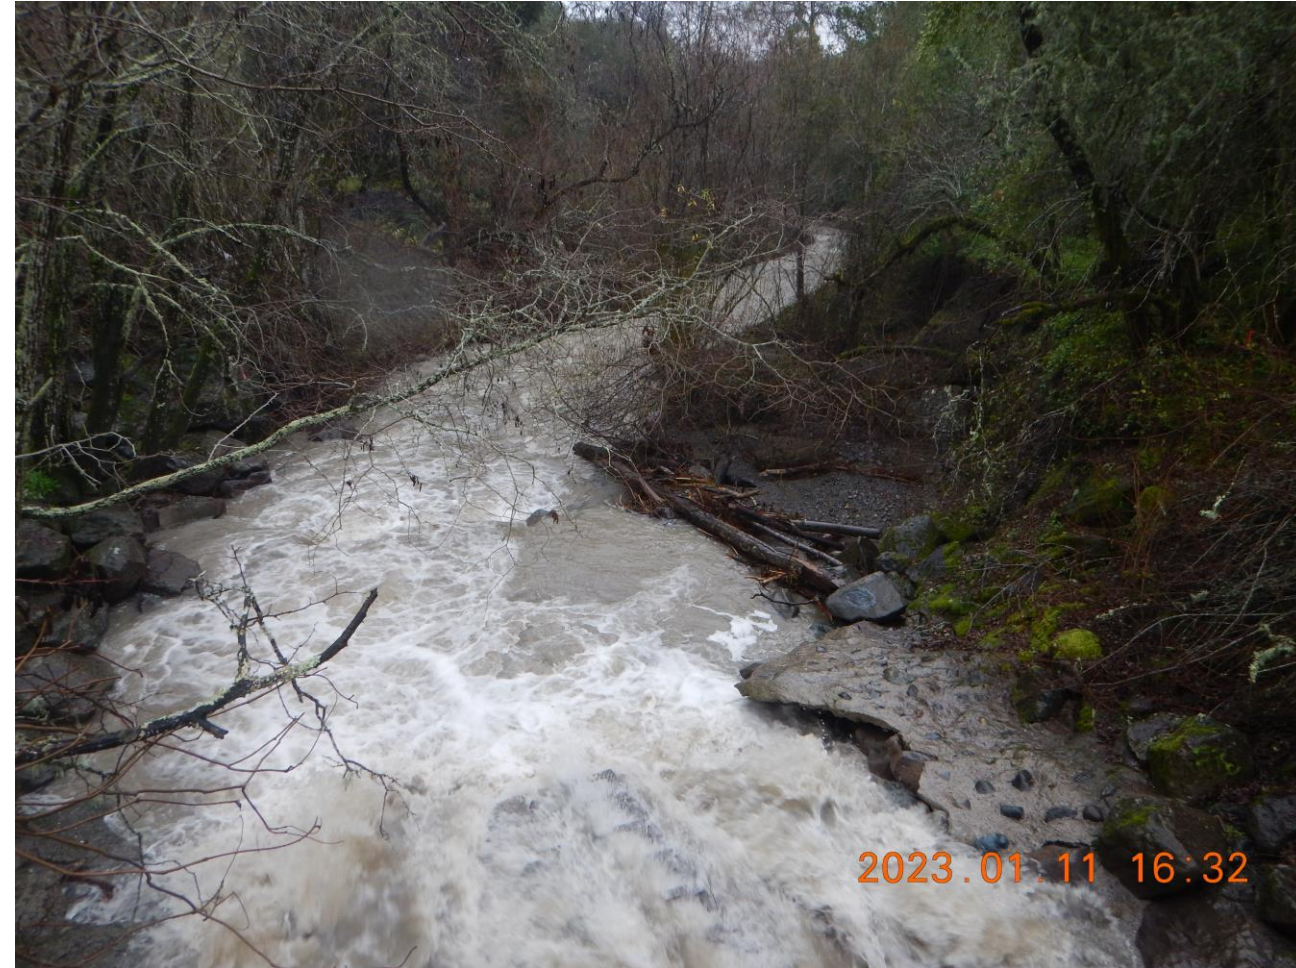
Design Objectives and Constraints

- Provide fish passage for all life stages
- Provide continuity of water and sediment flow
- Encourage fish transport through reach into high quality upstream habitat
- Avoid causing unstable bank conditions upstream and downstream
- Minimize the need for maintenance and debris removal
- Avoid worsening flooding of nearby infrastructure
- Appeal to landowner needs (site accessibility, fire concerns, aesthetics)

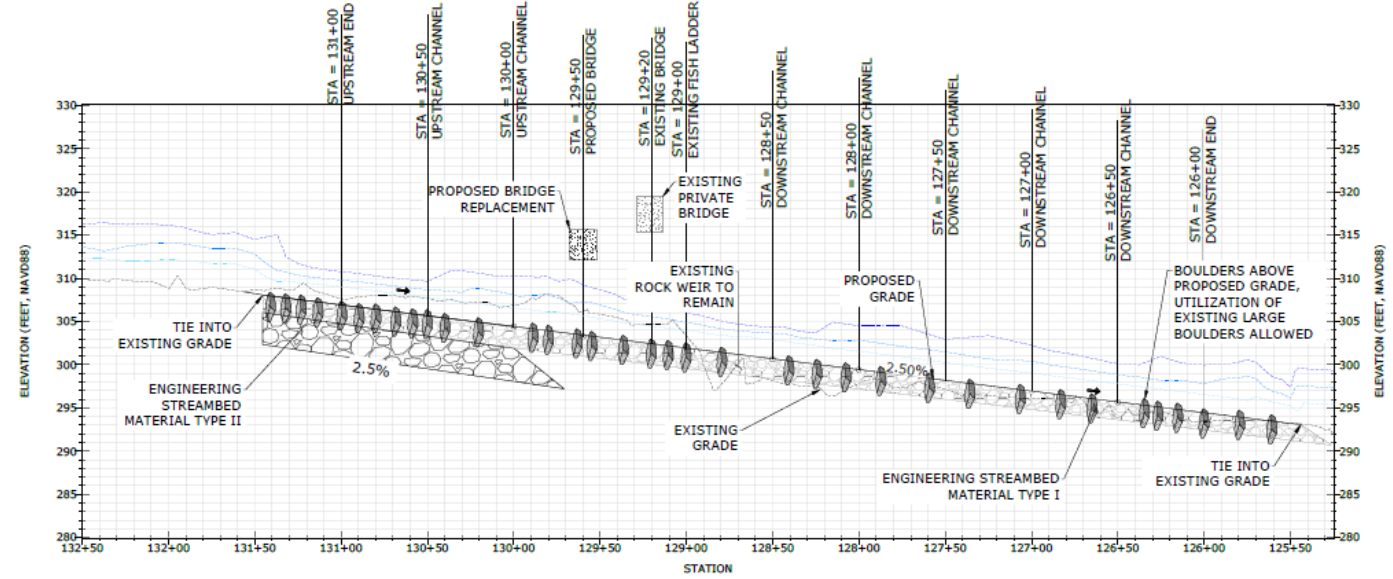
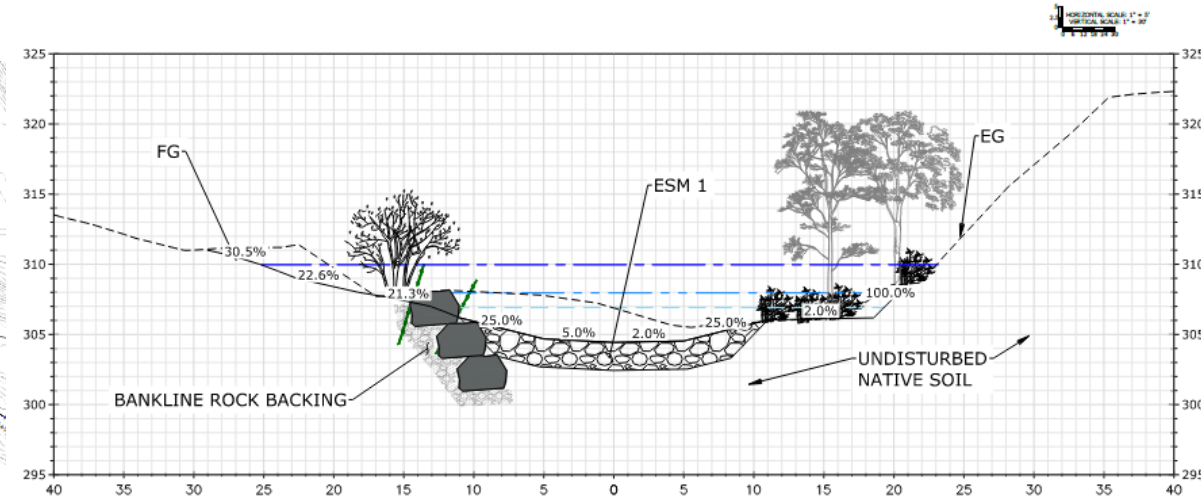
1 PROPOSED CHANNEL CENTERLINE PROFILE VIEW

Current Design
