San Luis Obispo Creek Barrier Remediation

California Fish Passage Forum

Reconciliation of Passage Needs For Multiple Aquatic Species

Project Title: San Luis Obispo Creek Passage for Lamprey and Steelhead

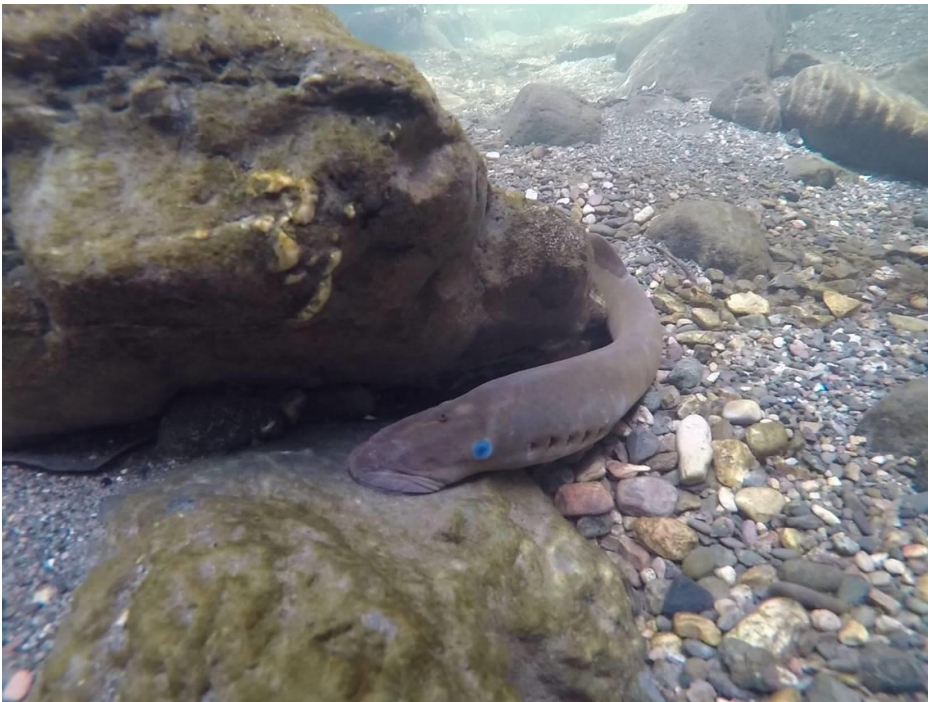
Adult lamprey building a nest (redd) in San Luis Obispo Creek in Central California (SLO Tribune article). Credit. D. Baldwin (California Department of Fish and Wildlife)

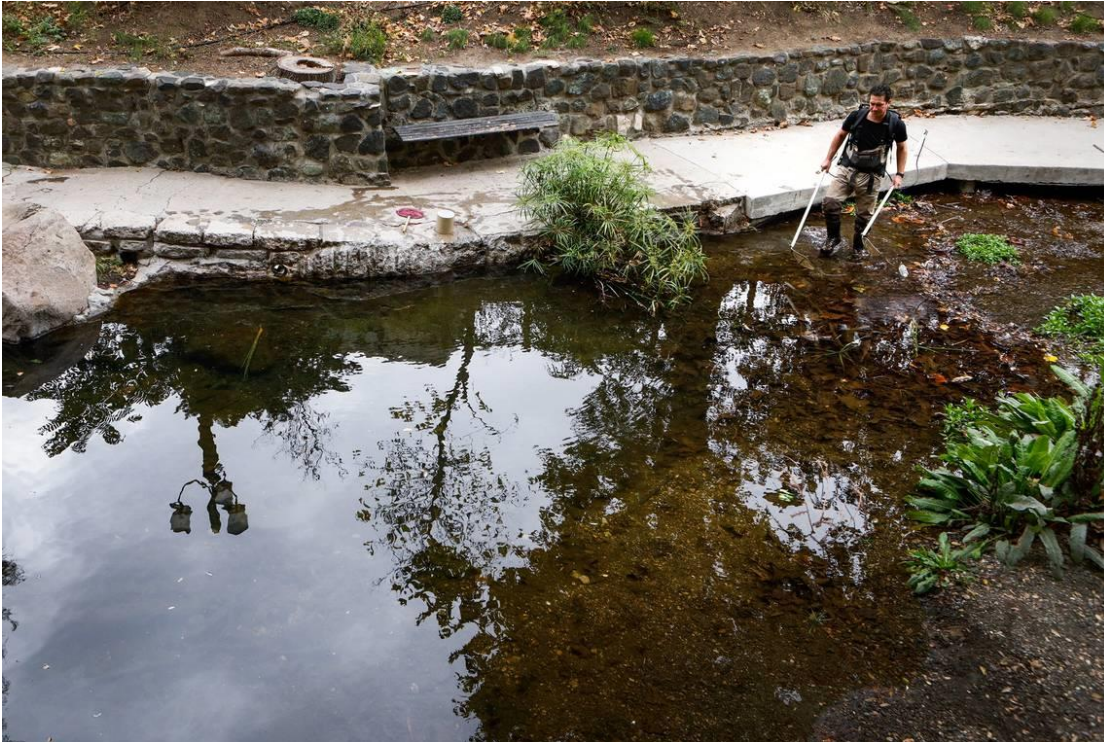
Damon Goodman, US FWS biologist, studies where lamprey in small gravel of San Luis Obispo Creek. (SLO Tribune article). Photo credit. D. Baldwin (CDFW).

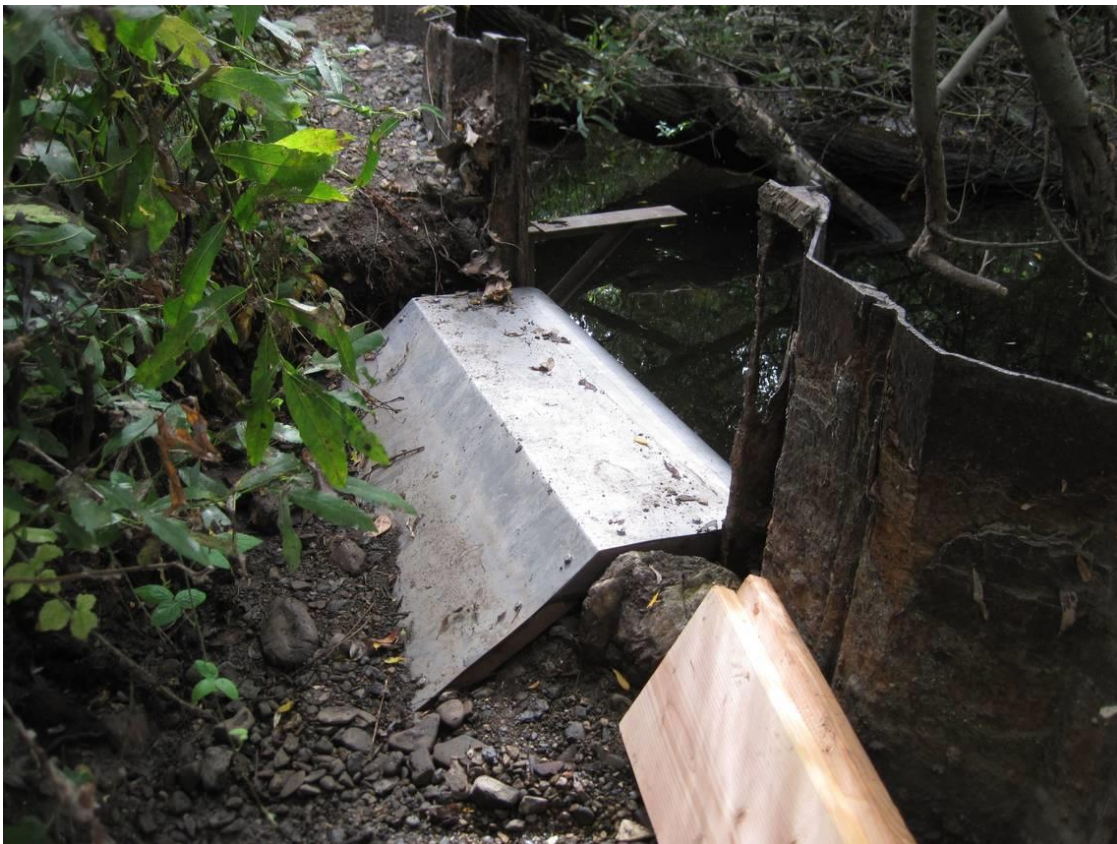
Lamp Ramp installed near the mouth of San Luis Obispo Creek in 2013. Photo courtesy of City of San Luis Obispo.

In 2013, the Central California Lamprey Working Group designed and installed an economical solution made from repurposed materials. This was a curved piece of metal placed over the weir that cost less than \$315. In 2017, adult Pacific lamprey were documented building redds in SLO mainstem and tributaries, indicating that the population had recolonized without the need of human facilitated reintroduction.

- 2013 - First lamprey passage modification installed (metal ramp)
- 2017 – Lamprey naturally recolonized the drainage.
- 2019 - Installation of a second phase structure on the other end of the weir (tube design), with lamprey video monitoring system.
