**FINAL REPORT: HUMBOLDT COUNTY CULVERT INVENTORY AND FISH  
PASSAGE EVALUATION**

**April 16, 2000**

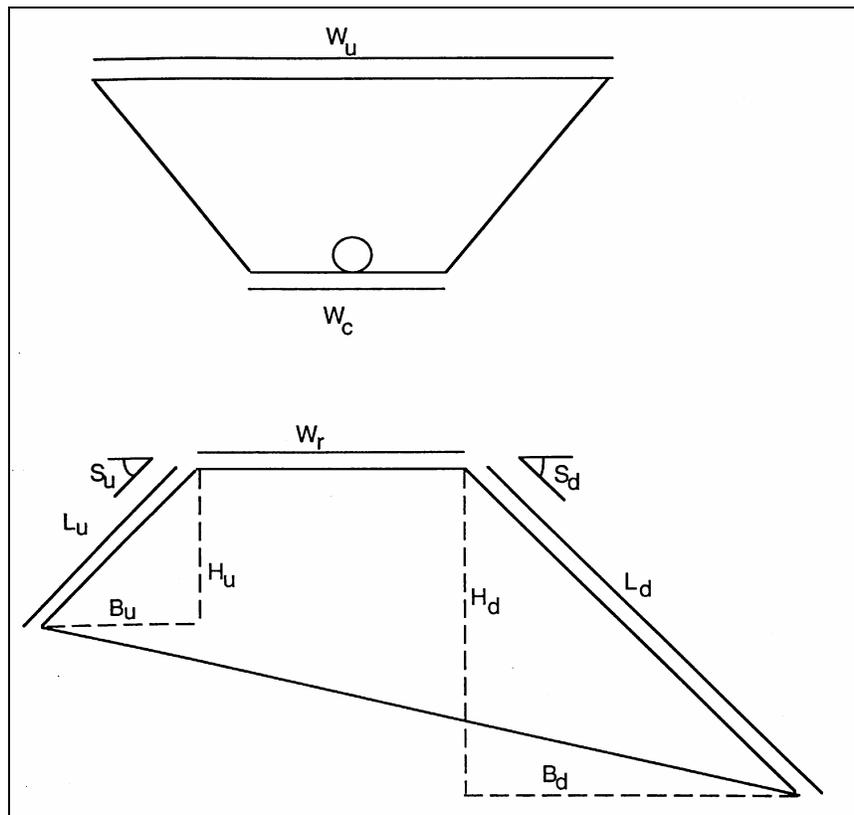
At each culvert, the amount of fill was estimated by calculating the volume of the fill prism between the road surface and the culvert (Figure 1) (from Flannigan et al 1997). The purpose of estimating fill volume was to assist in development of cost estimates for barrier removal by estimating equipment time required for fill removal and disposal site space needed.

The fill prism was calculated from the following measurements:

1. Upstream and downstream fill slope measurements ( $L_d$  and  $L_u$ ).
2. Slope (%) of upstream and downstream fill slopes.
3. Width of road prism ( $W_r$ ).
4. Length of road prism ( $W_u$ ).
5. Channel width (flood prone width) ( $W_c$ ).

**Figure 1. Fill measurements – solid lines were measured values, dashed lines were calculated.**
