**Manly Gulch
Fish Access and Habitat Restoration Project
Trout Unlimited**

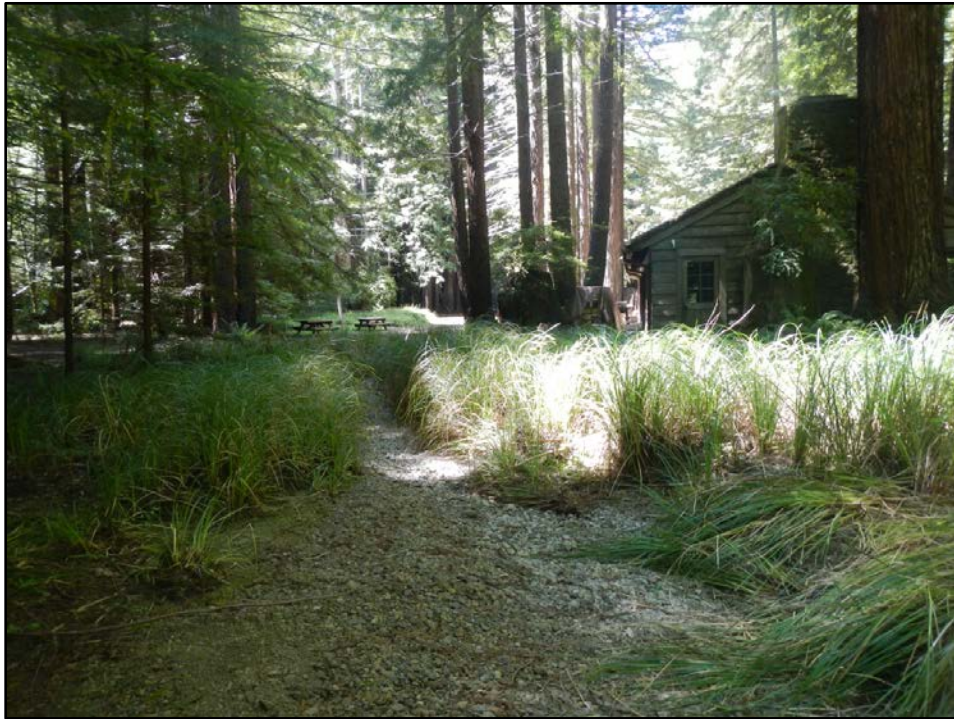
Manly Gulch (looking upstream). Channel transitions from defined to undefined channel.

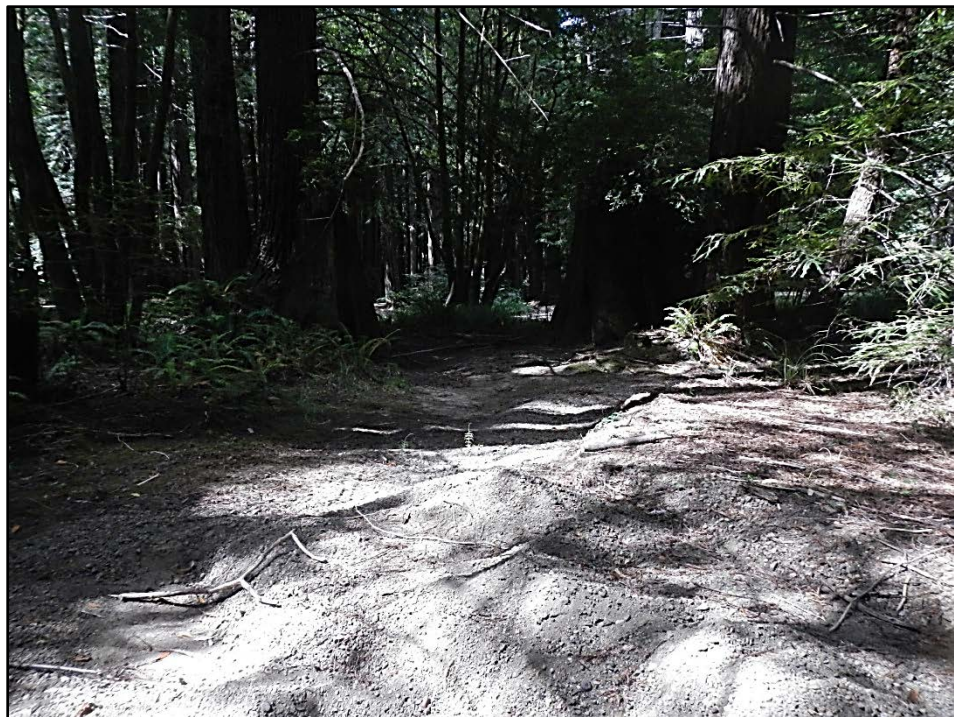
Reach of Manly Gulch that has become undefined due to sedimentation (looking downstream)

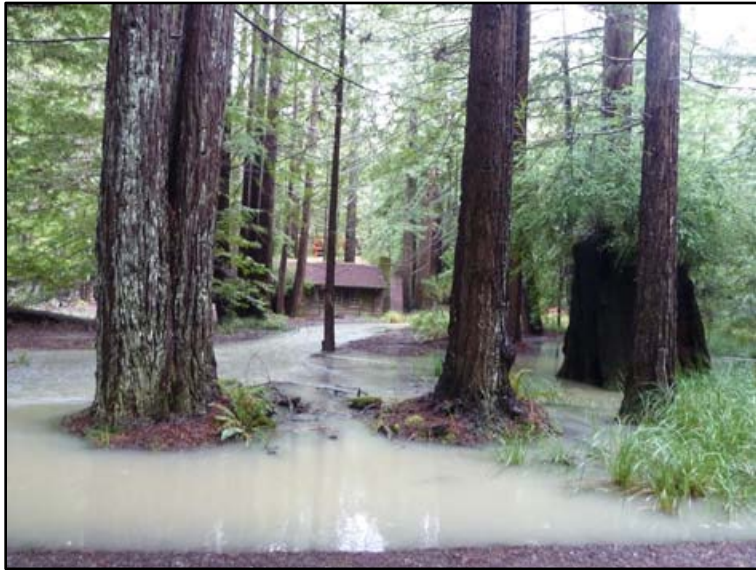
Flow spreading out of the undefined channel during a small flow event (looking upstream towards dining hall) (photo by Ming, Inc.)

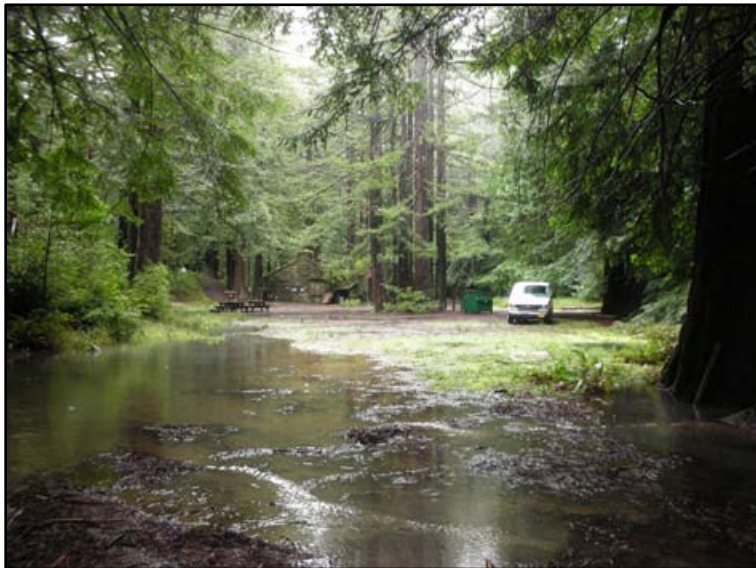
Flow spreading out of the undefined channel and into the parking lot during a small flow event (looking downstream towards Rocky Gulch) (photo by Ming, Inc.)
