# Inventory of Barriers to **FISH PASSAGE** in California's Coastal Watersheds

Conducted and Compiled by  
**The Coastal Conservancy**

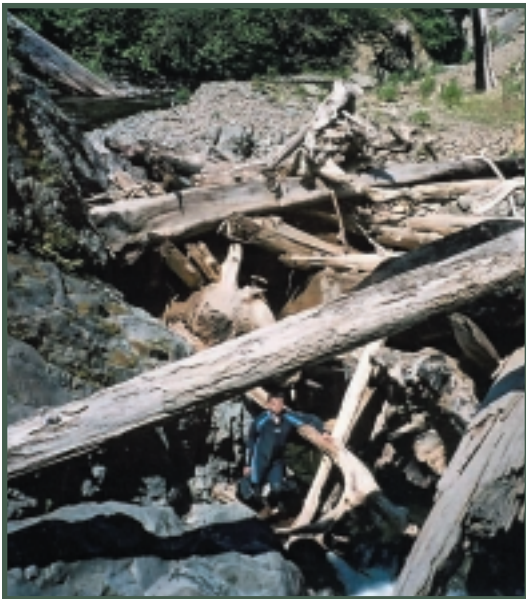
Field work is the only sure way to identify all barriers to fish passage. These sites on the Sisquoc River (top) and Terwer Creek (bottom) were newly identified in recent surveys.

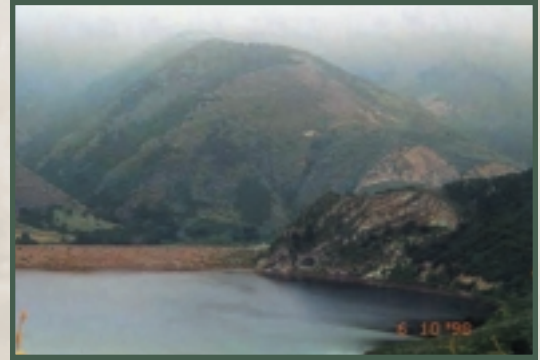
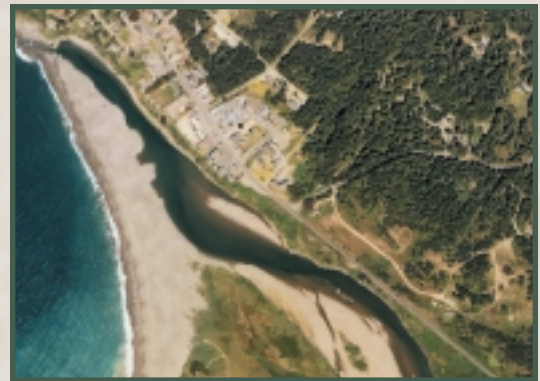
Some barriers are clearly bad, while others are beneficial. Dams, such as Twitchell Dam on the Cuyama River (above), cut off important habitat and restrict flows below the dam. In contrast, sandbars at the mouths of estuaries (below) are beneficial in their contribution to conditions vital to the successful growth of juvenile salmonids, and other life forms dependent upon healthy coastal estuaries. The Gualala River estuary and sandbar is shown.

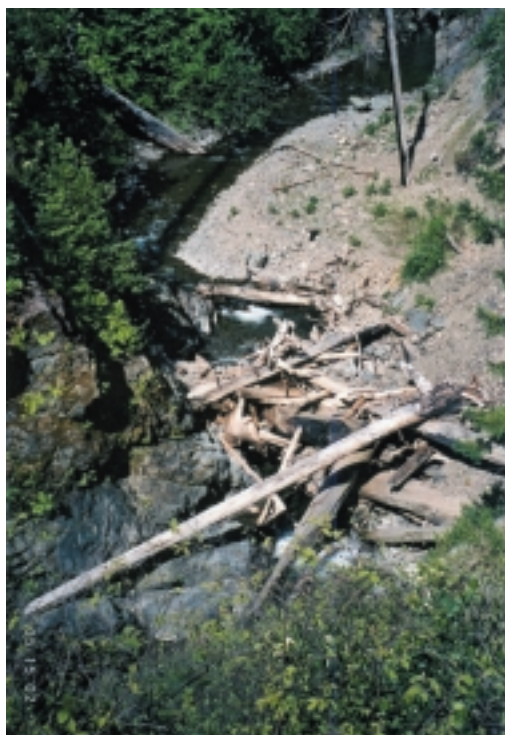
**SITE COMMENTS** Large woody debris jam posed a complete barrier to upstream passage. Modified by Yurok Tribal Fisheries Program in fall 2002 to re-establish passage. Now being monitored for project success.

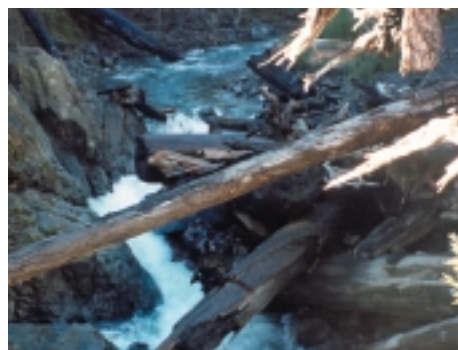
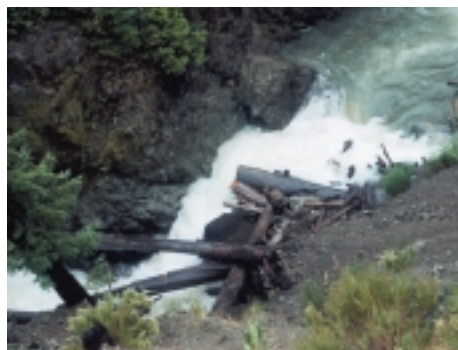
**PAD ID** 7288,7289 **STREAM** Quinby Creek (Trinity River)

**SITE COMMENTS** Good fish habitat, hardwood with few conifers in canopy. Cobbles to med/large boulders in stream bed. Large deep pool at outlet. Approximately 6.4 kilometers (4 miles 19,200 ft) of habitat above crossing. Modifying the existing culverts to improve passage should be considered due to the high cost of implementing a full replacement because the stream crossing contains nearly 6,000 cubic yards of fill material. Greater than 10% channel slope below culvert. The upstream is fairly steep and very little information exists regarding habitat quality or fish distribution. Quinby Creek may be utilized by summer-run steelhead. FishXing result: RED.

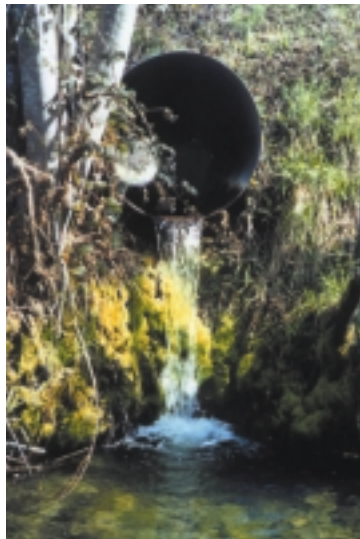
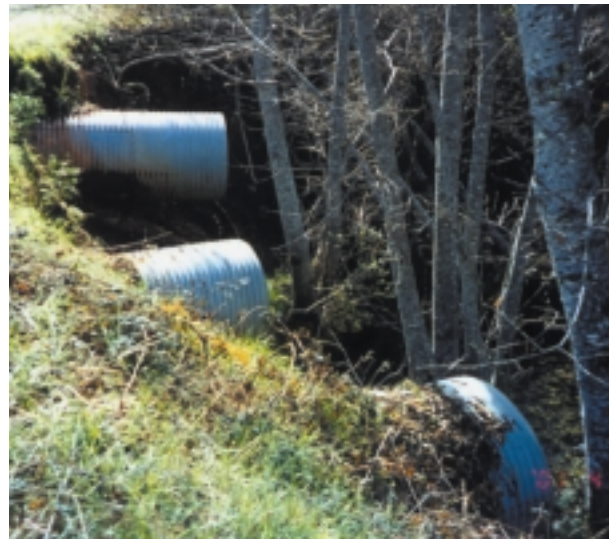
**SITE COMMENTS** This photo of the North Fork Caspar Creek fish ladder does not show the degraded condition of the facility. Leakage in the structure results in insufficient flow and impaired passability within the ladder during low flow periods — spring outmigration, summer emigration. This condition, which often precludes spawning in the upper reaches of the creek, is exactly mirrored on South Fork Caspar Creek. Additional location information: T17N, R17W, S16, USGS Mathison Peak.

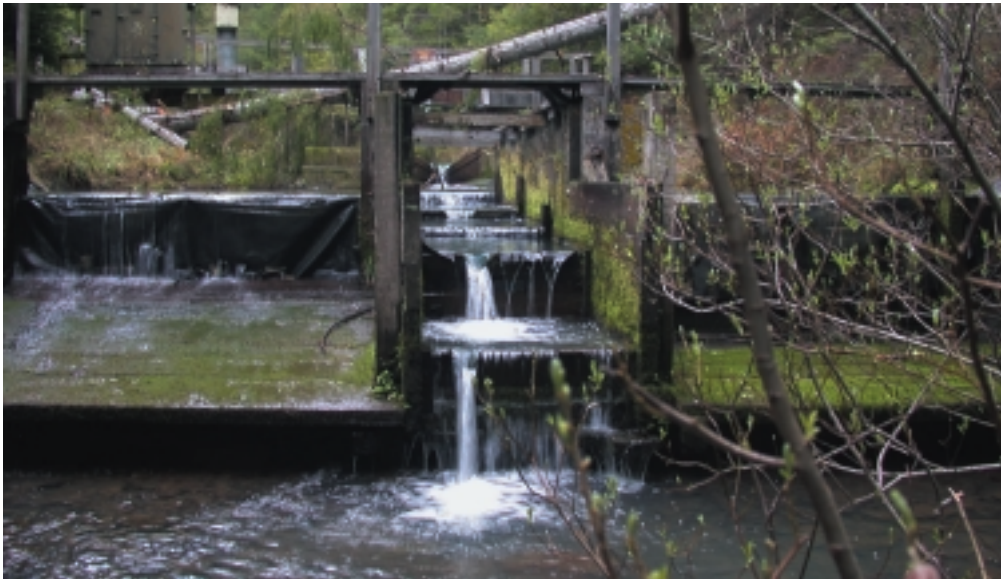
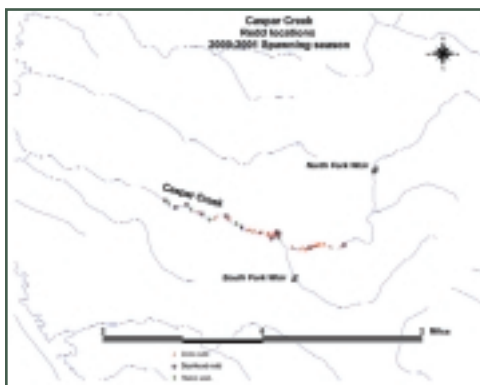
**PAD ID** 8347 **STREAM** Caspar Creek (Pacific Ocean)  
**SITE NAME** Pool and Weir with Fish Ladder in Disrepair  
**BARRIER TYPE** fish passage facility **LLID** 1238158393618 **BEG FT** 31727  
**LAT** 39.361183 **LONG** -123.73145  
**PASSAGE STATUS** partial and temporal barrier  
**TREATMENT NEEDED** yes **TREATMENT STATUS** planned  
**COUNTY** Mendocino **OWNER** Department of Forestry and Fire Protection  
**DATA SOURCE** Department of Fish and Game  
**SOURCE REFERENCE** Electronic Data File, A. Grass, D. Highland, Scott Harris  
**SOURCE COMMENTS**

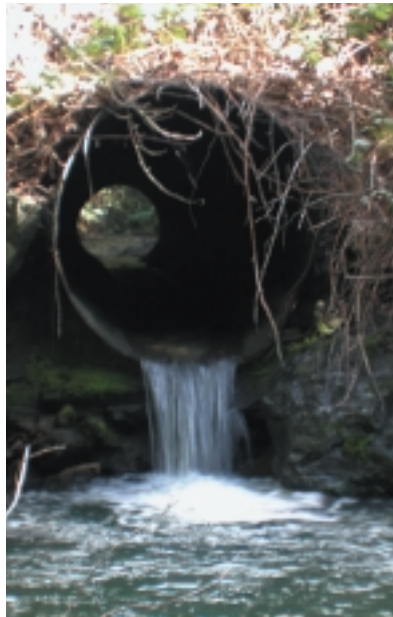
**PAD ID** 7207 **STREAM** Digger Creek (Pacific Ocean)

**SITE COMMENTS** Replaced in 2003 with an open-bottom, pre-manufactured arch structure that allows anadromous fish passage. Additional road crossings: Downstream (950' and 2,000'): two culverts within the Mendocino Coast Botanical Gardens replaced with small bridges in 2001 and 2002. Upstream (600'): Highway 1; concrete box culvert with perched outlet (about 3'); probable 100% barrier. USGS map indicates crossings exist on private roads, 600' and 2,300' upstream of Highway 1.

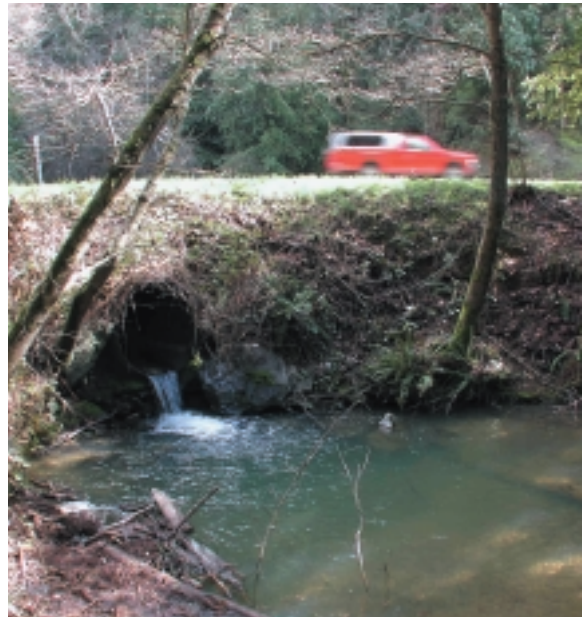
**SITE COMMENTS** Caltrans culverts blocking North and South Forks Ryan Creek, tributary to mainstem Eel River. Planned removal of county road culvert immediately downstream of Caltrans culverts in summer 2003 will provide anadromous fish passage to 8545 and 8546, thereby increasing opportunities for providing fish passage throughout this tributary.

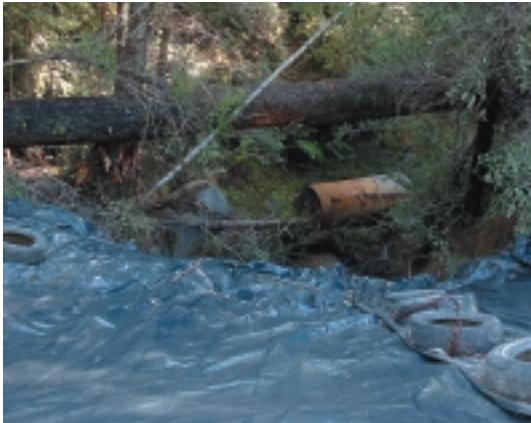
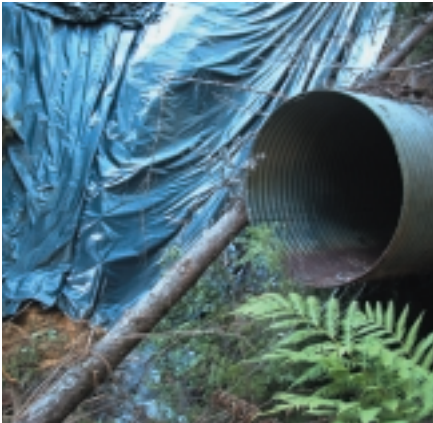
**SITE COMMENTS** Culvert will be replaced with bridge. Bridge Creek is tributary to South Branch North Fork Navarro River. Barrier affects 2.4 kilometers (1.5 miles) of stream habitat in good condition above barrier that would be good steelhead spawning and juvenile rearing habitat. Coho salmon have been observed in the South Branch North Fork Navarro in select years; coho are present in North Fork Navarro. Imminent failure of barrier will deposit large amounts of sediment downstream and into the Navarro River. Site visited by DFG personnel.

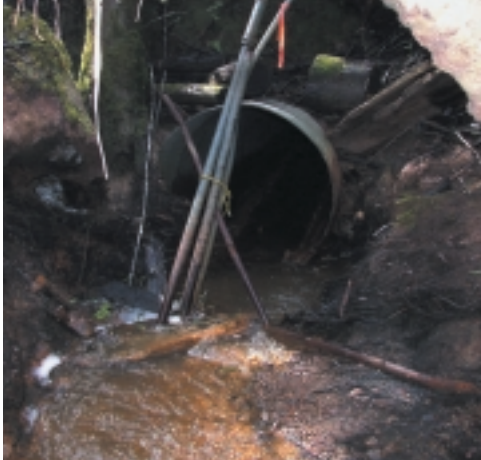
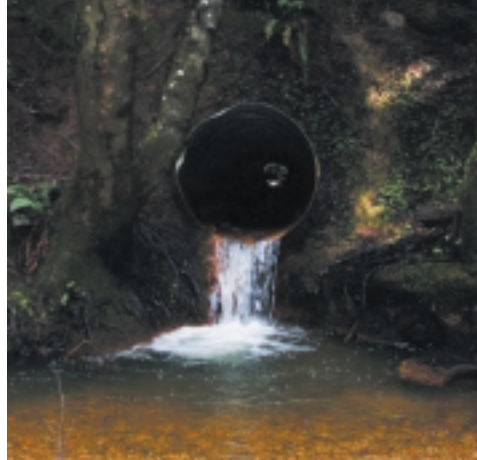
**PAD ID** 199892 **STREAM** Willow Creek (Russian River)

**SITE COMMENTS** County road fill across flood plain. Barrier affects  $\pm$  4.8 kilometers (3 miles) of fish habitat along Willow Creek by blocking passage during outward migration of coho and steelhead. Currently, the road is a barrier to both fish passage and sediment transport. Barrier date: installed about 1970.

**TREATMENT NEEDED** yes **TREATMENT STATUS** planned. Tentative plans are to remove a portion of the road across the flood plain and replace it with a span bridge that will allow fish and sediment to pass. Estimated cost to replace road and culvert with a bridge is \$1–2 million. No funding is currently available.

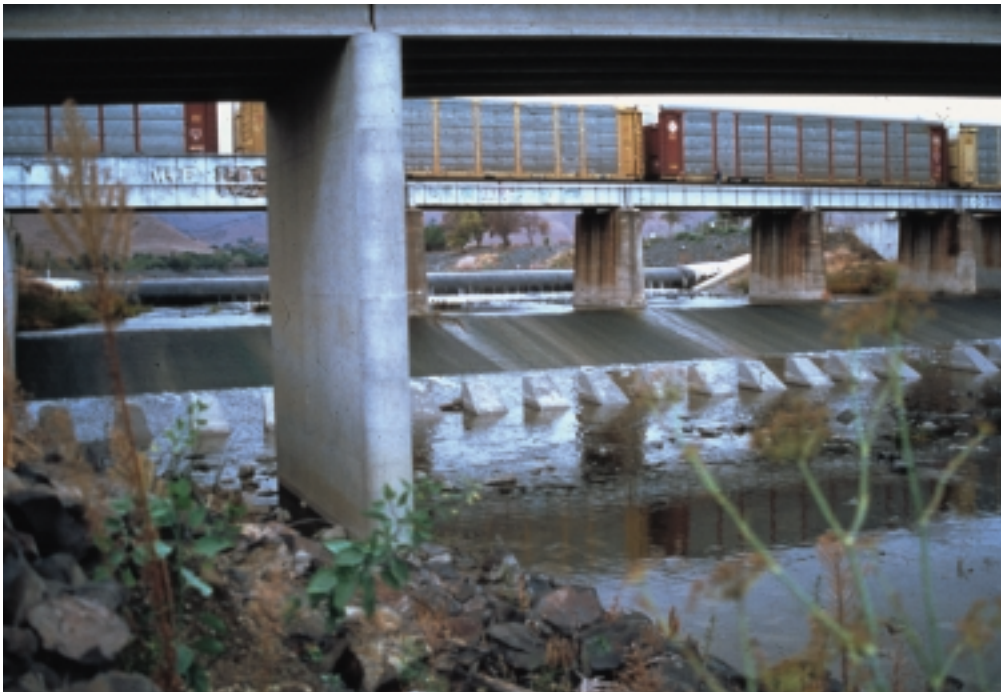
**PAD ID** 76 **STREAM** Alameda Creek (San Francisco Bay)  
**SITE NAME** Bay Area Rapid Transit Weir  
**BARRIER TYPE** grade control structure **LLID** 1221458375945 **BEG FT** 59234

**SOURCE COMMENTS** Project planning details available from Coastal Conservancy.  
**SITE COMMENTS** The concrete apron of the BART Weir is an impassable fish barrier due  
to its steep slope and the high sheeting velocities that occur over its surface. A proposed  
fishway would lift fish from the drop structure area to the pool upstream of the Middle  
Inflatable Dam regardless of whether the dam is inflated or not. The proposed design  
eliminates the need for two separate ladders and the possibility of fish falling back over  
the BART Weir's sloping apron. The lower portion of the fishway is designed as a vertical  
slot fishway for fish passage when the Middle Inflatable Dam is deflated. The proposed  
design affords the least channel constriction at the top of the drop structure of options  
considered. It also can be constructed without compromising the structural integrity of  
the adjacent retaining walls and bridge footings.

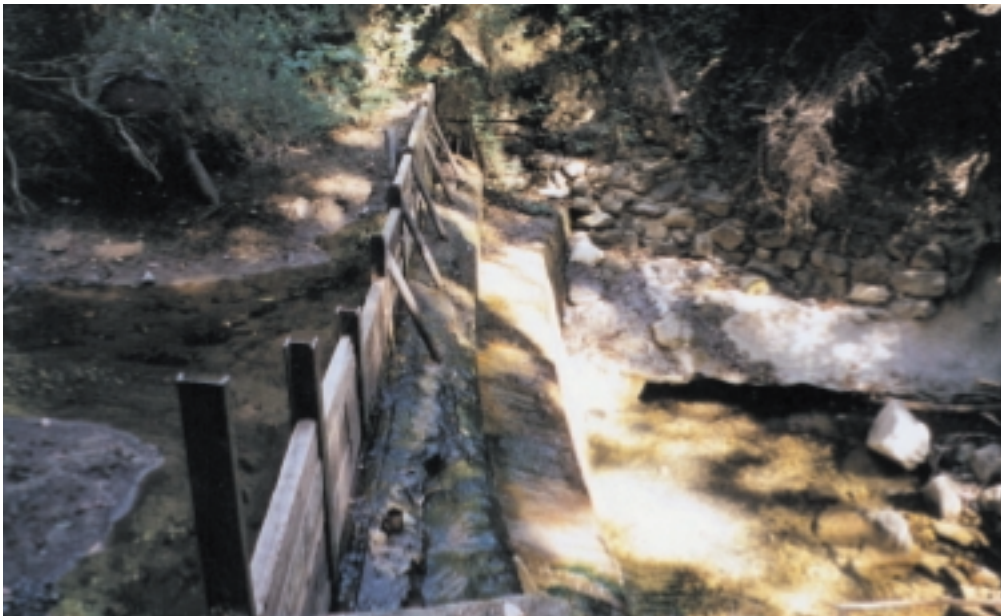
**PAD ID** 7084 **STREAM** Bear Gulch (San Francisquito Creek/San Francisco Bay)  
**SITE NAME** Bear Gulch Diversion Dam #15  
**BARRIER TYPE** dam **LLID** **BEG FT**

**SOURCE COMMENTS** Additional information available.  
**SITE COMMENTS** Pre-1914 (1860's) dam used as a diversion location for large domestic water supply. Pool at the base of the ten-foot high dam is roughly one-foot deep. Water is diverted to Bear Gulch Reservoir east of Woodside. The dam blocks access to 0.96 kilometers (0.6 miles) of habitat with relatively good pools, good substrate conditions, and high summer streamflow. Discussions should be undertaken with California Water Service about potential modification of the structure (including lowering) that would improve fish passage and maintain or improve water diversion operations.

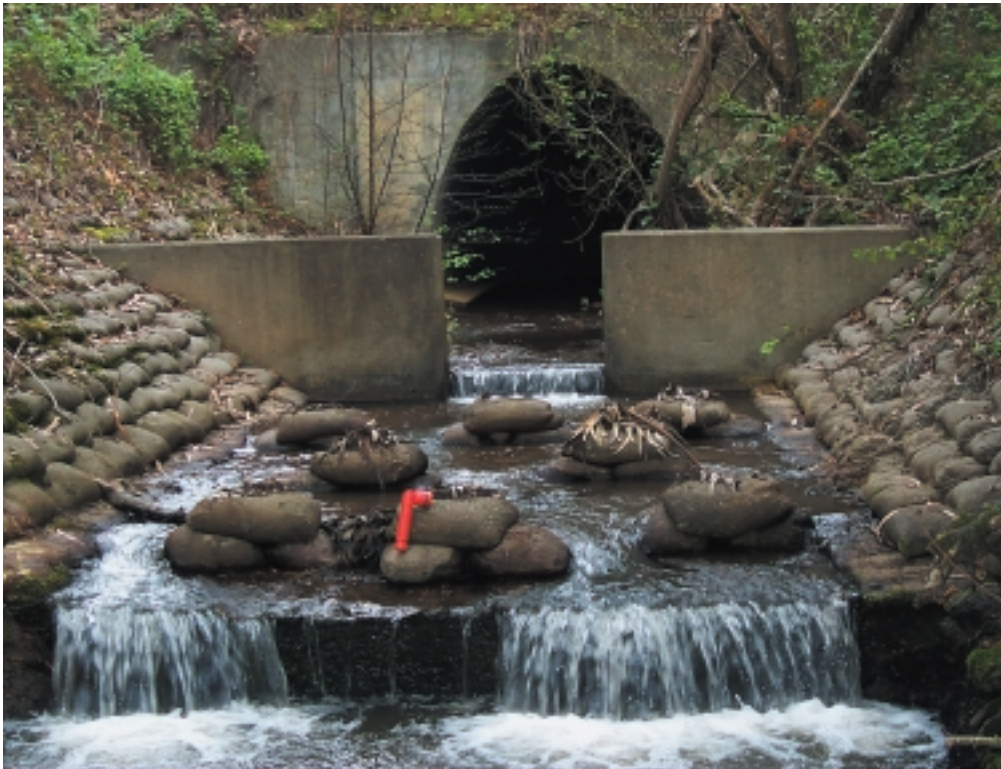
**SITE COMMENTS** Concrete culvert, 300 feet in length, curved with the upstream half one foot higher than the downstream half. Significant almost-barrier near the ocean, adversely affects fish production in a largely-protected watershed. Coho are not known from this watershed, but it is in the middle of their southern range and they might come back if passage is provided. A local stakeholder group is interested.

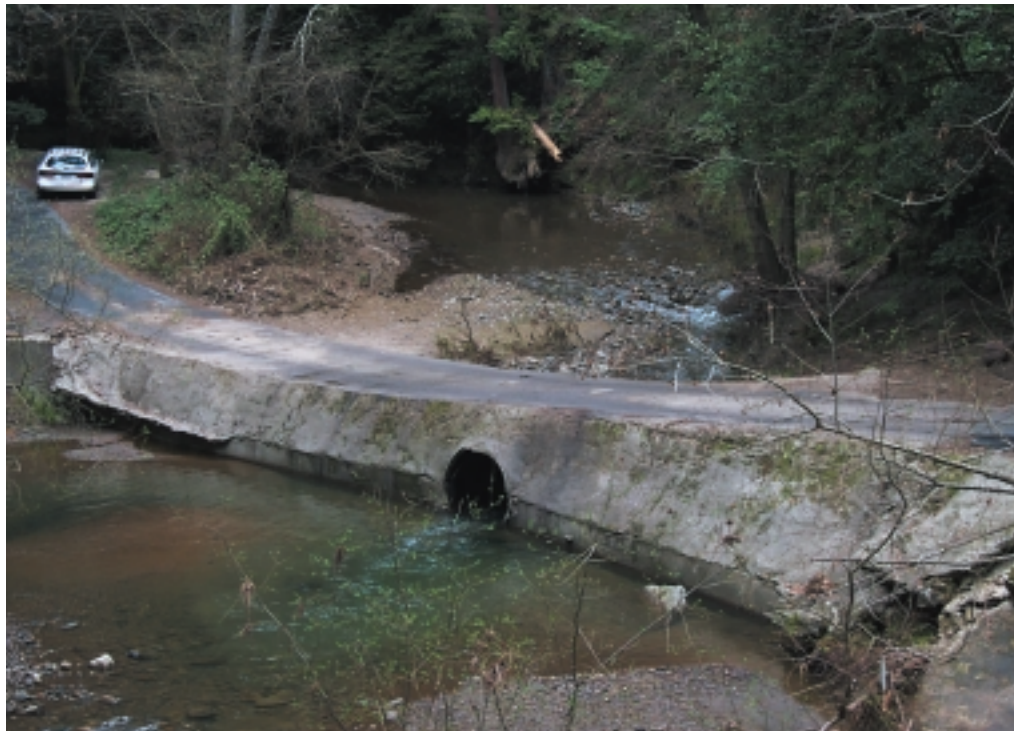
**SITE COMMENTS** Five-foot diameter culvert (defunct) through concrete ford crossing channel. Remediation: remove and replace with bridge or notch center with grate on top. Total length of anadromy 11.4 kilometers (7.1 miles). Significant impediments that adversely affect fish production in a watershed that seems to be a refuge in the Soquel system, and were identified as such by a stakeholder-led comprehensive watershed assessment. It's coho habitat.

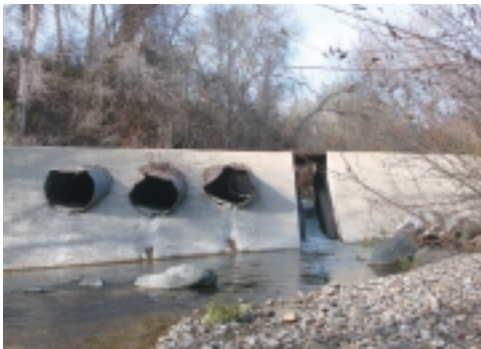
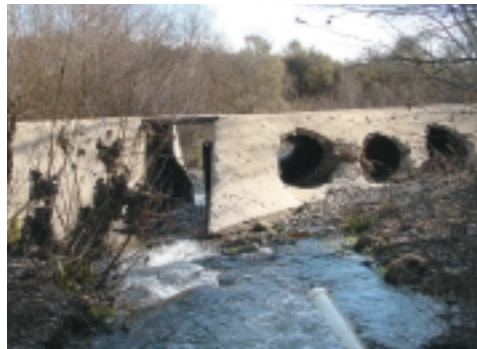
**PAD ID** 188 **STREAM** Santa Rosa Creek (Pacific Ocean)  
**SITE NAME** Ferrasci Road Culverts and Denil Ladders  
**BARRIER TYPE** road crossing (culvert) **LLID** 1211105355685 **BEG FT** 17431  
**LAT** 35.5687 **LONG** -120.06445  
**PASSAGE STATUS** temporal  
**TREATMENT NEEDED** yes **TREATMENT STATUS** unknown  
**COUNTY** San Luis Obispo **OWNER** San Luis Obispo County  
**DATA SOURCE** CDFG, Land Conservancy of SLO Co., California Conservation Corps  
**SOURCE REFERENCE** Electronic Data File, B. Stark, Electronic Data File, A. Grass, D. Highland

**SITE COMMENTS** Barrier at high flows, frequently plugs with debris, highest priority, hydraulic assessment completed, regional priority. The crossing was installed by the county in 1965 and the ladder was inserted at a later date after the crossing had caused down cutting. The culverts are 4 ft. dia. and the ladder is slightly wider. It is a denil type with metal baffles. This creek moves a lot of bedload up to boulder size, woody and vegetative debris and agricultural debris (fence wire, plastic, old machine parts, pipe, etc.) and plugs or is obstructed after virtually every significant storm.

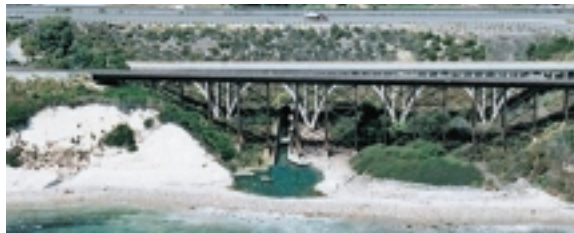
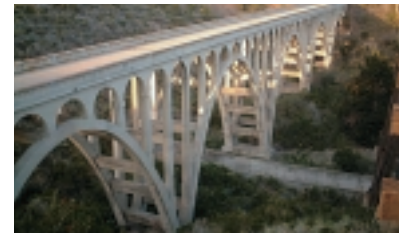
**SITE COMMENTS** Fishway planned. Submitted plans for improvement. Total length of structure: 0.09 miles. It appears upstream steelhead passage is possible during moderate to high flow conditions when there is adequate water depth inside the mild sloping culvert and moderate water velocities are encountered. However, the window of opportunity for steelhead to pass upstream is very short and may not occur often, or at all, during a migration season with low stream flows. Excellent salmonid habitat conditions exist in Arroyo Hondo Creek upstream of the highway. This is the only anthropogenic barrier on the creek and improving access at this culvert ensures access to all accessible habitat in the watershed. Photo right: [www.westcoastroads.com](http://www.westcoastroads.com).

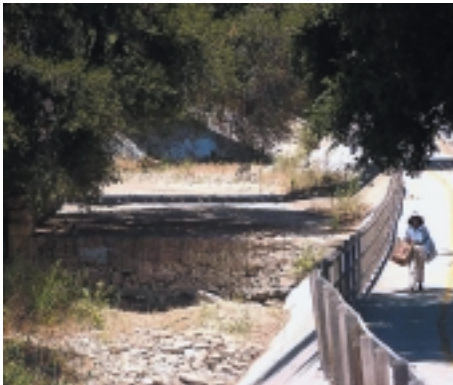
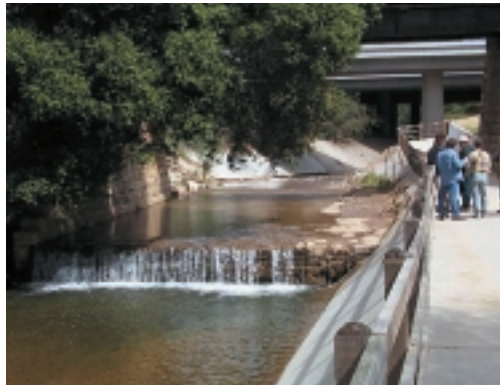
**PAD ID** 8926 **STREAM** Mission Creek (Pacific Ocean)

**SITE COMMENTS** Total length of structure: 0.74 miles. From Castillo Bridge to upstream of Arrellaga Bridge. During low flows, upstream steelhead migration is not possible due to the unconfined, shallow water depth throughout the channel. When adequate water depth occurs in the channel, accelerated stream velocities are sustained throughout the long channel with no velocity breaks. Upstream steelhead passage is prevented due to exhaustion attempting to migrate the long channel. Location identified by the Environmental Defense Center. Due to the structural and political complexity of providing flood control and landowner safety, stream restoration and steelhead passage in lower Mission Creek needs to be addressed in a much larger planning process that seems to be moving forward in Santa Barbara. In order to make the most informed decision about the future of lower Mission Creek, a watershed-focused stakeholder planning process should be initiated that assesses long-term fish passage alternatives from the ocean to at least the Santa Barbara Natural History Museum. Photo: David Pritchett.

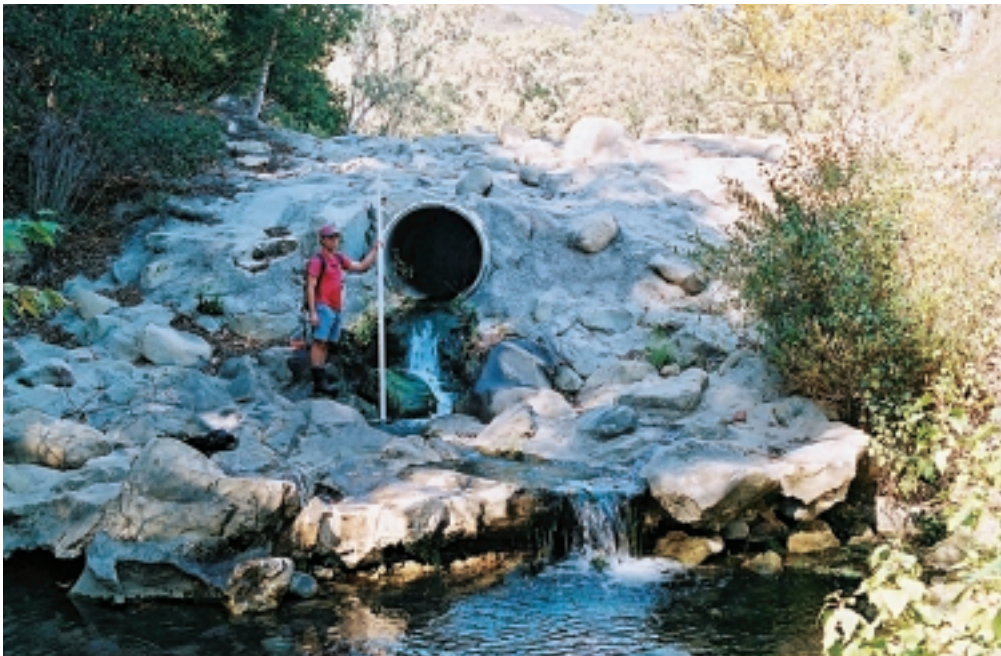
**PAD ID** 7870 **STREAM** Carpinteria Creek (Pacific Ocean)  
**SITE NAME** Private Bridge and Channelization  
**BARRIER TYPE** road crossing **LLID** 1195195343904 **BEG FT** 15470  
**LAT** **LONG**  
**PASSAGE STATUS** total barrier  
**TREATMENT NEEDED** yes **TREATMENT STATUS** unknown  
**COUNTY** Santa Barbara **OWNER** private landowner(s) (non-corporate)  
**DATA SOURCE** Matt W. Stoecker and Conception Coast Project  
**SOURCE REFERENCE** Steelhead Assessment and Recovery Opportunities in Southern Santa Barbara  
**SOURCE COMMENTS**  
**SITE COMMENTS** Due to the combined difficulty of migrating across this complex structure, upstream steelhead migration is likely completely blocked.

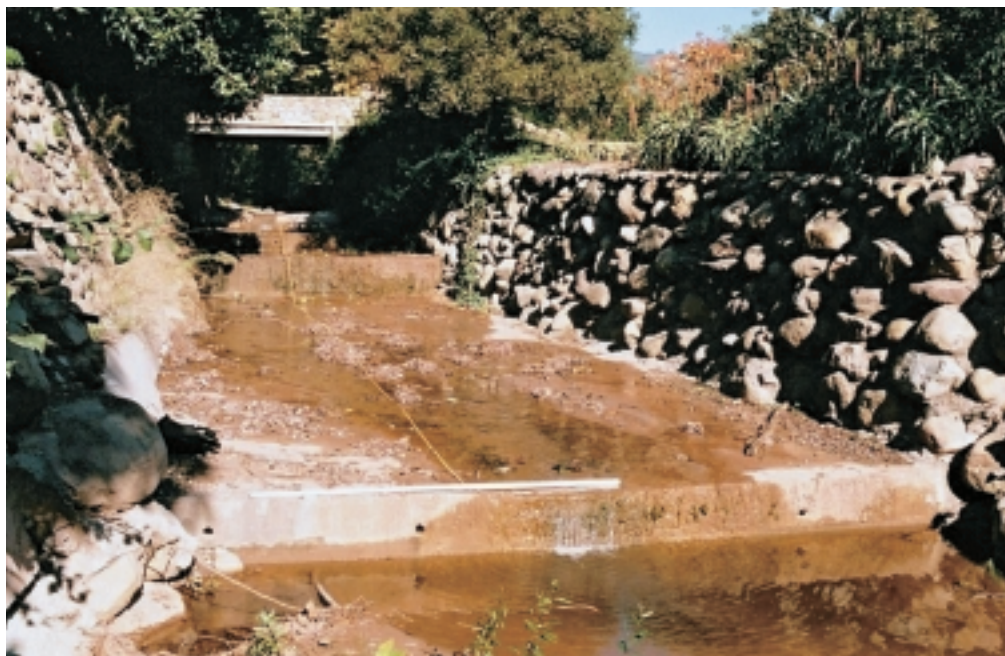
**PAD ID** 7879 **STREAM** Gobernador Creek (Carpinteria Creek)

**SITE COMMENTS** The downstream pool has sufficient depth for a steelhead to execute a vertical jump of at least six feet and likely more during high flows as the pool becomes deeper. During migration flows, the 10-foot vertical jump and 15-foot horizontal jump to the crossing make this structure impassable to upstream migrating steelhead. The small, smooth metal culverts provide no opportunity for fish passage.

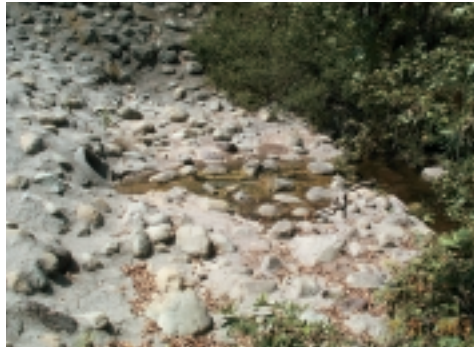
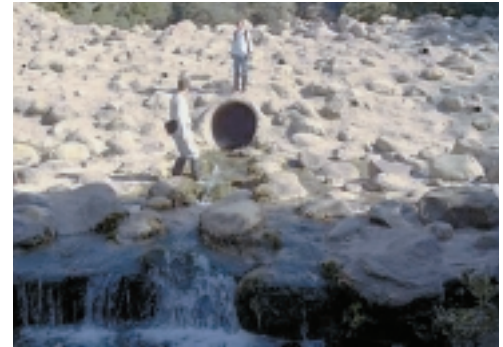
**SITE COMMENTS** During migration flows, the jump onto the apron and passage among the large embedded boulders would be moderately difficult for adult steelhead. The long, smooth culvert through the debris dam is impassable to upstream migrating steelhead due to the shallow water depth during low flows and the excessive water velocities during moderate and high flows. Photo left: Santa Barbara County Flood Control and Water Conservation District.

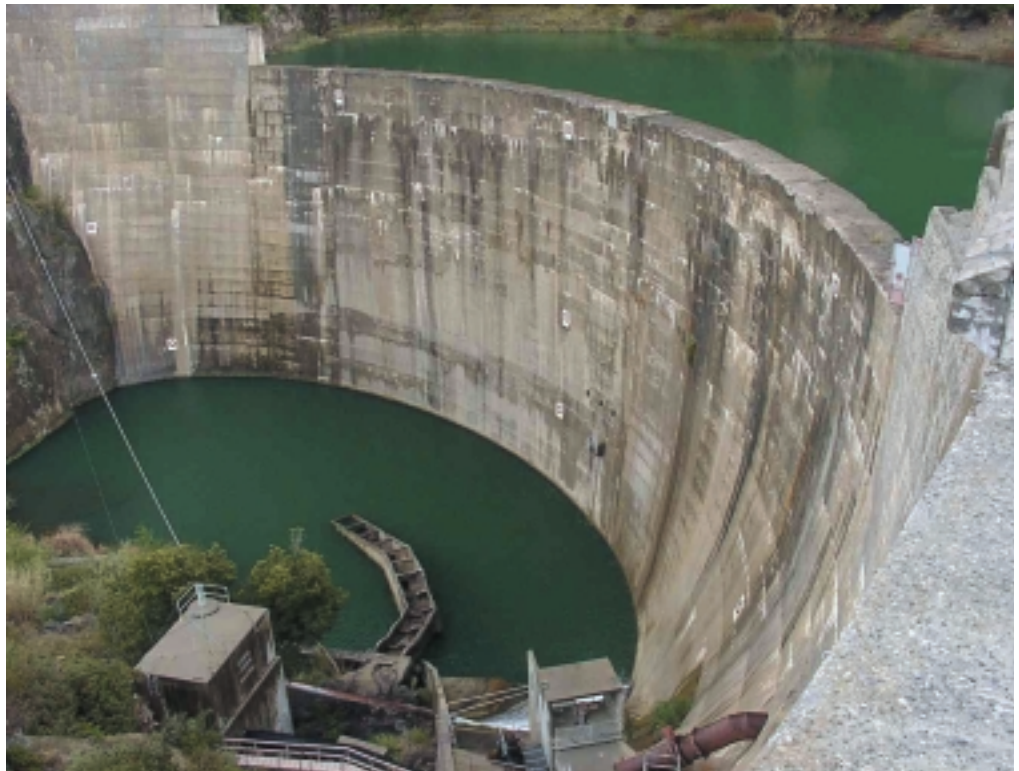
**SITE COMMENTS** Middle Fork of Matilija Creek. Decrepit fish ladder boxes below, reservoir above. Dam removal feasibility study now underway. Photo: David Pritchett.

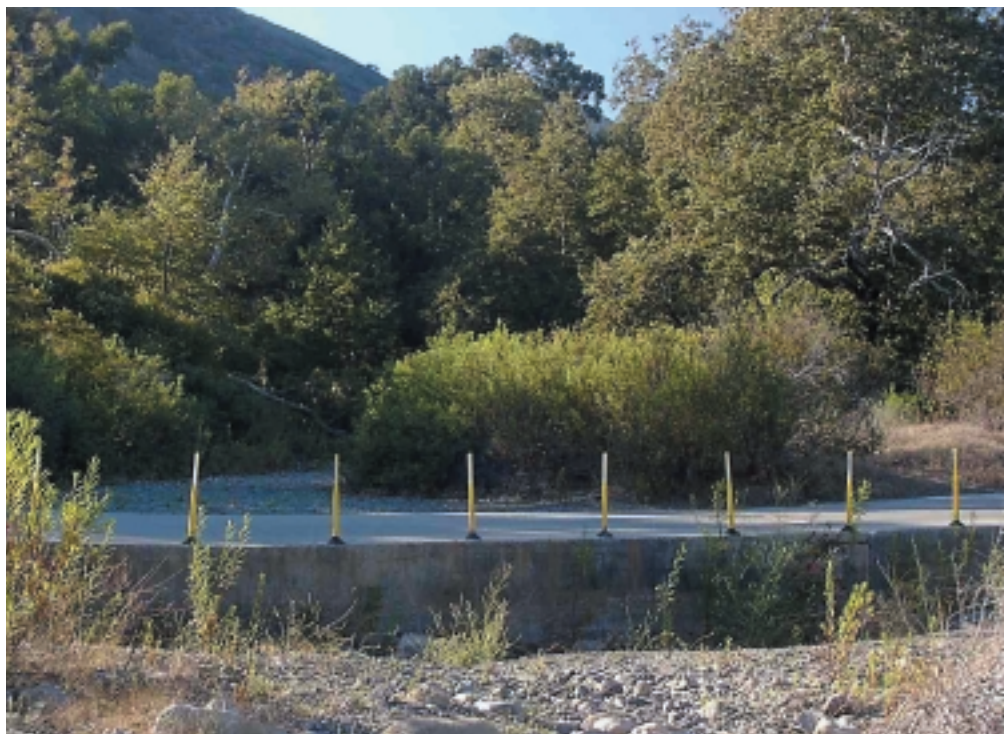
**SITE COMMENTS** Barrier during high flow periods. Arizona crossing is constructed by pouring a concrete apron across a portion of the streambed to allow for a low water crossing for vehicles. A hefty road crossing connecting campground to beach. Vertical drop about 1.3 meters at time of picture, autumn 2002. Site to be analyzed fully in Coastal Conservancy-funded assessment of Santa Monica Mountains streams, led by CalTrout. Steelhead occasionally sited in upper Arroyo Sequit, but passage improvement needed. Photo: David Pritchett.

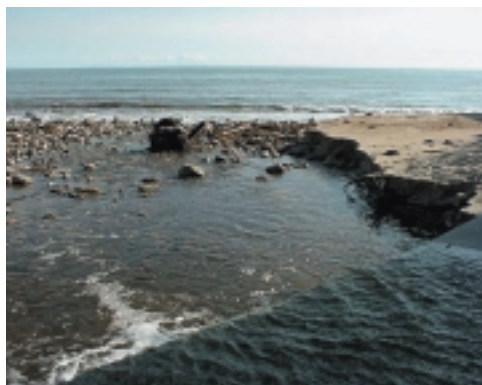
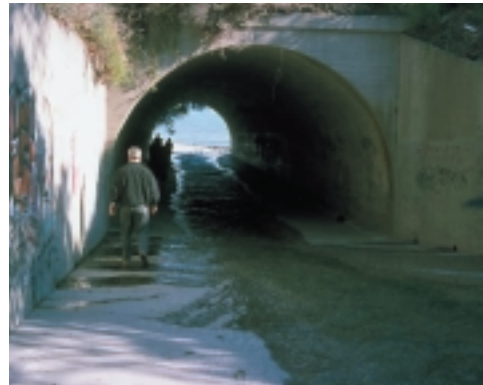
**SITE COMMENTS** Two highway culverts. Caltrans is in the process of removing the road culvert. Four Arizona crossings and several other man-made structures are upstream.

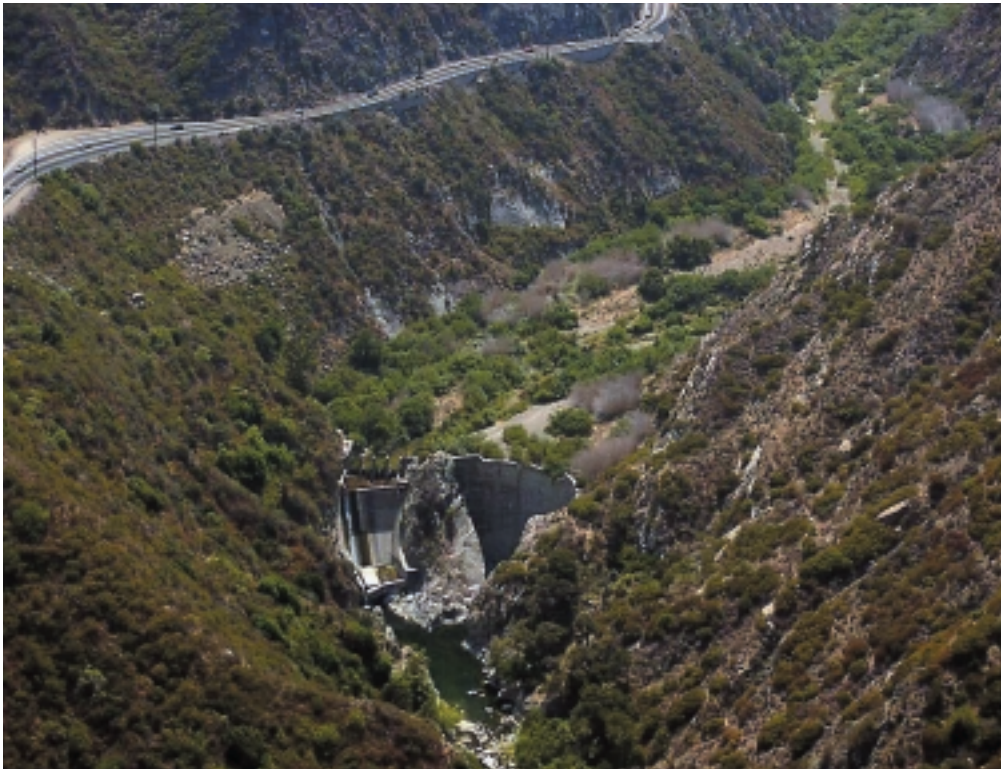
**SITE NAME** Rindge Dam

**SITE COMMENTS** 3.8 kilometers (2.4 miles) upstream from ocean. Feasibility study now underway following models developed for Matilija Dam study. Funds provided by Coastal Conservancy and Santa Monica Bay Project. Photo: David Pritchett (view from Piuma Road, across canyon from Malibu Canyon Road).

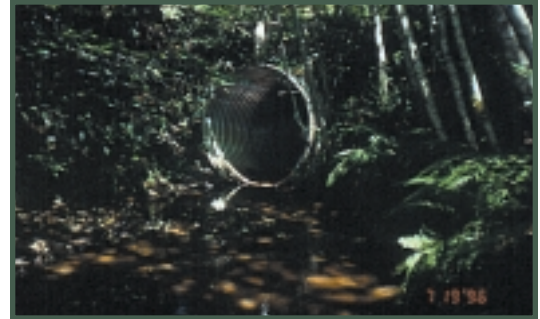
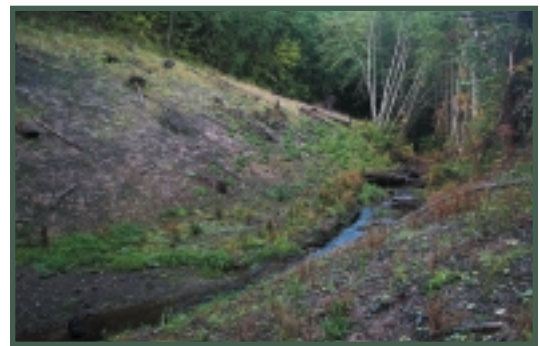
Removing barriers can be done, at relatively low cost, with high benefits both in terms of recovery of species, and maintenance of infrastructure. Here at McGarvey Creek, tributary to the Klamath River, a 100-foot culvert posing a complete barrier to fish migration was removed, as well as the soil on top of it, the channel was restored to its original configuration, and steelhead may now access habitat upstream of the restoration site. Moreover, the costly maintenance of this site is no longer a concern to the landowner, Simpson Resource Management, Inc.

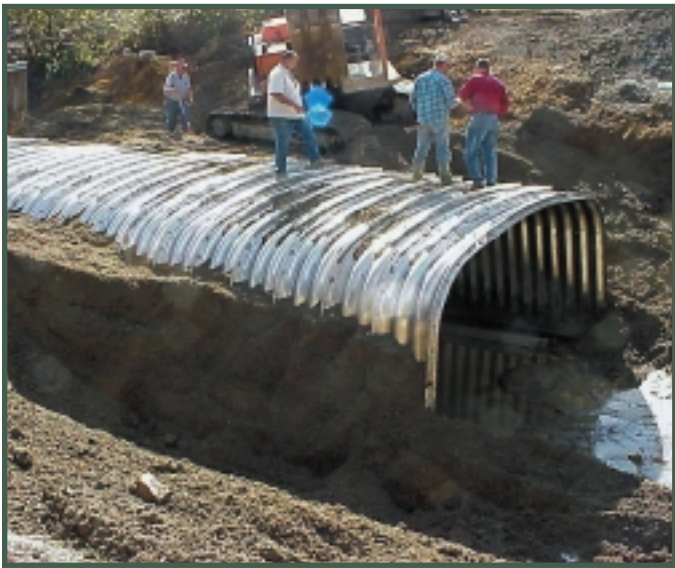
Although initial costs seem high, County governments realize substantial, long-term savings in maintenance costs from fish passage improvement projects, such as this installation of a fish-friendly, natural-bottom culvert at Jordan Creek, Del Norte County.
